# GALWAY'S HERITAGE IN STONE

## Catalogue No. 9

### The 2023 Archaeological and Conservation Works at St. Nicholas' Collegiate Church Galway and Menlo Castle

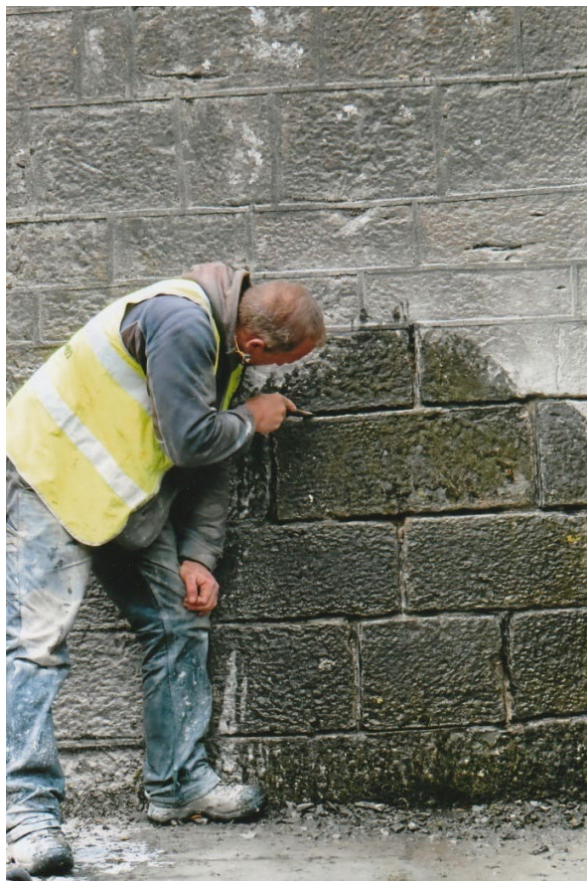
*Fig. 3 Laurik Mathieu, Conservation Stone Mason raking out joints on the exterior of the south transept extension. The raised ribbon pointing was applied during works carried out between 1958 and 1962. Old photographs taken before that date show flush pointing with eroded lime mortar pointing. The raised ribbon pointing has trapped moisture in the core of the wall. Photograph: J. Higgins.*

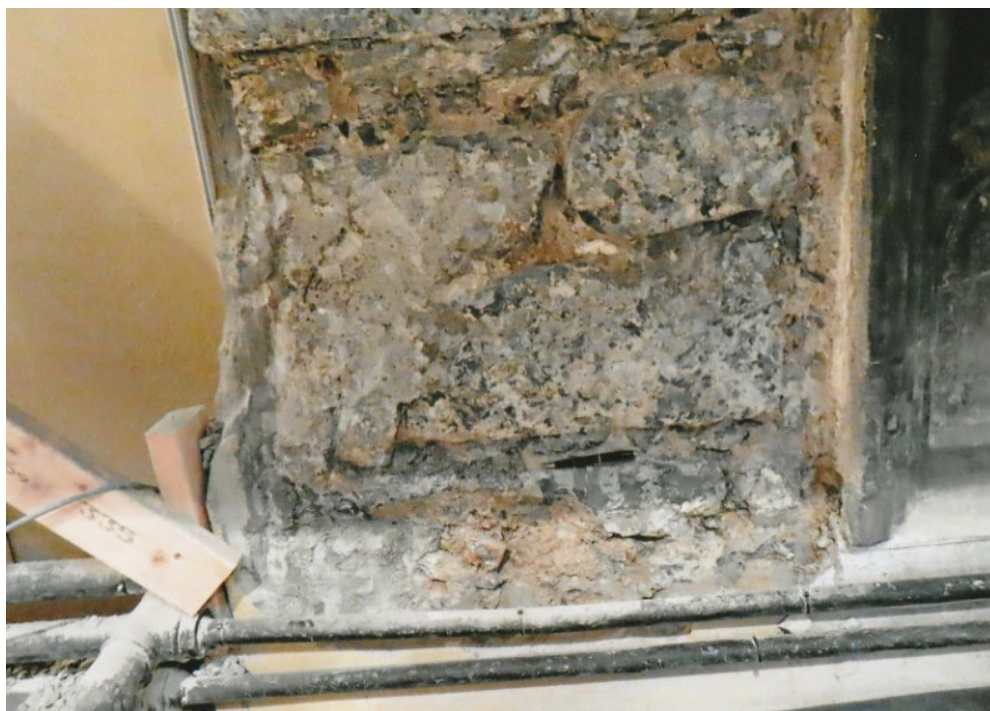
*Fig. 4 Part of the rectangular surround to the flamboyant canopied and traceried wall tomb or wall frame. This incorporates reused stone of 12-14th century date as well as 15th and 16th century material. The stone with the pen on it projects by about 6cms from the wall face and has two wedge-like stones similar to a relieving arch on top of it. This is a broken lintel, a crude fill below it. It is possible that there was an entrance to a vault here. Photograph: J. Higgins.*

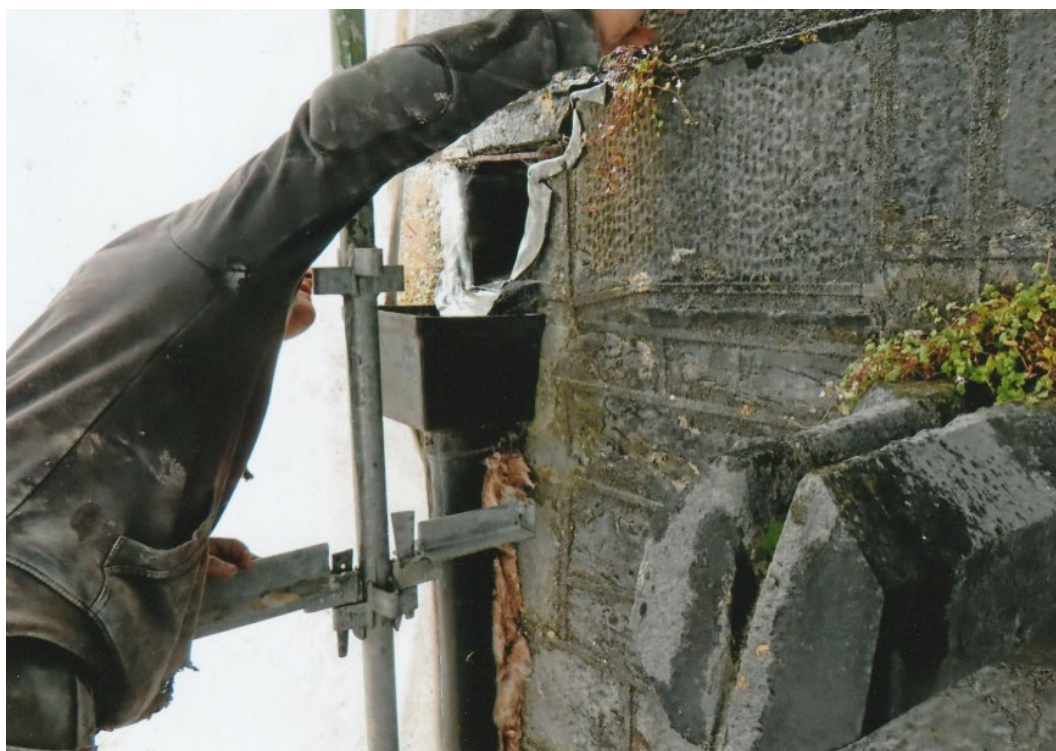
*Fig. 6 The 19th century water spouts became defunct when a metal lined conduit was set behind the parapet and fed into the down pipes in the 1958-62 works. Photograph: J. Higgins.*

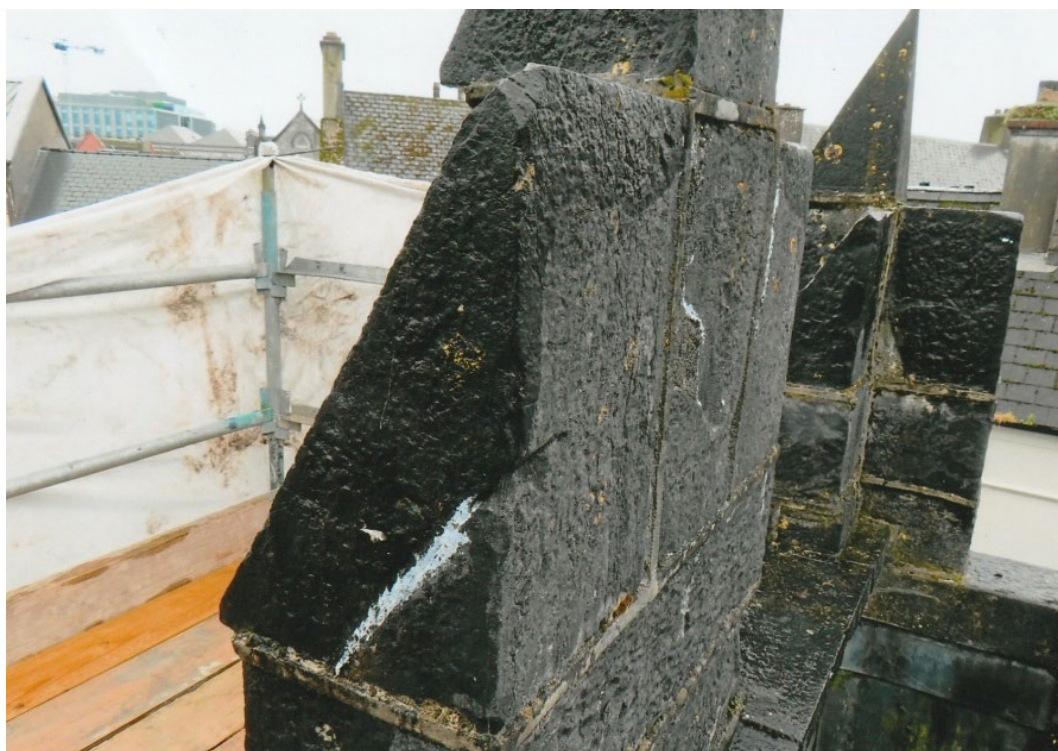
*Fig. 8 The crenellations are of several dates and have been re-set. Mastic used to repair breaches in the stone in the 1990's or 2000's was removed and replaced with lime mortar. Photograph: J. Higgins.*

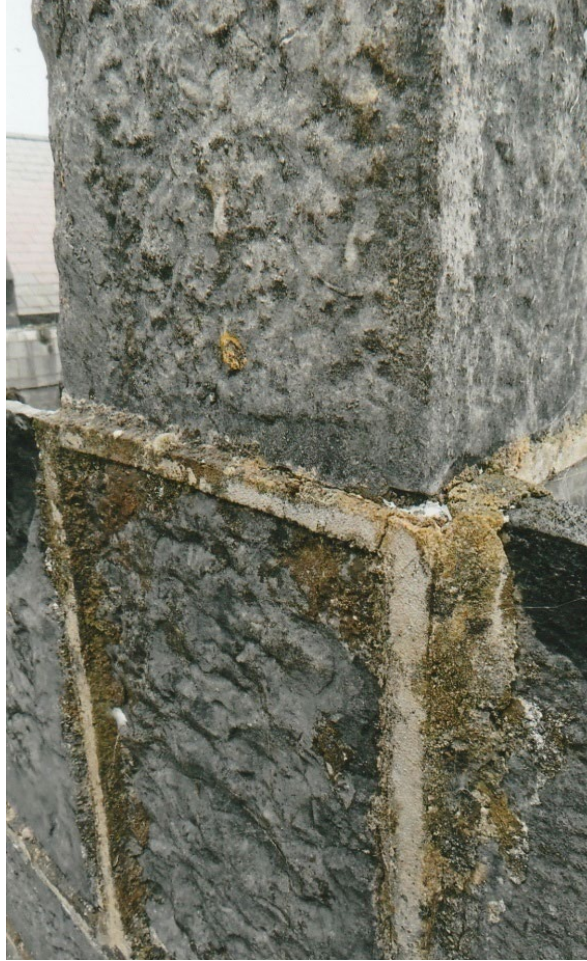
*Fig. 9 Recent mortar raised strip-pointing was put over mastic in places. This has now been removed and replaced with a lime mortar mix set back in the joints. Photograph: J. Higgins.*

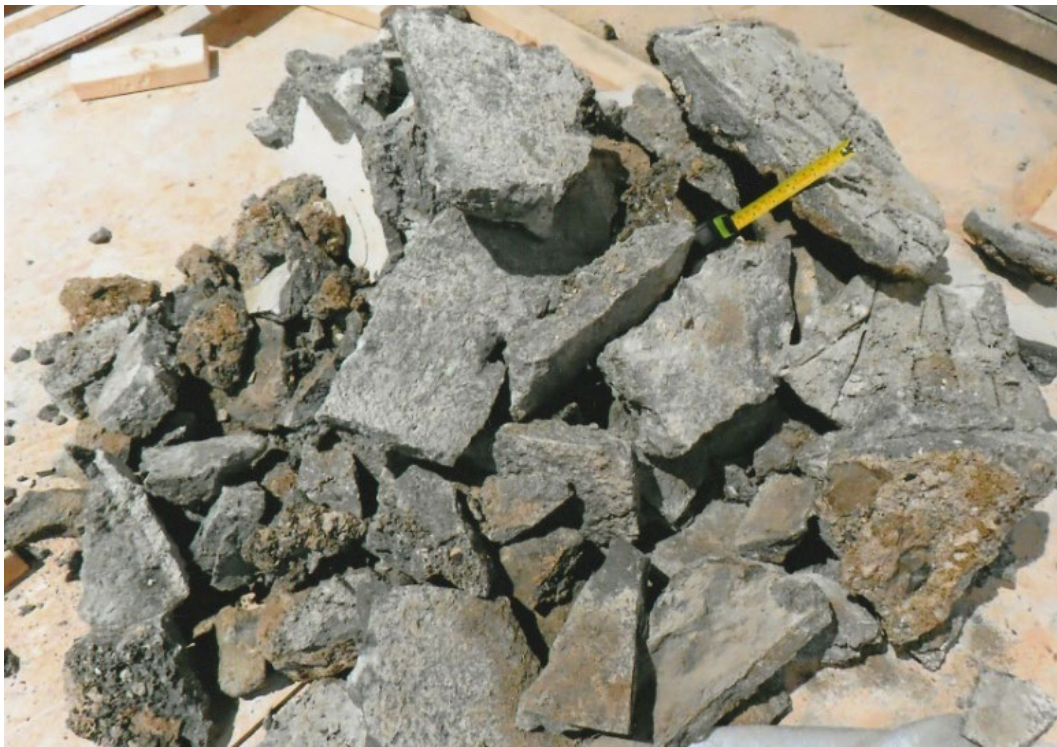
*Fig. 12 Cementitious, mortar and stone along with degraded brown and grey mortar from the infill of the upper window of the South Transept Extension. Photograph: J. Higgins.*

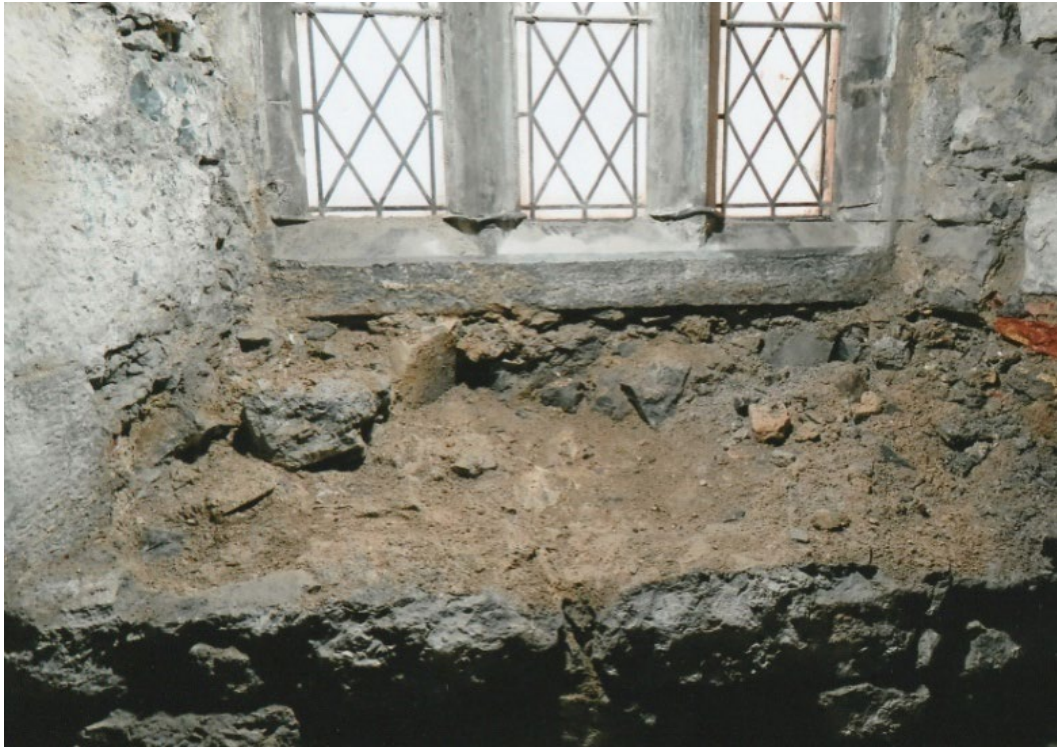
*Fig. 13 The inclined base of the ingoing of the upper window of the south transept extension after the removal of the 1958-62 concrete capping. Note the red brick in the right side of the ingoing. Photograph: J. Higgins.*

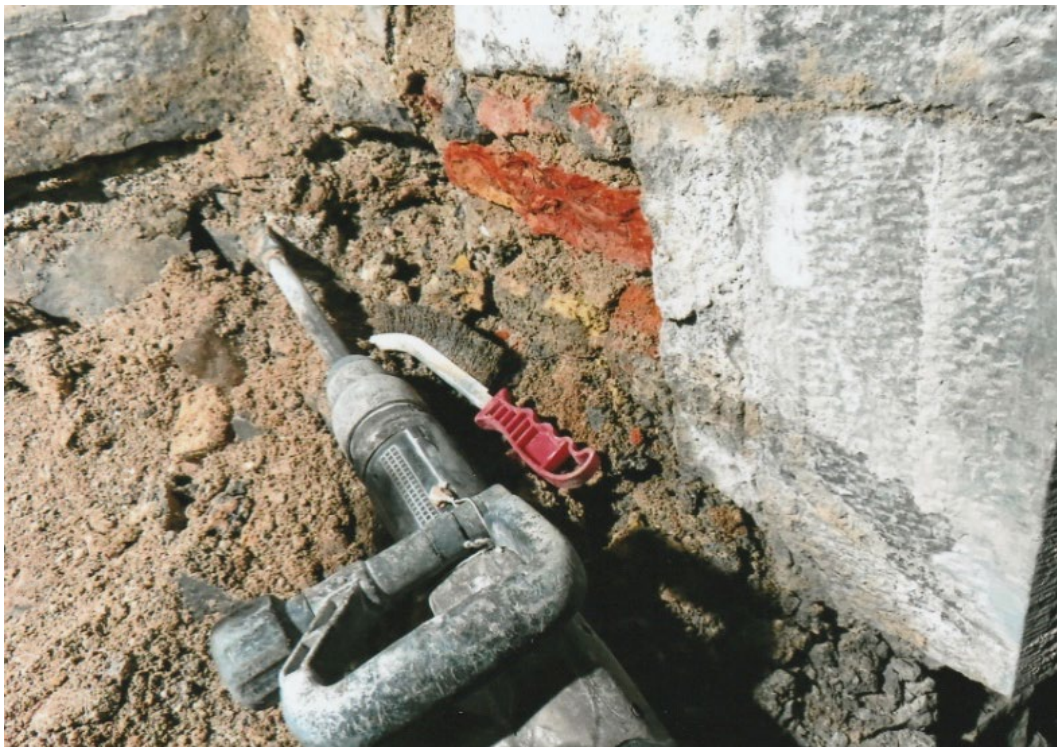
*Fig. 14 The ingoing of the upper window part of the window is rebuilt. The block of ashlar and brick on the right are indications of repair or rebuilding. Note the post-medieval tooling on the stone. Photograph: J. Higgins.*

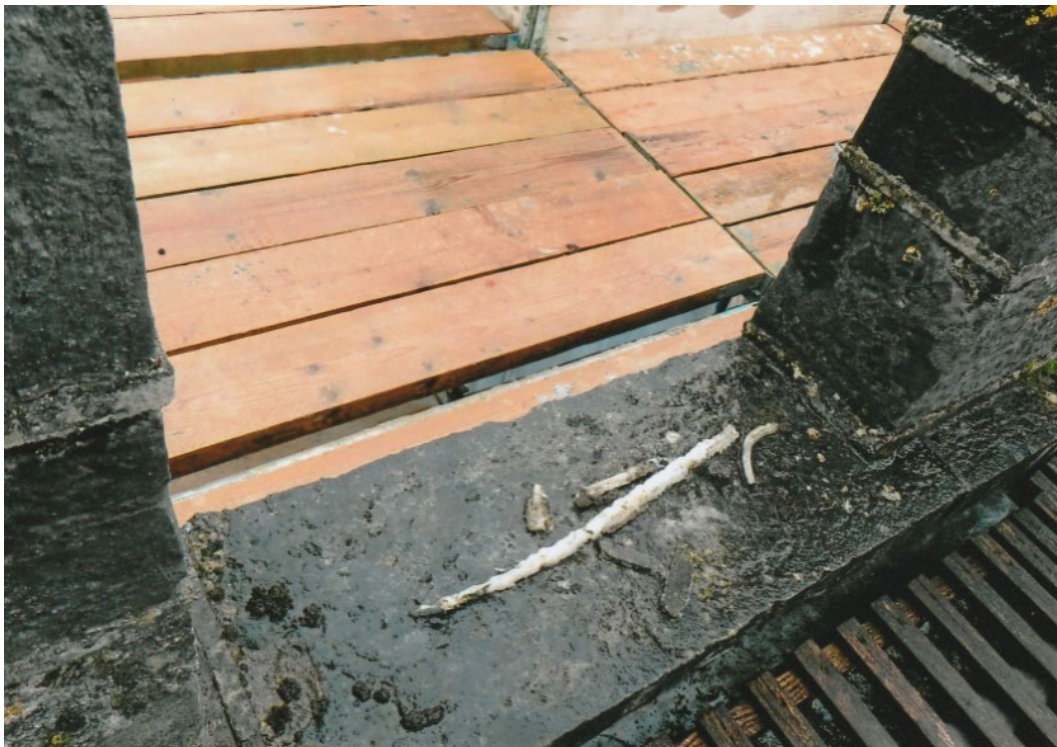
*Fig. 31 In the last few decades the crenellations had been “pointed” with mastic and cementations and non-cementations raised bands. These inappropriate materials have been removed. Note the post-medieval string course on which the crenellations had been set. Photograph: J. Higgins.*

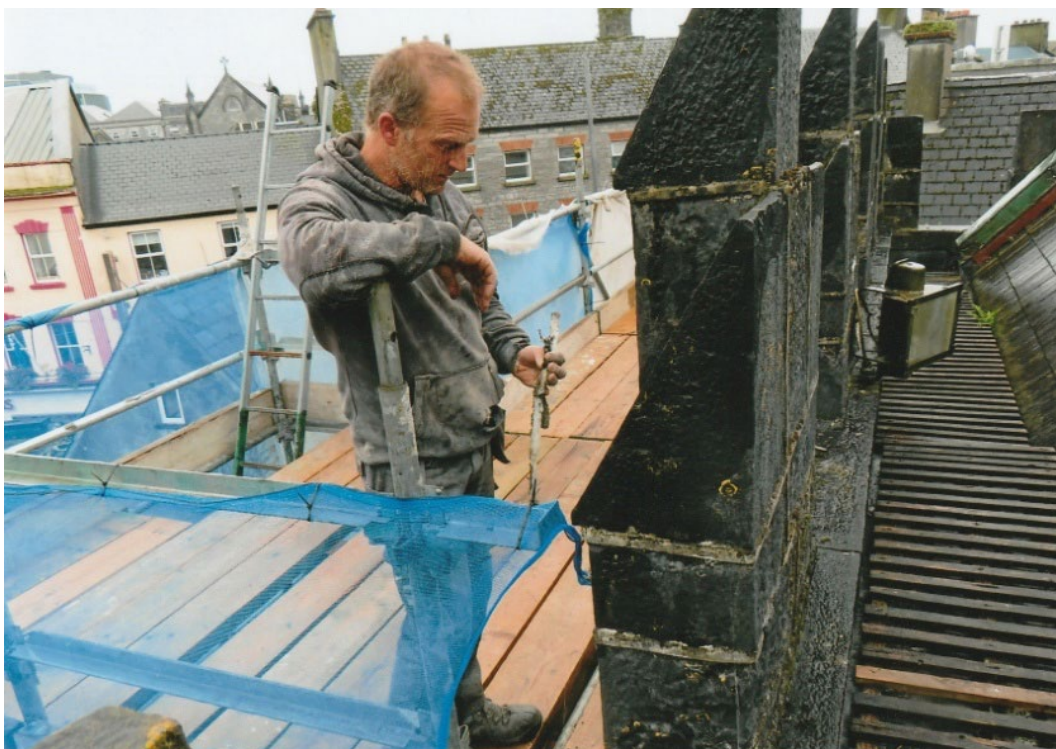
*Fig. 32 Removing mastic “strip pointing” in some areas mortar pointing had been used over mastic and was failing. Photograph: J. Higgins.*

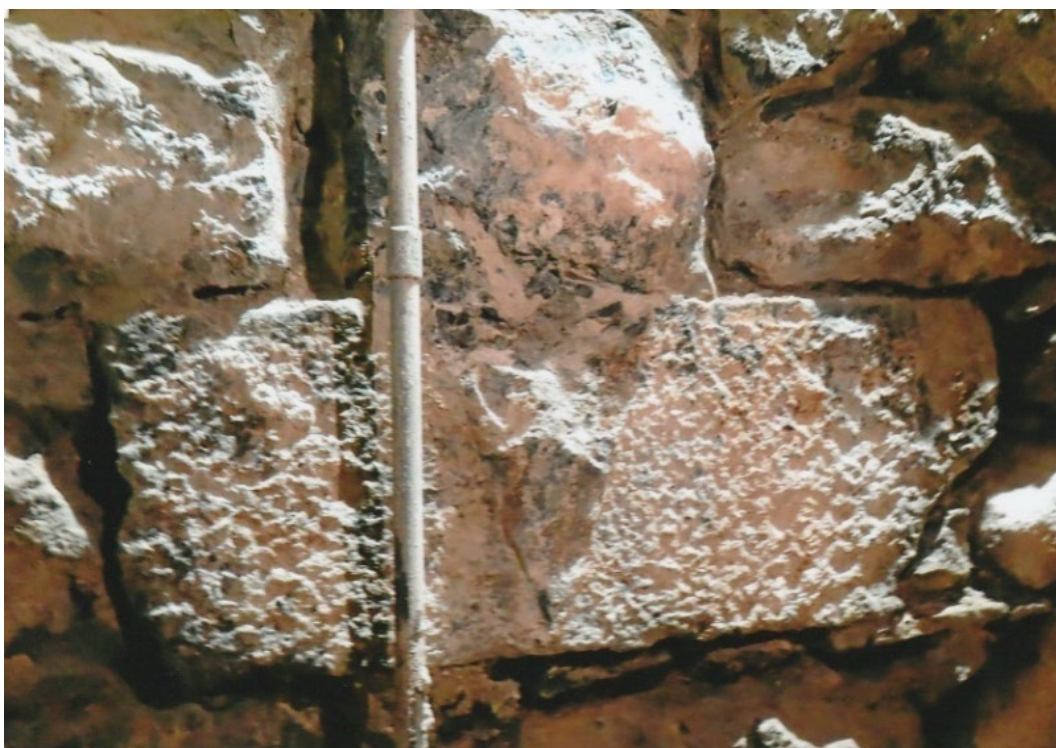
The very battered remnants of two tapering, stone brackets or corbels were found above and to either side of the 16<sup>th</sup> century ground floor window. These had been battered away and red and yellow brick occurred as filling above both brackets. These two corbels may have been moulded or plain originally and these are smaller versions of the projecting brackets supporting the soffit-ribs of the crossing tower of circa 1500 and of the arches between the tower and the north and south transepts or the church. The top of the left hand bracket occurs 35.5cms above the ground.

*Fig. 33 The battered remnants of the left hand corbel / bracket which supported part of a gallery across the South end of the South Transept Extension. Photograph: J. Higgins.*

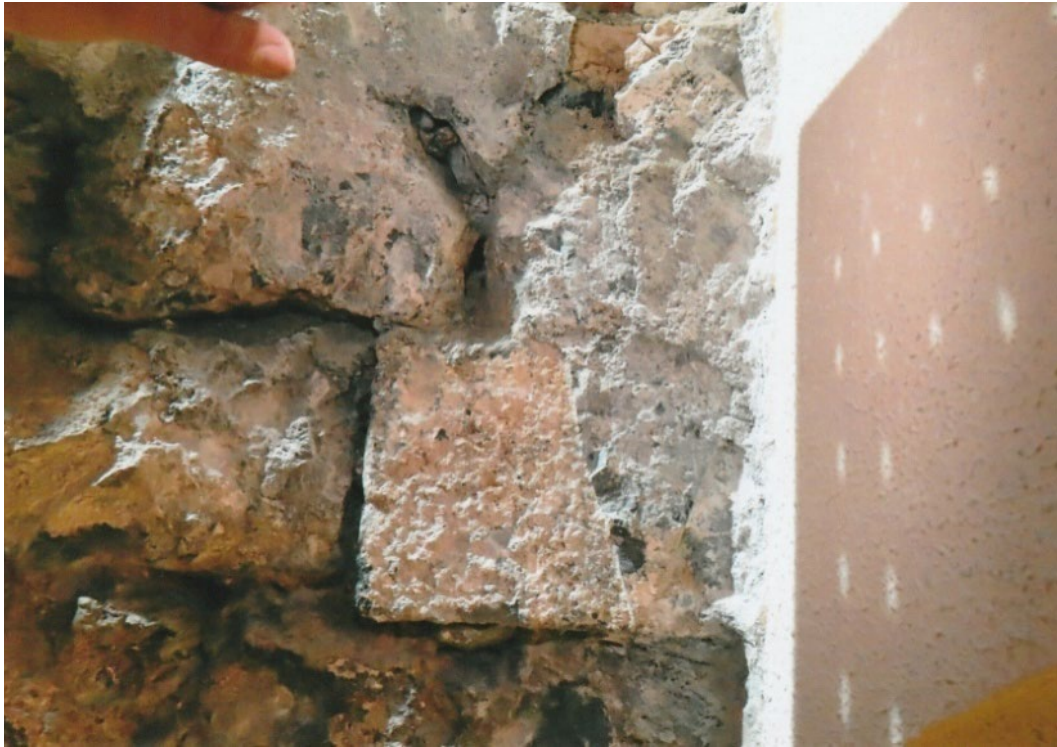
*Fig. 34 The remains of the right hand corbel or bracket from which supported the gallery from Lynch's stair turret across the South end of the South Transept Extension.*

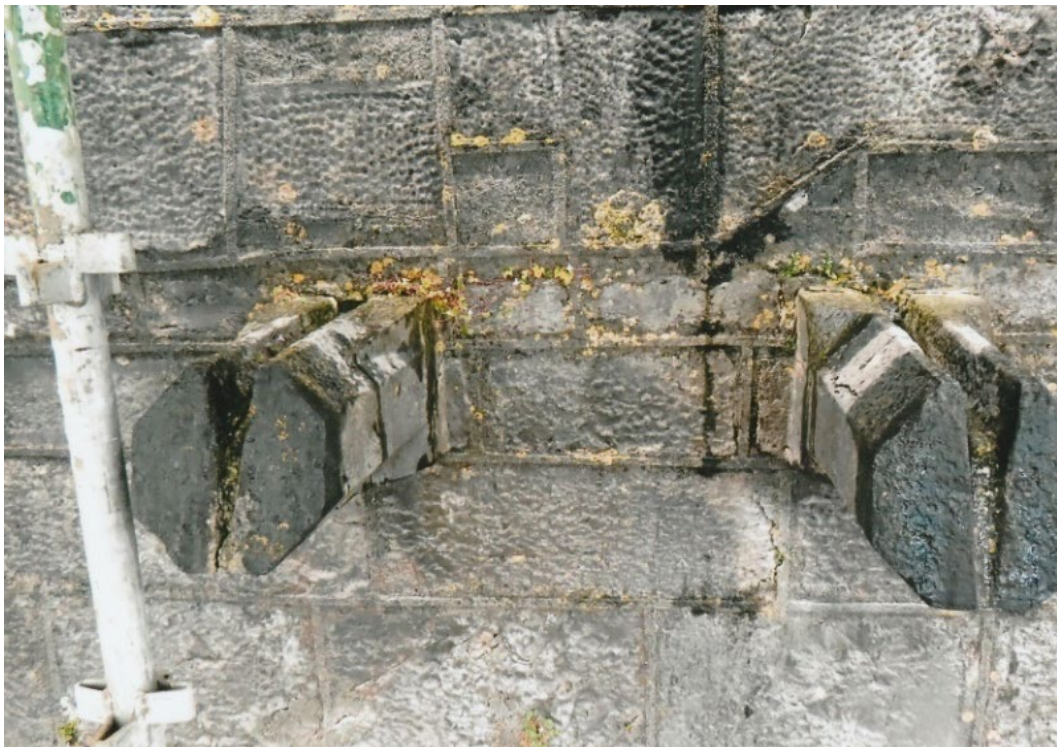
*Fig. 35 The water spouts and stonework on the exterior of the south transept extension before the removal of the 1950's – 1960's raised pointing. Photograph: J. Higgins.*

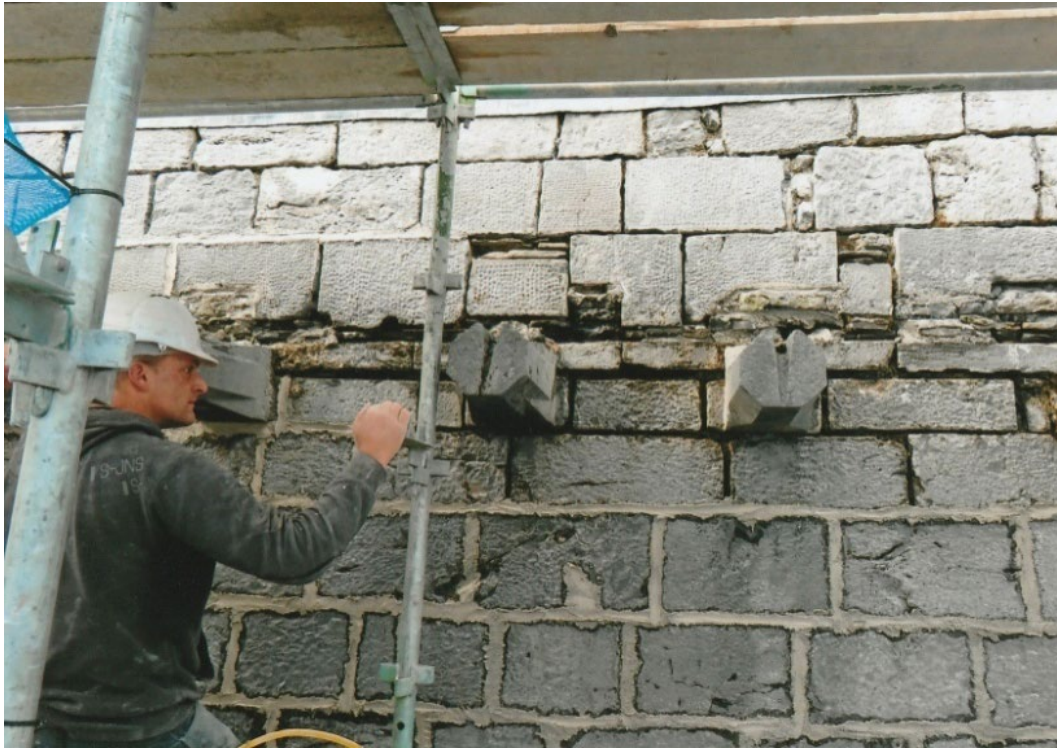
*Fig. 36 The removal of the 1950's – 1960's pointing has shown several phases in the water management features above the string course on top of the spouts the entire parapet was rebuilt.*

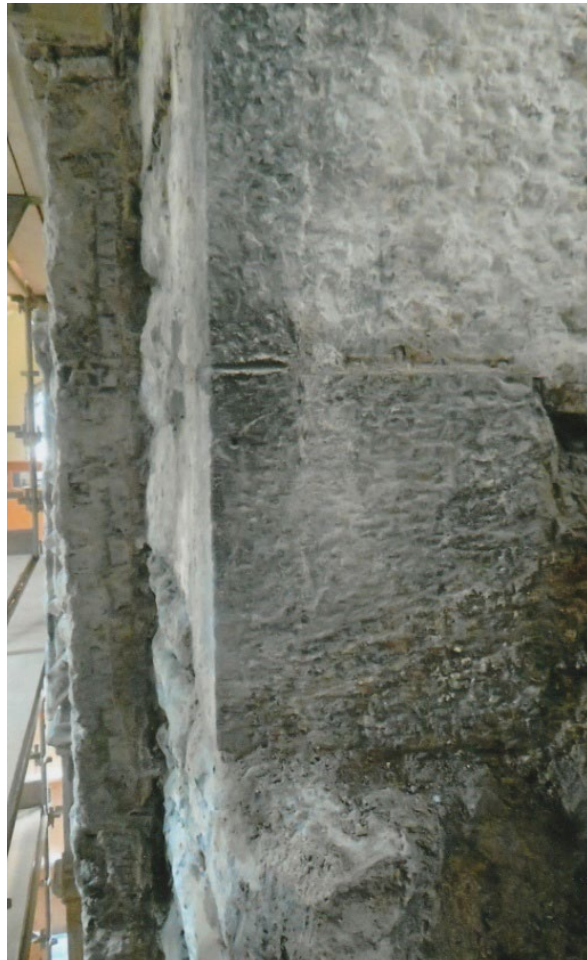
*Fig. 43 The corner of the ingoing of the upper window on the east side of the east wall of the south Transept extension. The lower most stone on the left side has later tooling and may be a 19th century repair or insertion. Photograph: J. Higgins.*

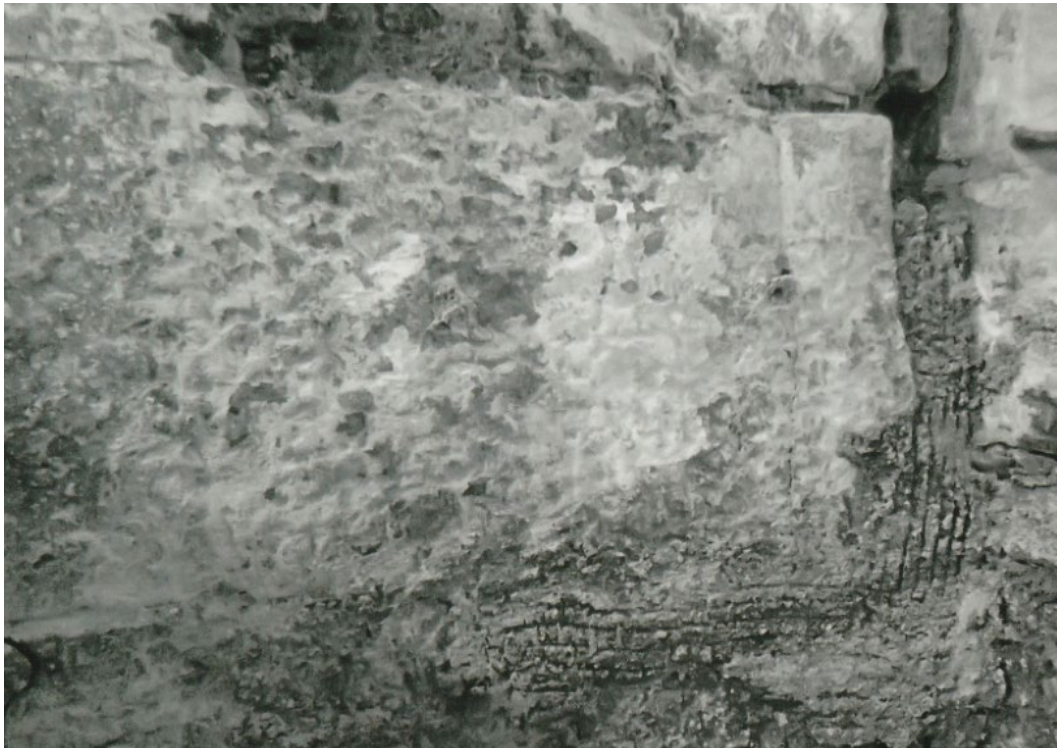
*Fig. 44 Traces of lime-wash along with later small drilled holes and 1950's / 60's mortar filling in the ingoing of the lower window. The rough mortar filling was been striated to take the 1950's / 1960's cementitious mortar render.*  
*Photograph: J. Higgins.*

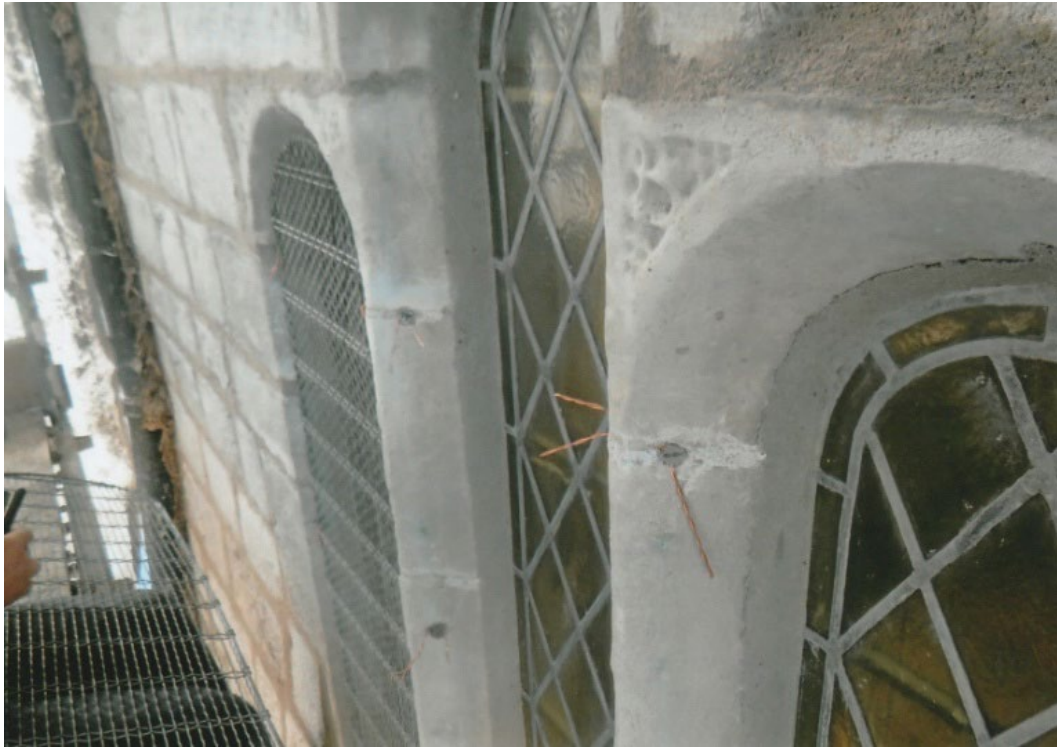
*Fig. 46 New copper ties set in lead to hold the window grills of the exterior windows of the South Transept Extension.  
Photograph: J. Higgins*

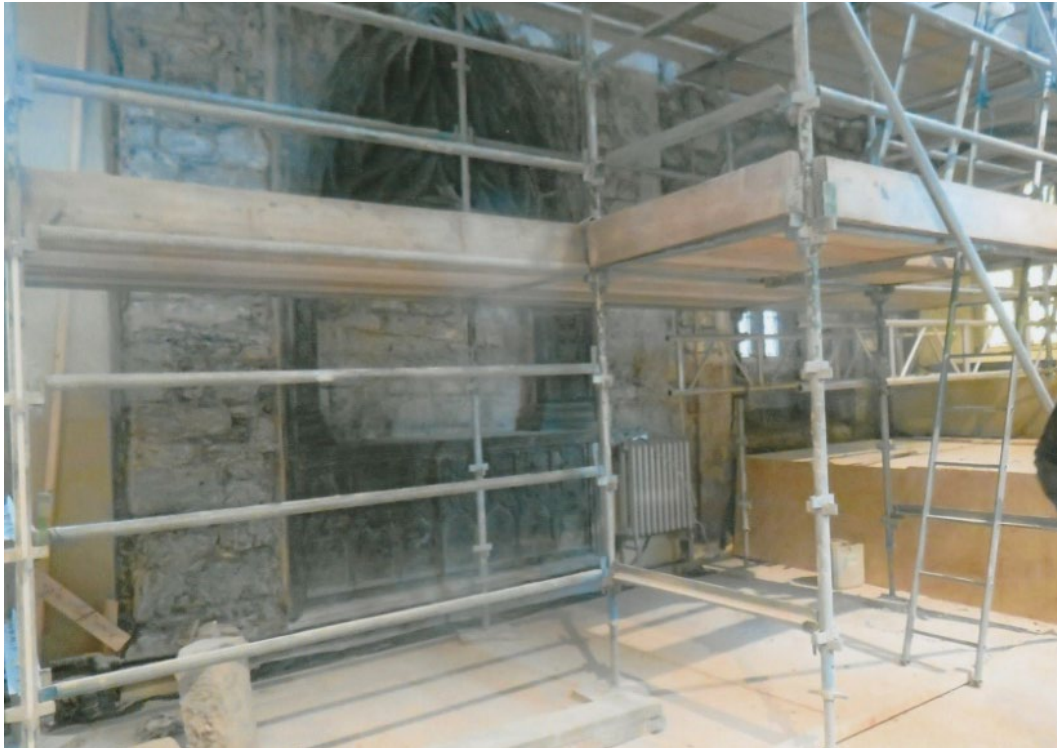
*Fig. 48 The scaffolded area in the South Transept Extension. In the east wall the Flamboyant tomb projects from a rectangular area of walling (left). The Lynch Corner-tomb (right) has been boxed in with wood. The windows above the tomb and the area above and around the Flamboyant Lynch tomb were stripped of modern mortar which was trapping moisture. Photograph: J. Higgins.*

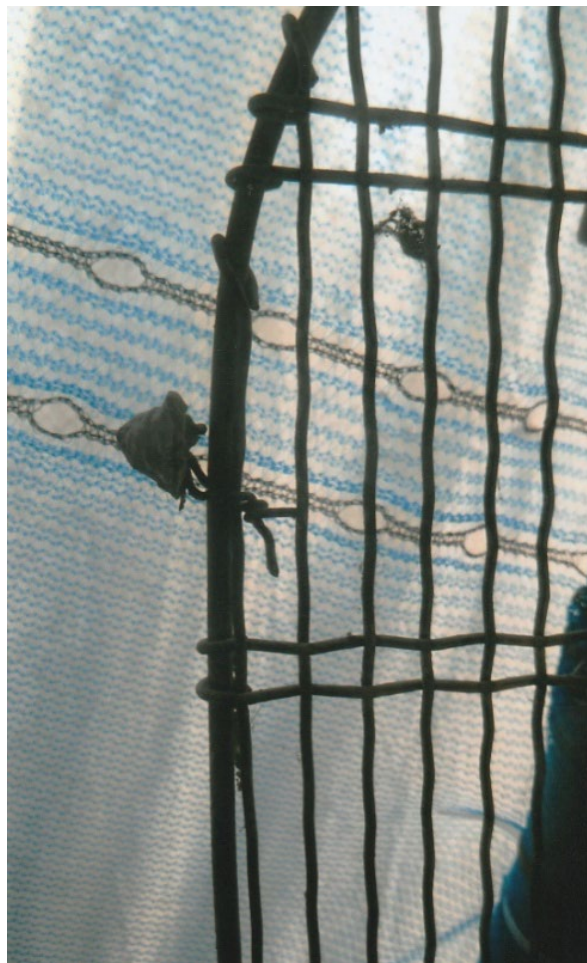
*Fig. 49 The window grills were removed and now copper alloy ties and lead plugs were used to replace the old ones shown here. Photograph: J. Higgins.*

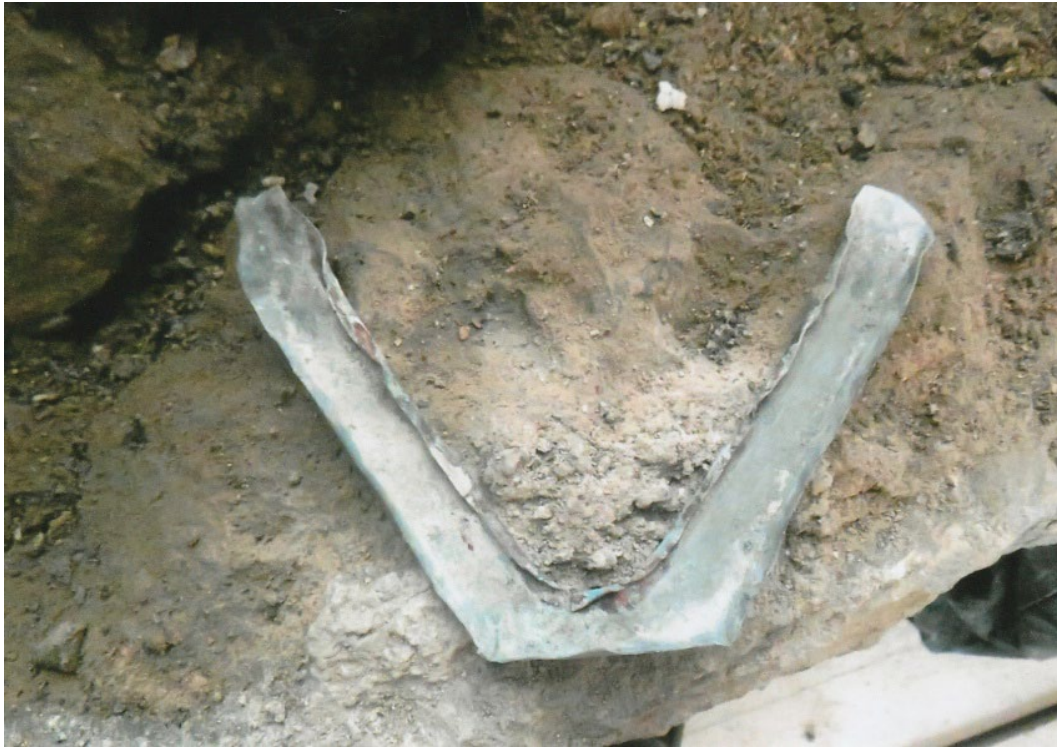
The mullions of both windows were cut into with an angle grinder during the 1950's – 60's work and a three sided tray of copper with the copper alloy being soldered were inserted just above the sills to trap water. One of these had become detached. The mullions seem to have been smoothed or cleaned in places with an angle grinder. The inner sides of the mullions were coated with smooth cement. Cement was used to try prevent water ingress above the sill level but had failed.

*Fig. 50 A loose drip tray of copper alloy. These had been set in grooves cut with an angle grinder in the window mullions in the 1950's – 1960's works. Photograph: J. Higgins.*

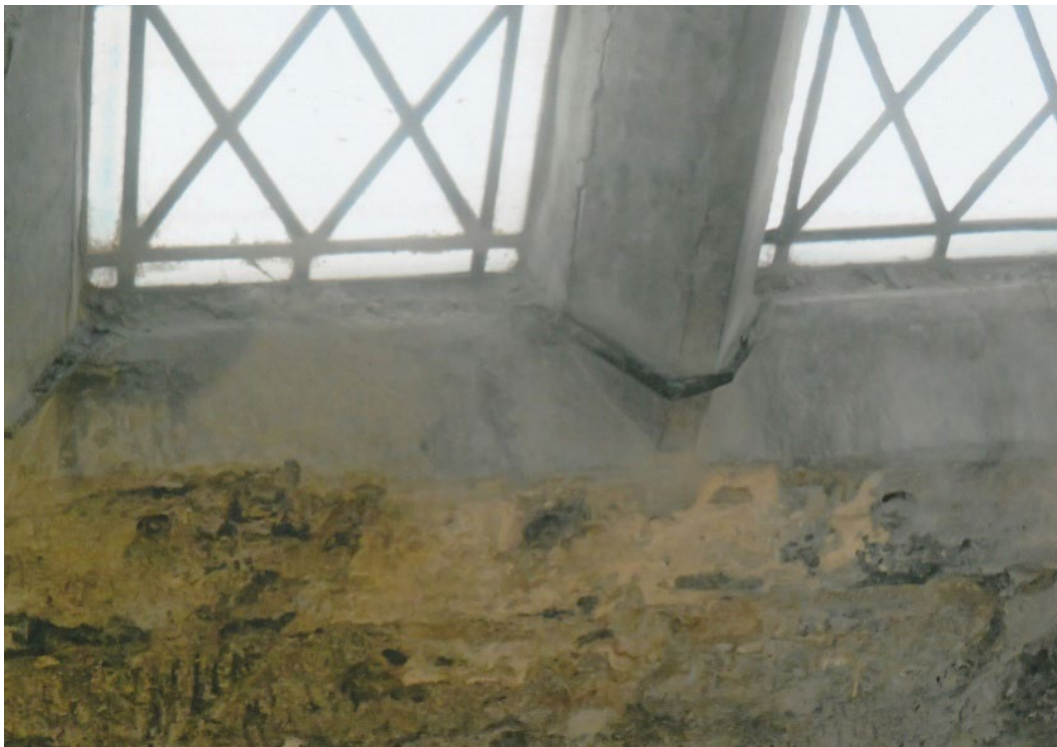
*Fig. 51 The window mullions were smoothed with an angle grinder in the 1950's – 1960's and were cut with an angle grinder to insert copper alloy 'drip trays'. The intersection between the window and the mullions at the base, and the old glazing grooves were filled with cement. Photograph: J. Higgins.*

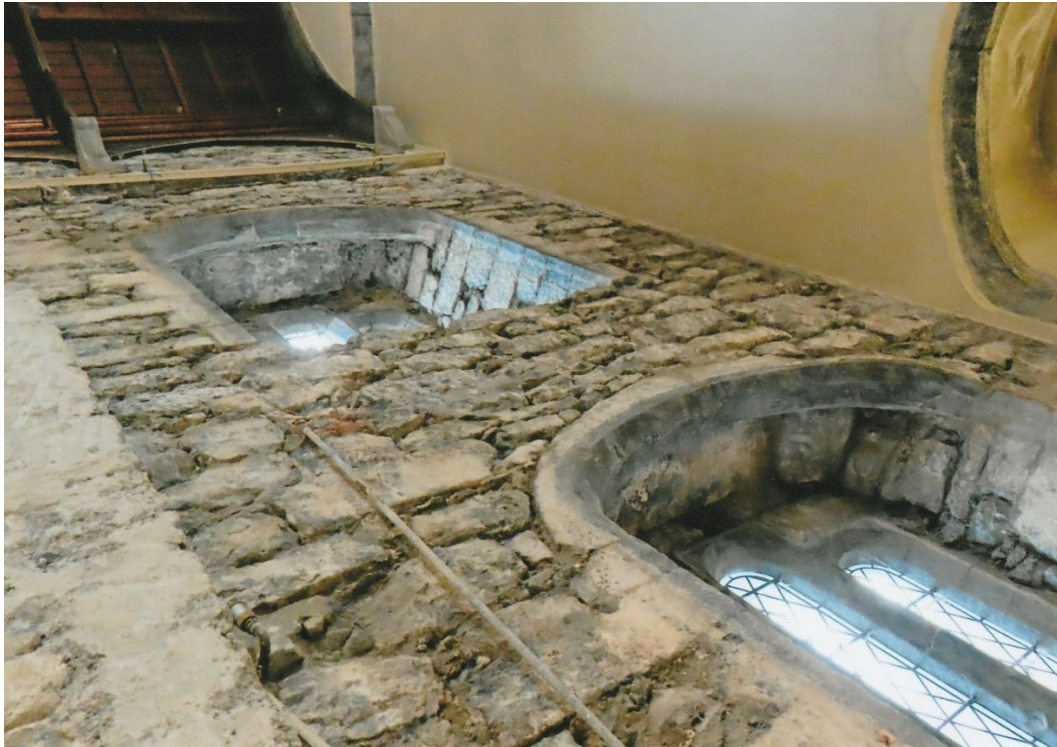
*Fig. 54 The windows in the east wall of the South Transept Extension as revealed in October 2023. The lintels were used instead of an arch in the core of the wall. Flat slabs and cantilevered stones and packing including some reused stone was used to support the window heads internally.*

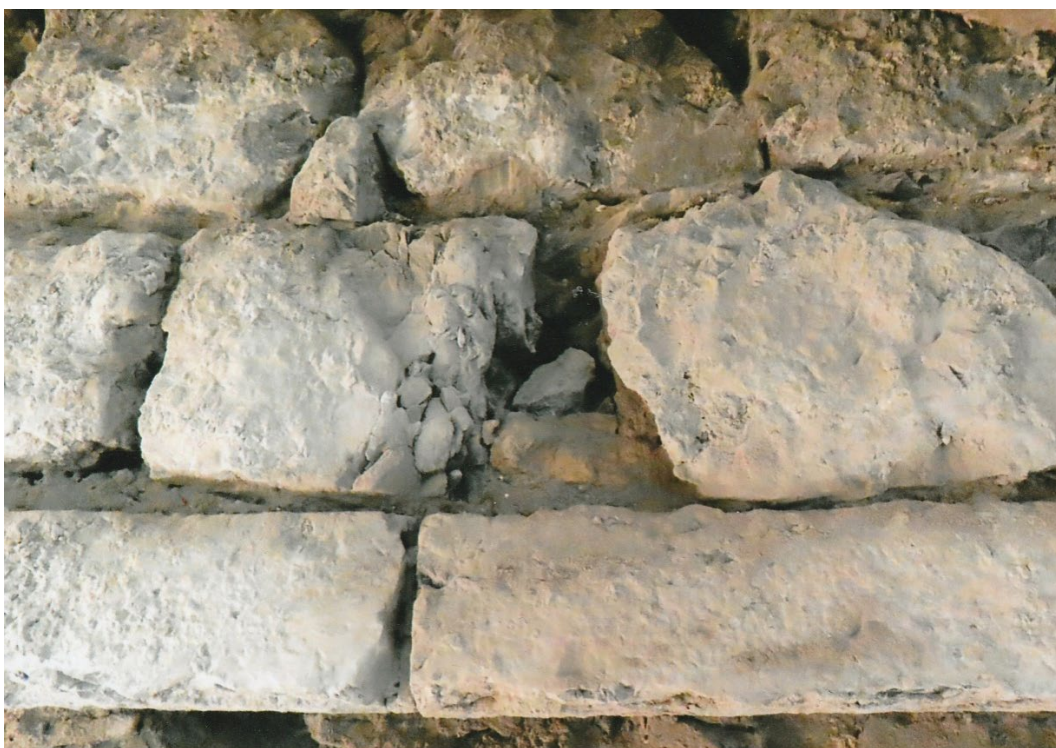
*Fig. 57 A partially brick filled hole above the upper frame of the rectangular niche above the Flamboyant Lynch tomb.  
Photograph: J. Higgins.*

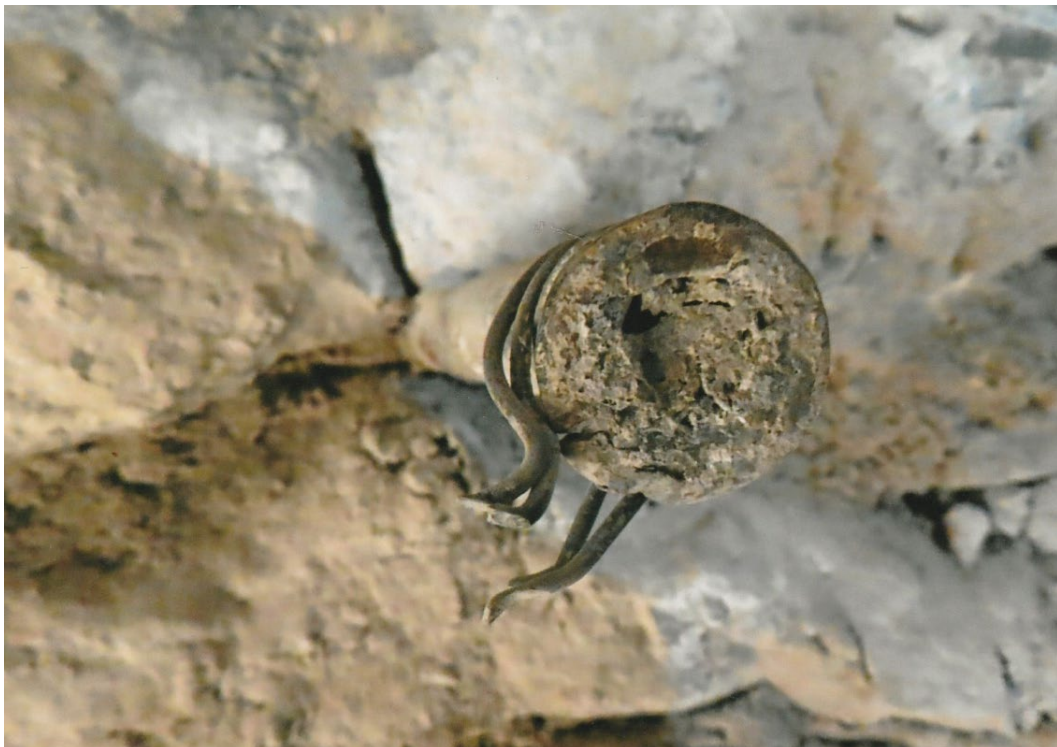
*Fig. 59 The wire was threaded through wooden shuttering while the concrete was inserted in the fill of the wall-niche.*

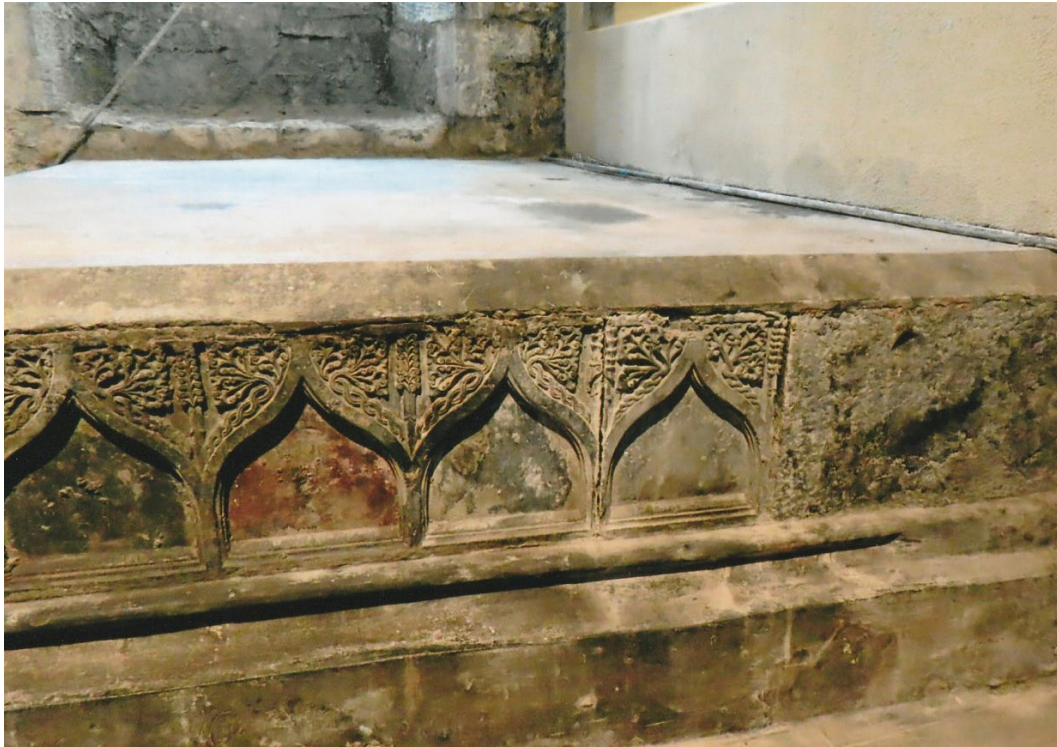
*Fig. 60 The Lynch corner tomb in the S. Transept with a blank panel on the right. The concrete capping predates the 1950-1960's works and seems to have been added in the late 19th century.*

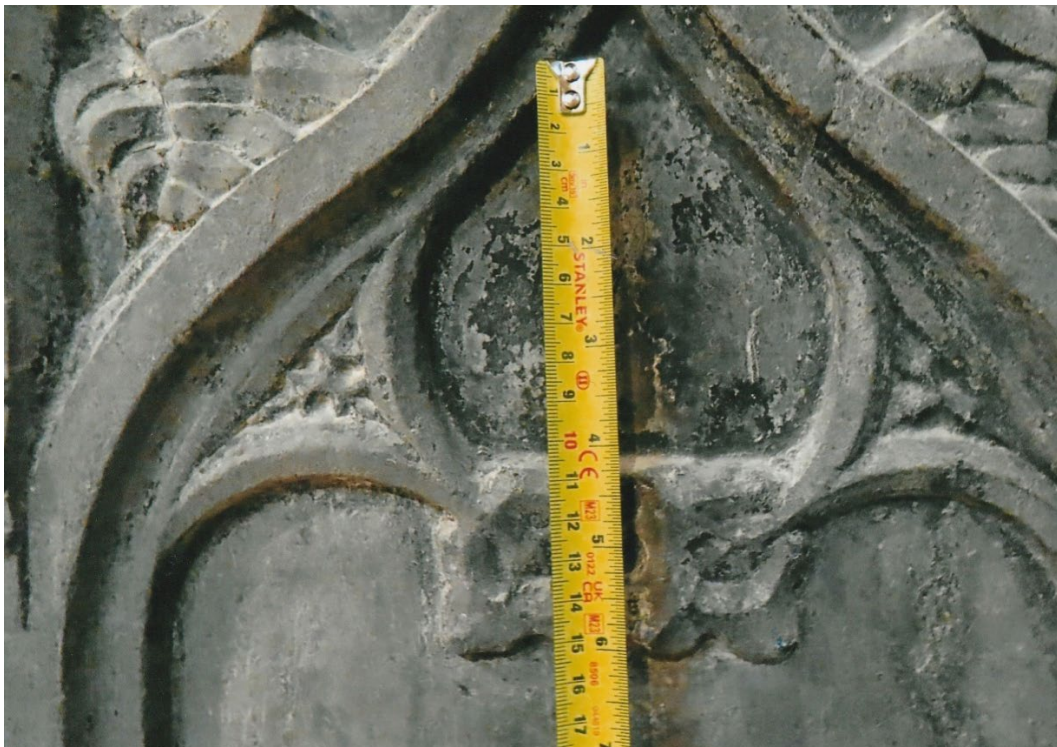
*Fig. 63 Traces of eroded paint on the arcading of the Flamboyant Canopied and Traceried Lynch Tomb.*

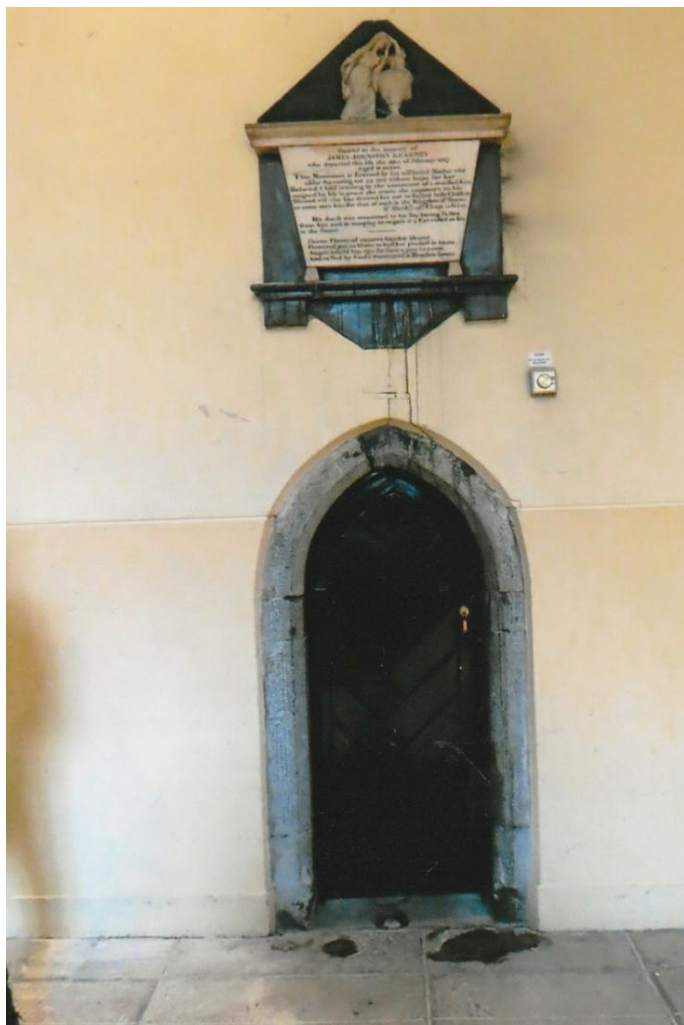
*Fig. 70 Trapped moisture making its way from around a wall plaque and doorway onto the floor of the South Transept of St. Nicholas' Collegiate Church, October 2023.  
Photograph: J. Higgins.*

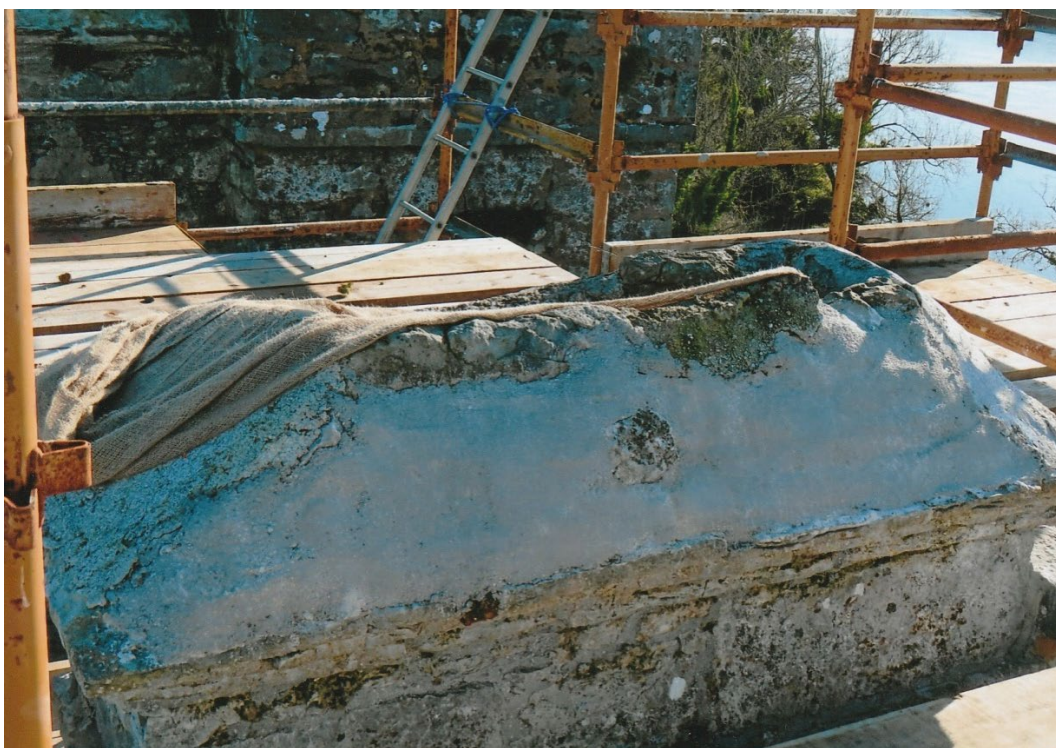
*Fig. 77 Repairs to one of the Menlo Castle chimney stacks in 2023.  
Photograph: J. Higgins.*
