# GALWAY'S HERITAGE IN STONE

## Catalogue No. 9

### The 2023 Archaeological and Conservation Works at St. Nicholas' Collegiate Church Galway and Menlo Castle

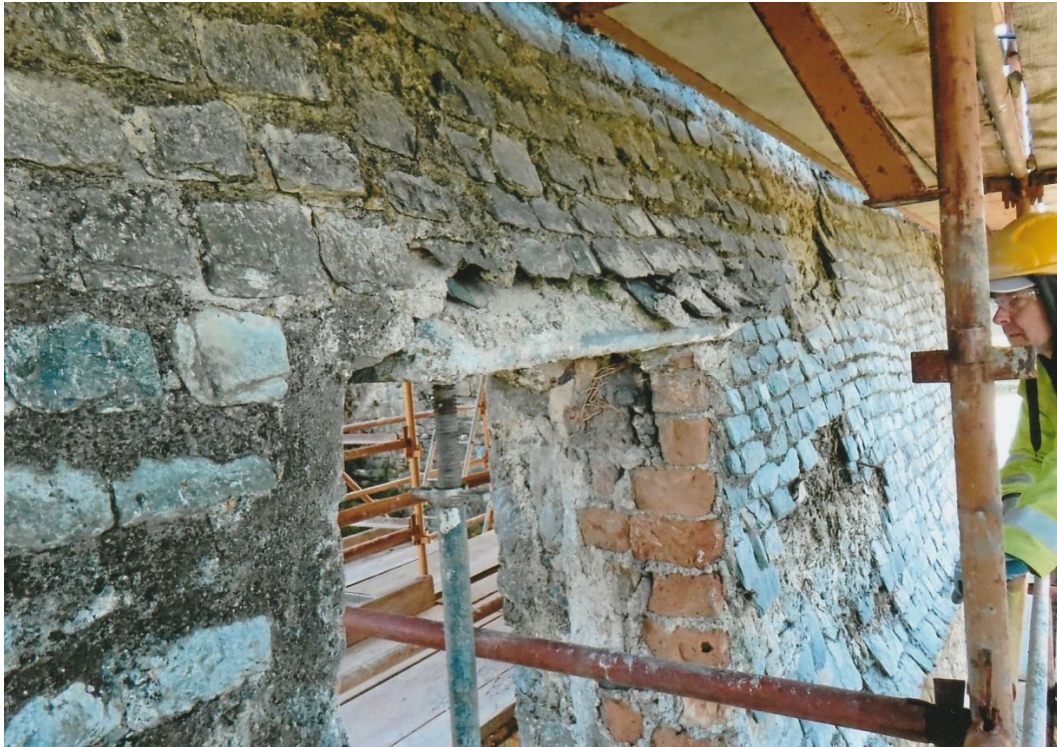
*Fig. 78 Some of the inserted Georgian sash windows inserted on the River front of the 17<sup>th</sup> and 18<sup>th</sup> century block were precarious. An old limestone coping of some sort had been used as a lintel but did not fill the gap. The slate weather sheeting overlay it.*

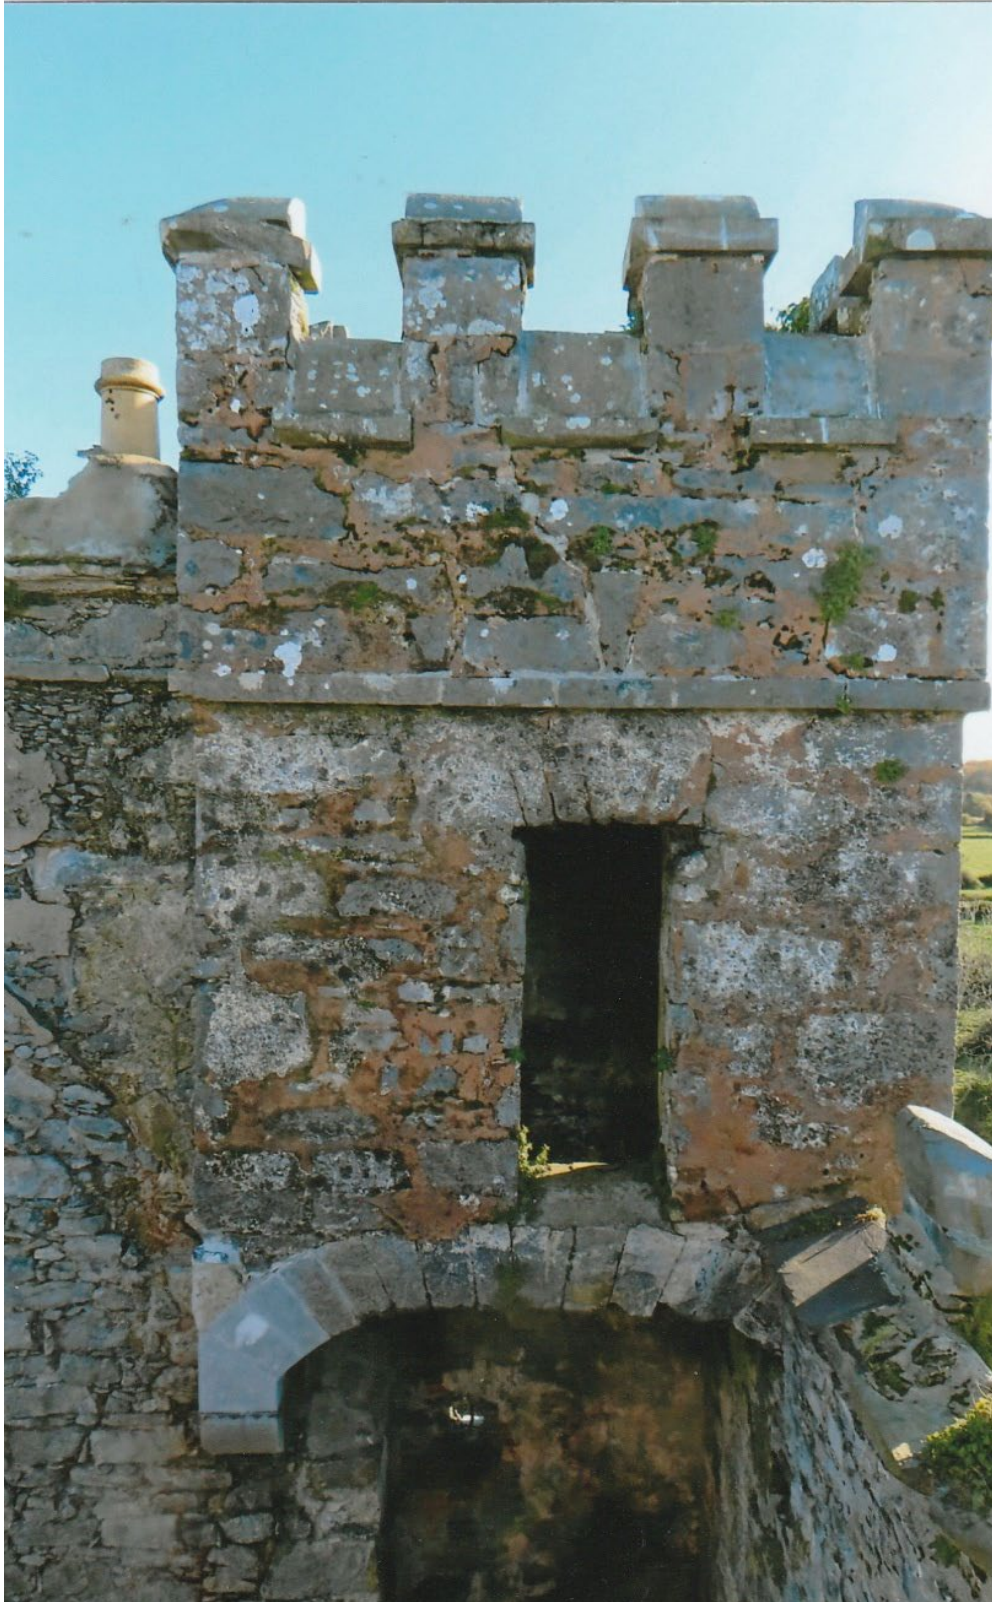
*Fig 80 The 19<sup>th</sup> century crenellated turret or Belvedere at Menlo Castle. This was supported on an arch and projected over 18th century fabric. The arch needed re-supporting and two new voussoirs, a o shew-back and a very large curved-fronted corbel were inserted in 2022 by Galway Stone Design to replace lost features.*

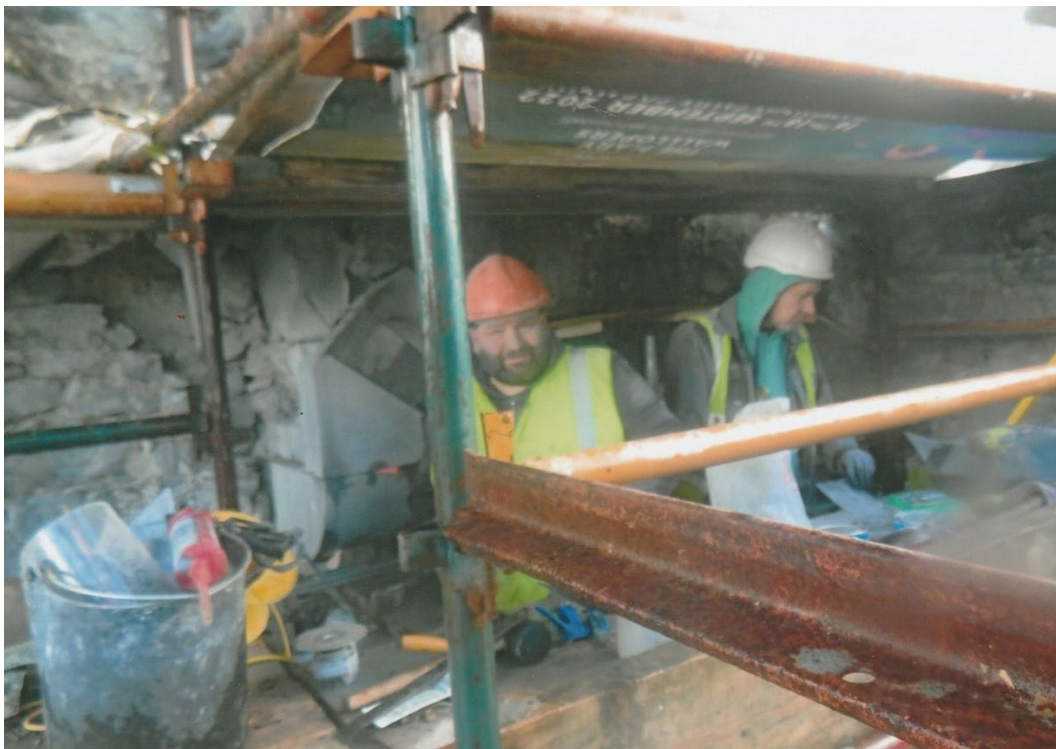
*Fig. 81 Sebastian and Kris of Galway Stone Design inserting the voussoirs and corbel to support the Turret in 2022.*

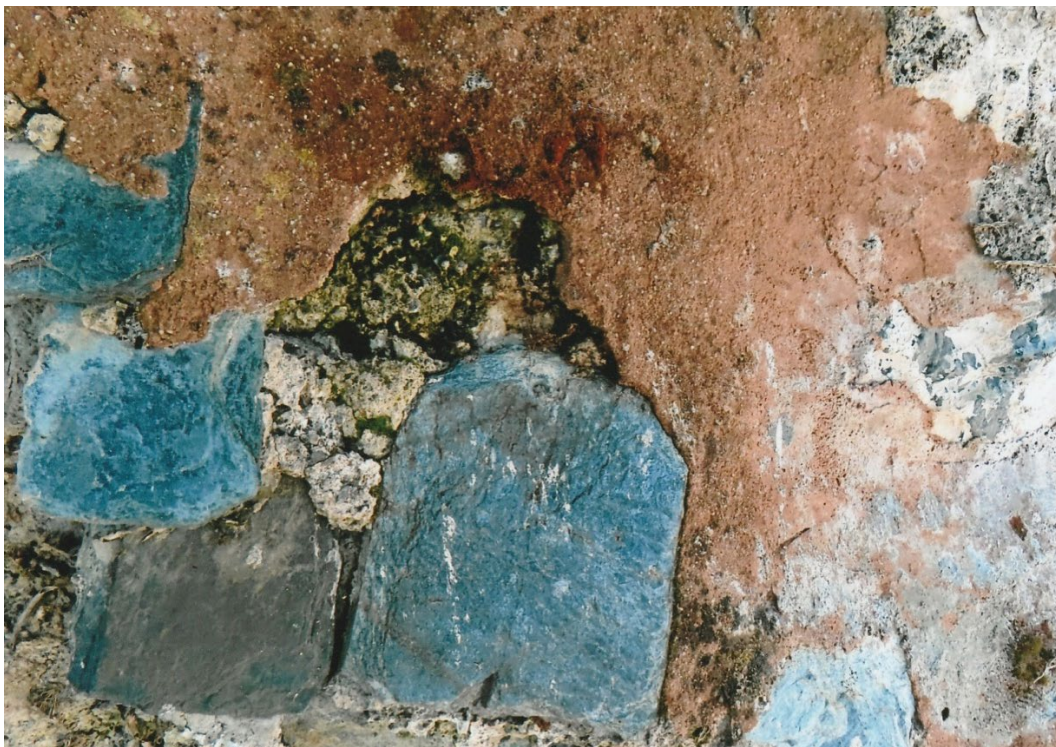
*Fig. 83 Some areas of 19<sup>th</sup> century repair with Roman Cement over earlier lime mortar and schist and grey slate weather sheeting at Menlo Castle.*

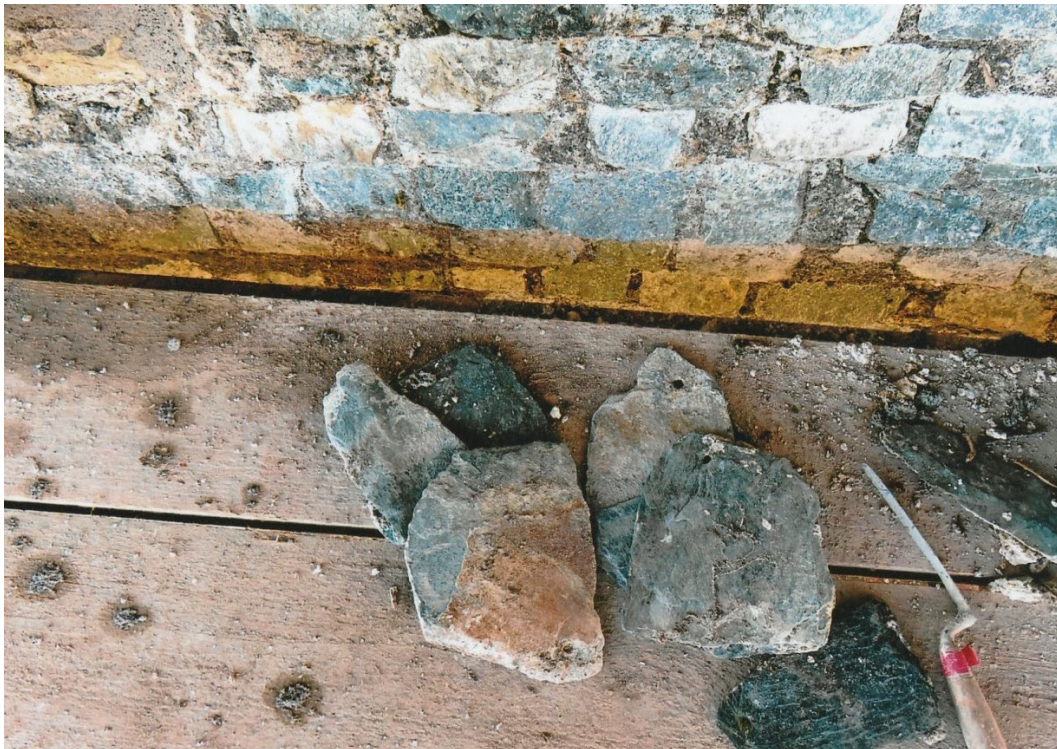
*Fig. 91 Detached weather sheeting slates which fell when the ivy was removed are being put back.  
Note the nail holes in some of the slates.  
Photograph: J. Higgins.*

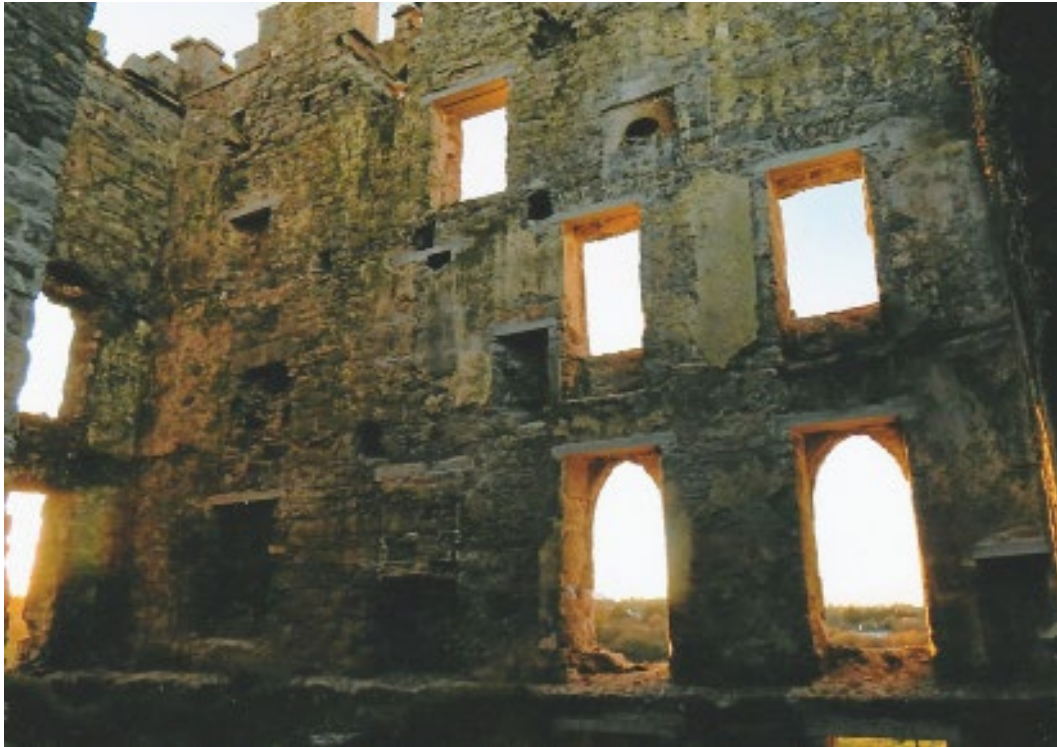
*Fig. 93 Internal Work: Twelve of the rotted out and burnt wooden lintels visible in this photograph were replaced by limestone lintels in 2023. Photograph: J. Higgins.*

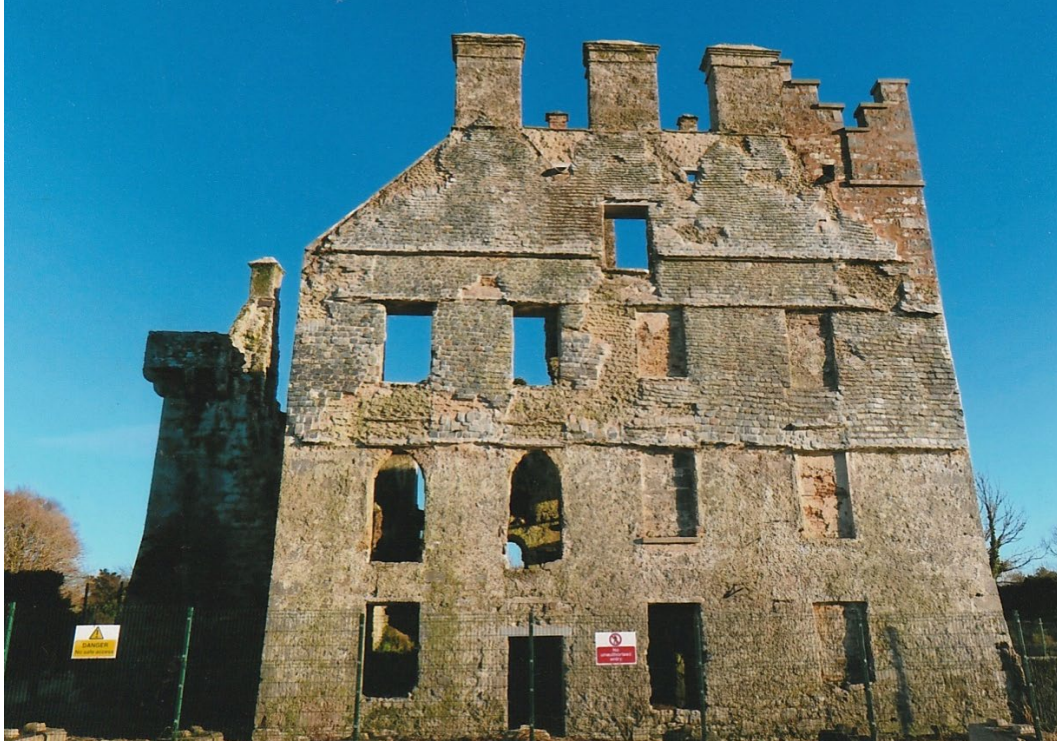
*Fig. 94 The exterior face of walling consolidated in 2023. Photograph: J. Higgins.*
