General Condition Tree Survey of *Picea abies* – Norway spruce.

Prepared For:  
Enda Farrell  
Assistant Parks Landscape Officer  
Galway City Council.

9<sup>th</sup> July 2026

Drew Bardell  
Dip Arb, 'TechAhor A'  
Beith Tree Consultancy

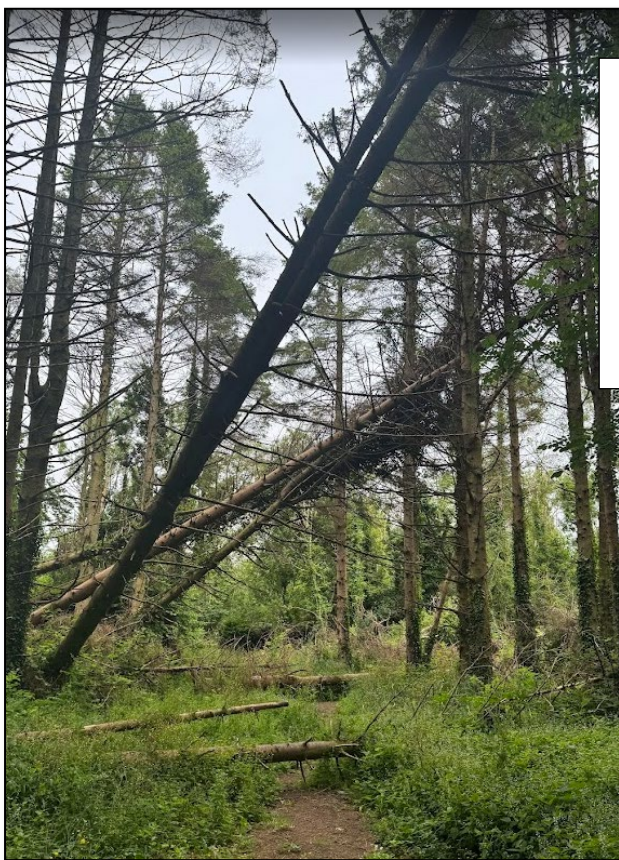
Ref 04;

| Reference Point | Comments | Risk of harm: | Recommendation? | Within what timeframe? |
|---|---|---|---|---|
| Ref 04 | Multiple mature windblown trees, leaning west to east, laying on the ground and hung up leaning over the foot path, multiple trees laying on each other and resting on trees located on the eastern aspect of the 2m wide gravel path. The footpath is blocked and not passable heading north toward Ref point 17 located on the 4m wide gravel footpath at orienteering post 58. Large gaps in forest canopy at this point. There are also multiple dead standing trees within the stand at this location some of which are, unfortunately, being used for firwood, fire pit with stones present, and there are signs of other antisocial behaviour. | YES<br>High | Harvest trees with southern section. | 5 months |

Severe windblow damage with multiple trees hung up over the path and leaning toward the footpath, blown from south to north direction. A large corridor of trees has been damaged,

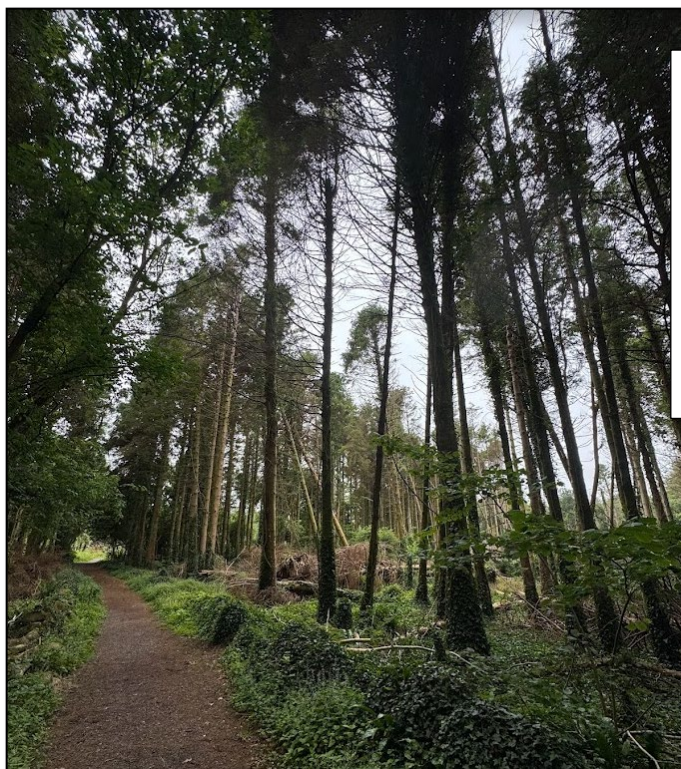
Ref 06;

| Reference Point | Comments | Risk of harm: | Recommendation? | Within what timeframe? |
|---|---|---|---|---|
| Ref 06 | Severe windblow damage from the south of the path. A large corridor of trees has been damaged, either fully windblown, partially windblown, hung up on adjacent trees or the stems have snapped. Multiple trees leaning toward the footpath, blown from south to north direction. There is a very large opening in the forest canopy at this point. The main path has been cleared however; a previous desire line is blocked. There are also multiple desire lines blocked heading east from the 4m wide gravel path toward the castle close to Post 56 and windblown trees that are hung up leaning toward the path. | YES<br>High | Harvest trees with southern section. | 5 months |

Severe windblow damage from the south of the path. A large corridor of trees has been damaged, either fully windblown, partially windblown, hung up on adjacent trees or the stems have snapped. Multiple trees leaning toward the footpath.

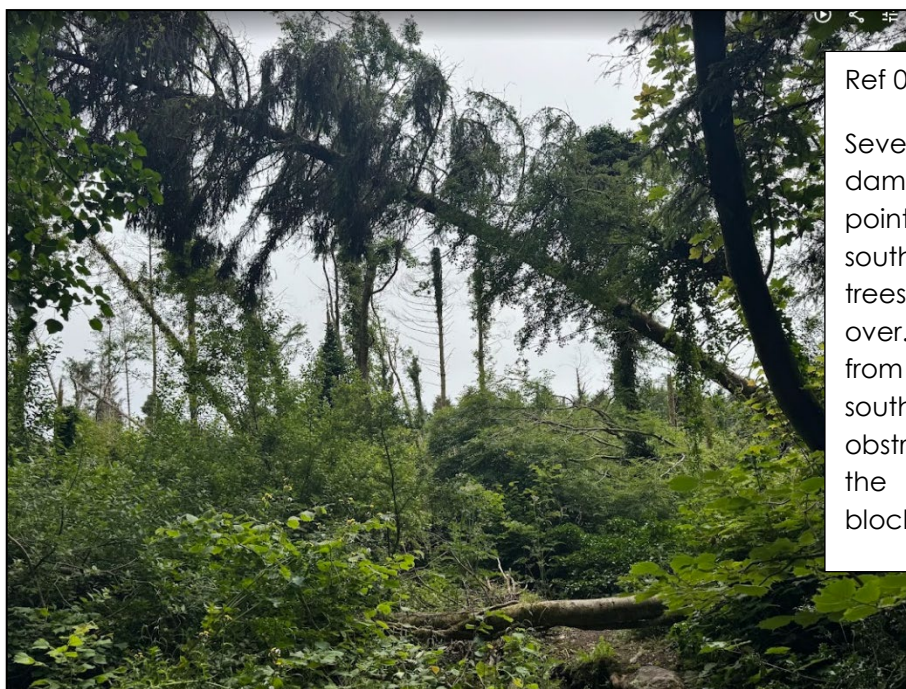
Ref 09;

| Reference Point | Comments | Risk of harm: | Recommendation? | Within what timeframe? |
|---|---|---|---|---|
| Ref 09 | Sever windblow and storm damage to the trees at this point over a wide area looking south southeast. Most of the trees are completely blown over some dead standing and snapped stems remain. Trees from the corridor from Ref point 08, from the south, are windblown obstructing the path, stems are between 400mm above ground level to 1.5m above ground level. The path is complete blocked at Ref point 9. No further access northeast or southwest. | Yes<br>High | Harvest trees with southern section. | 5 months |

Sever windblow and storm damage to the trees at this point over a wide area looking south southeast. Most of the trees are completely blown over. Trees from the corridor from Ref point 08, from the south, are windblown obstructing the path prior to the path being completely blocked.

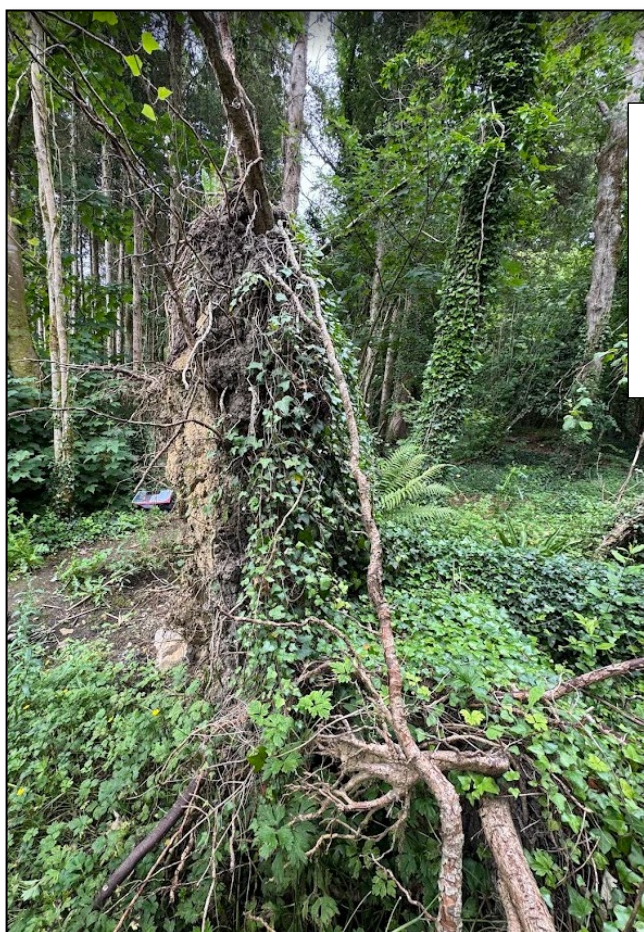
Ref 13;

| Species | Comments | Risk of harm: | Recommendation? | Within what timeframe? |
|---|---|---|---|---|
| Ref 13 | Further continuation of this corridor of storm damaged trees, some trees fully windblown others are partially windblown hung up on other trees. Large root plate on desire line. All damage is southeast of the stream. Again, significant opening of forest canopy. | YES<br>High | Harvest trees with southern section. | 5 months |

Lifted root plate after windblow, the root plate is only 350mm deep with no visible sinker roots.
