Refurbishment / Demolition Asbestos Survey (RDAS) No. 1 Munster Avenue, Galway, H91 V2XR

Date: 5 th September 2022	
Surveyor: Patrick Leyden <i>Patrick Leyden</i>	Approved by: James McCusker (Principal Consultant)

Client	Galway City Council – Housing Section
Project Title	RDAS – 1 Munster Avenue, Galway City
Document Title	Refurbishment / Demolition Asbestos Survey (RDAS) No. 1 Munster Avenue, Galway City
Report No:	Report No: A041/22

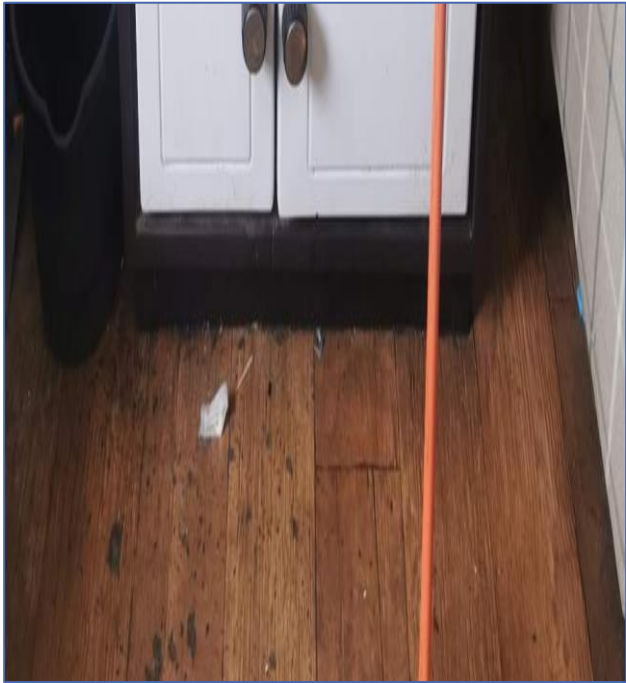
Location	Sample No:	Result of analysis
Vinyl Floor Tiles – Ground Floor (Under Lino)	A	No Asbestos Detected

Extent
		N/A
Material Risk Assessment		Risk Rating
Asbestos type: -	N/A	0
Type of product: -		0
Condition: -		0
Surface Treatment: -		0
		No Asbestos

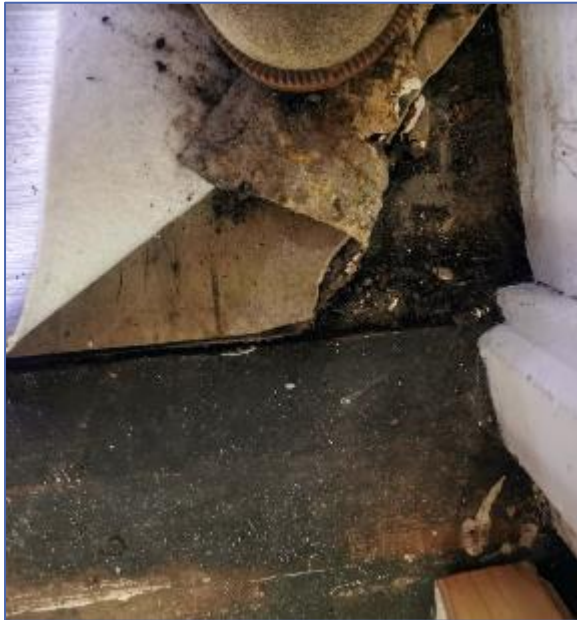
Location		Sample No:	Result of analysis
Kitchen Extension – Lino under lino		B	Chrysotile Asbestos Confirmed

Extent	Kitchen floor
Material Risk Assessment		Score	Risk Rating
Asbestos type: -	Chrysotile	1	High Risk
Type of product: -	Paper lining	2	Medium Risk
Condition: -	Medium Damage	2	Low Risk
Surface Treatment: -	Non-Friable Composite	0	Very Low Risk
		5	Low Risk

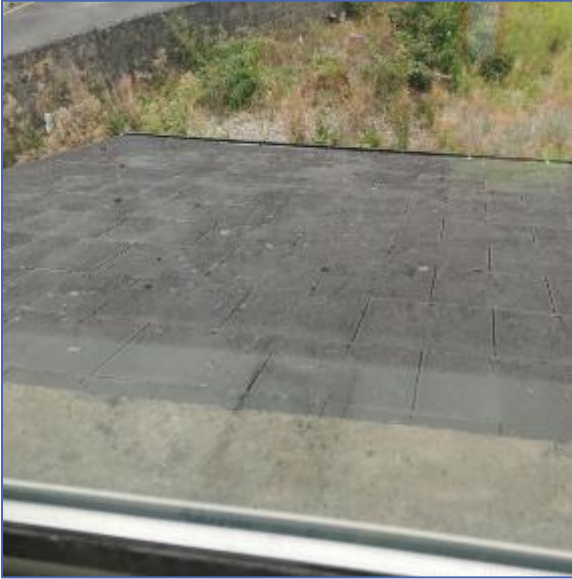
Location		Sample No:	Result of analysis
Extension Roof slate		C	Chrysotile Asbestos Confirmed

Extent	Entire Roof Area
Material Risk Assessment		Score	Risk Rating
Asbestos type: -	Chrysotile	1	High Risk
Type of product: -	Reinforced Composite	1	Medium Risk
Condition: -	Low Damage	1	Low Risk
Surface Treatment: -	Non-Friable Composite	0	Very Low Risk
		3	Very Low Risk

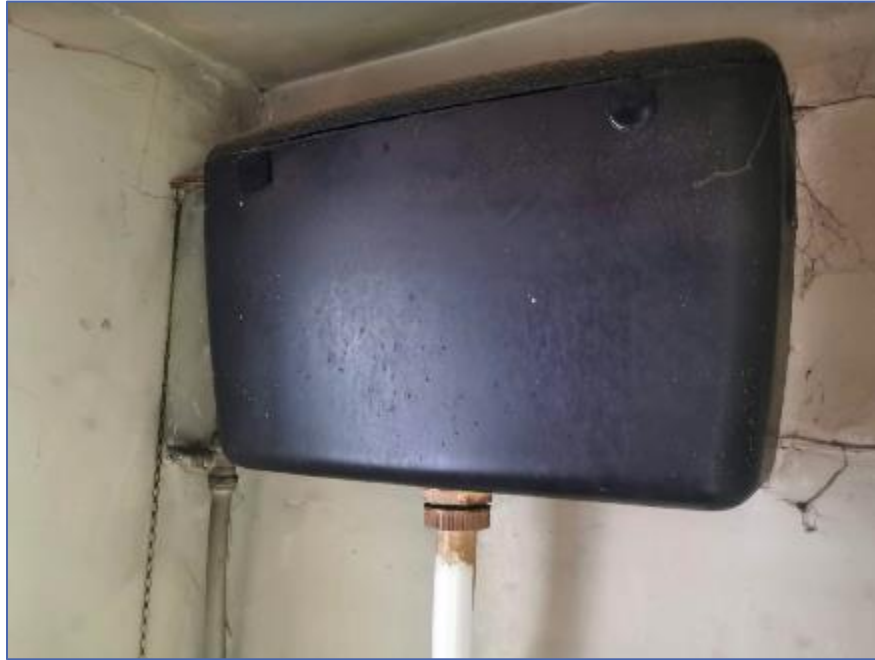
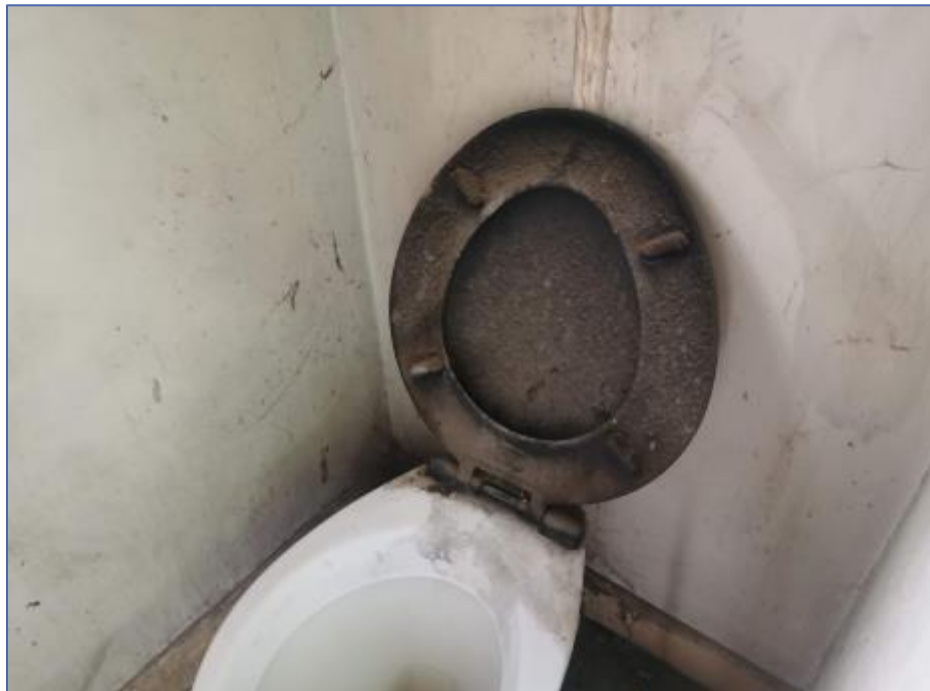
Asbestos Toilet Seat & Cistern

- Asbestos Containing roof slates were confirmed. The roof slates are deemed very low risk if undisturbed and can be managed in place. If removal is planned, then the roof slates must be removed and disposed of according to the current Asbestos Regulations.
- The lino in the Kitchen as an asbestos paper backed lining. The lino should be removed under controlled conditions and disposed of as asbestos waste.
- The toilet seat and cistern must be removed intact, double bagged and disposed of as asbestos waste.

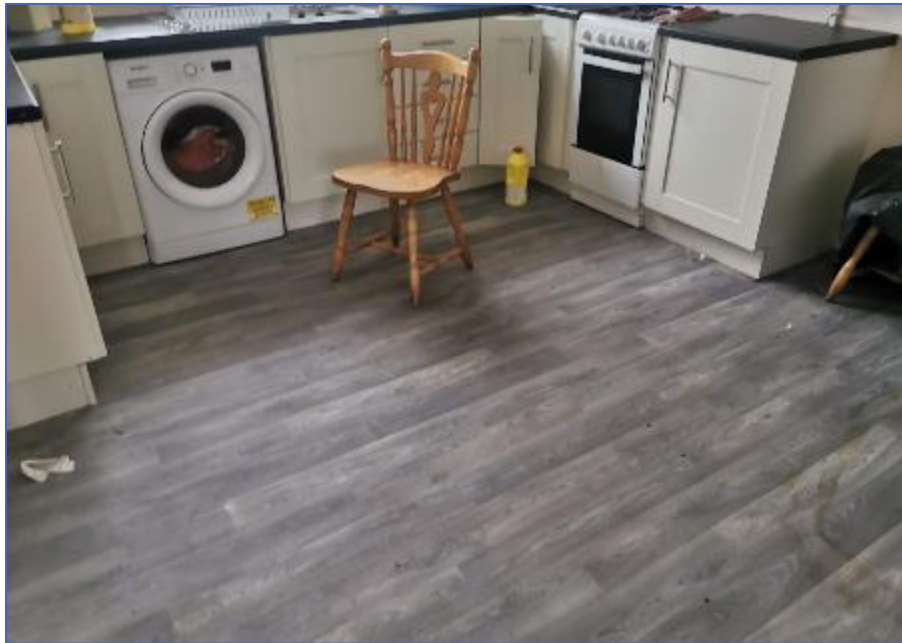
Asbestos lino – under new lino in Kitchen

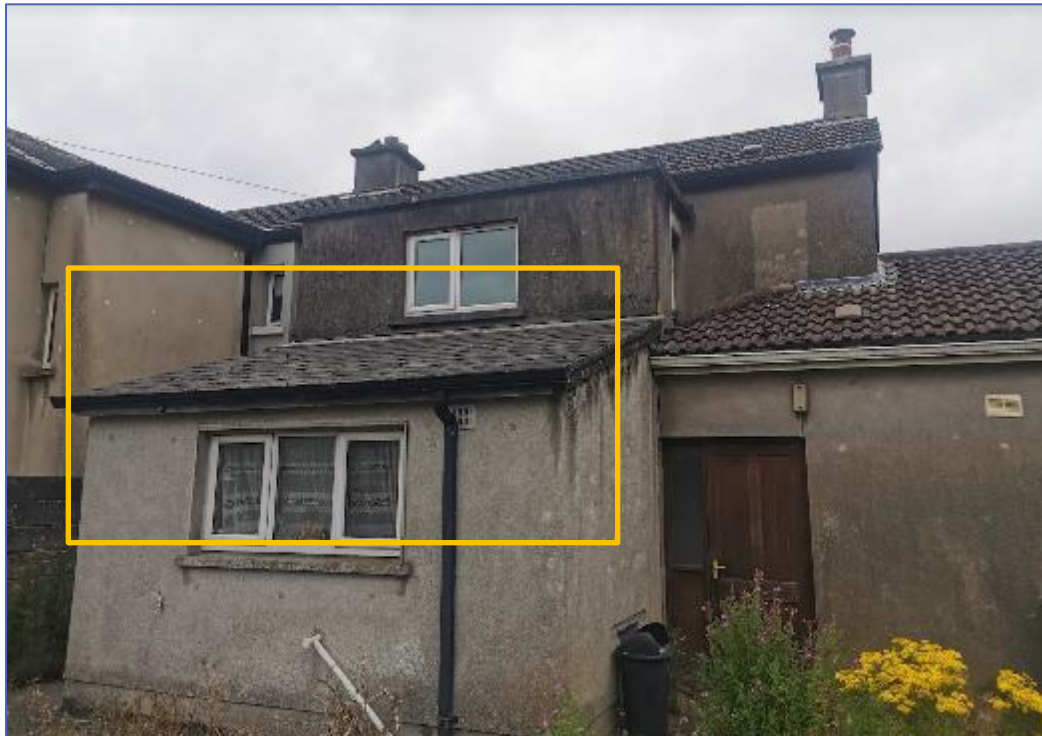
Asbestos Roof Slates
