## **Stage 1 Road Safety Audit**

**Neighbourhood Centre & Social Housing Scheme,  
Ballyburke, Knocknacarra, Galway**

On behalf of Galway City Council

**October 2023**

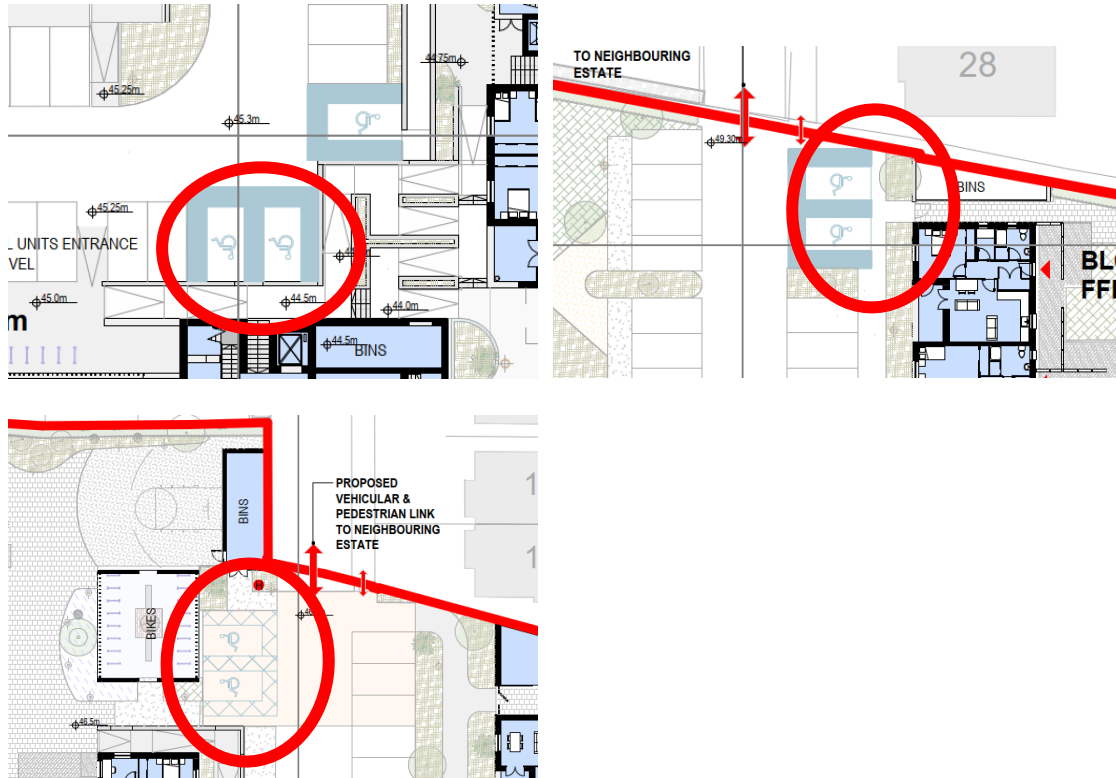
### 3.2.3 Disable Users Access to Footpaths

**Problem:** It is not clear from the drawings if the disabled user parking spaces have direct access to a suitable width, segregated footpath.

**Hazard:** The disabled user may be required to travel within the carriageway, to the rear of other parked vehicles in order to access a suitable footpath. Impact from vehicles egressing parking spaces or other carriageway users may result.

**Recommendation:** Ensure all disabled user parking spaces have a direct and suitable access to a suitable width segregated footpath.

| TO BE COMPLETED BY DESIGNER | | | | TO BE COMPLETED BY<br>AUDIT TEAM LEADER |
|---|---|---|---|---|
| 3.2.3 | Yes | Yes | | |

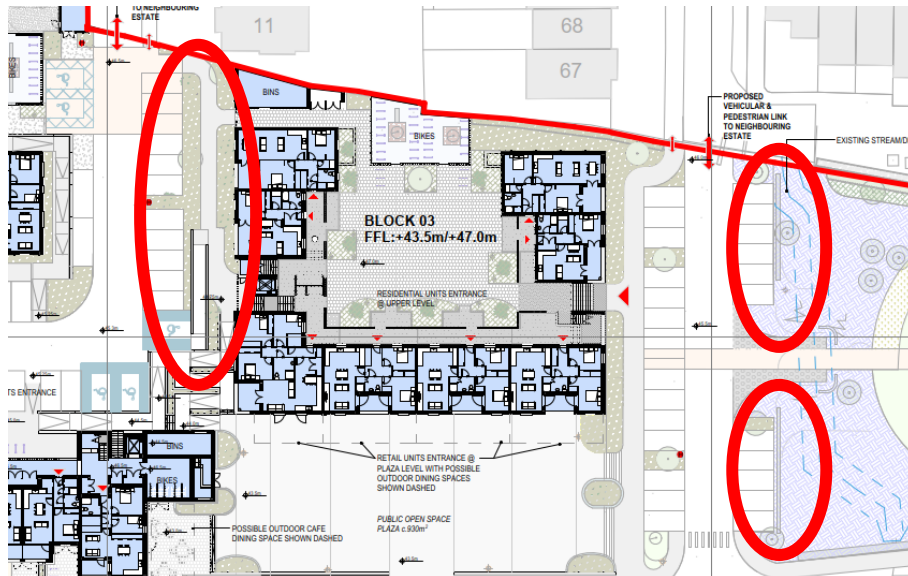
### 3.2.4 Access to Footpaths

**Problem:** There are a number of car parking spaces that do not have access to adjacent footpaths.

**Hazard:** Car users are likely to walk within the carriageway in order to access the closest footpath. These users are at risk of impact from reversing or passing vehicles.

**Recommendation:** Provide a footpath adjacent to the car parking bays.

| TO BE COMPLETED BY DESIGNER | | | | TO BE COMPLETED BY<br>AUDIT TEAM LEADER |
|---|---|---|---|---|
| 3.2.4 | Yes | Yes | | |

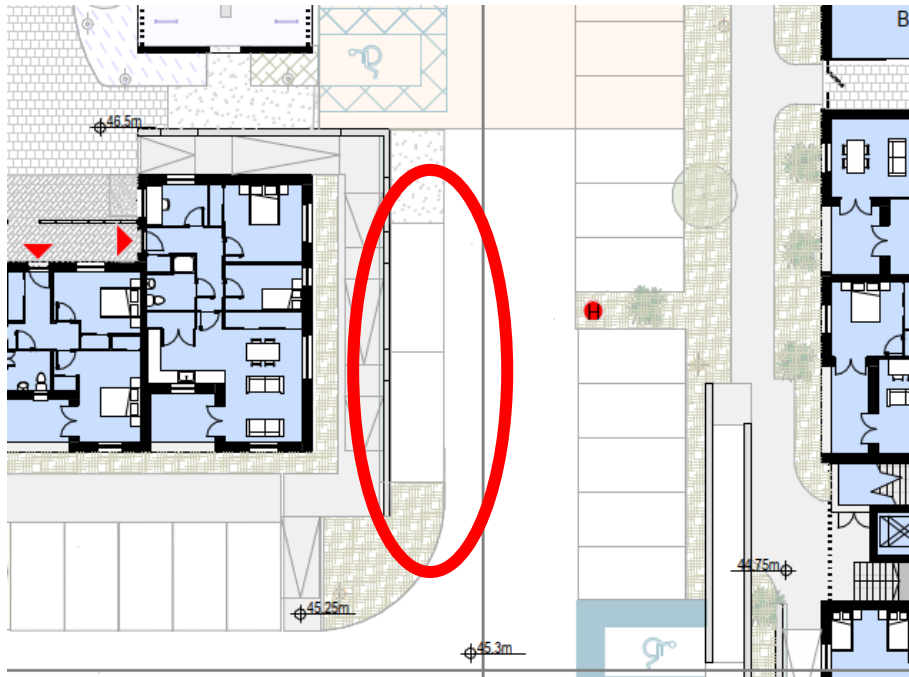
### 3.2.5 Accessible Car Parking Bays

**Problem:** There are parallel car parking bays indicated adjacent to walls. Vehicular access to the bays is likely to be difficult. Furthermore, egress from the vehicle will be restricted due to the wall. It is likely the driver will not park within the bays but leave room between the wall and the vehicle for passenger entry/exit. The vehicle will protrude into the carriageway.

**Hazard:** Passing traffic may swerve to avoid the protruding vehicle and impact with opposing users.

**Recommendation:** Amend the design to provide adequate room for the vehicle and passenger.

| TO BE COMPLETED BY DESIGNER | | | | TO BE COMPLETED BY<br>AUDIT TEAM LEADER |
|---|---|---|---|---|
| 3.2.5 | Yes | Yes | | |

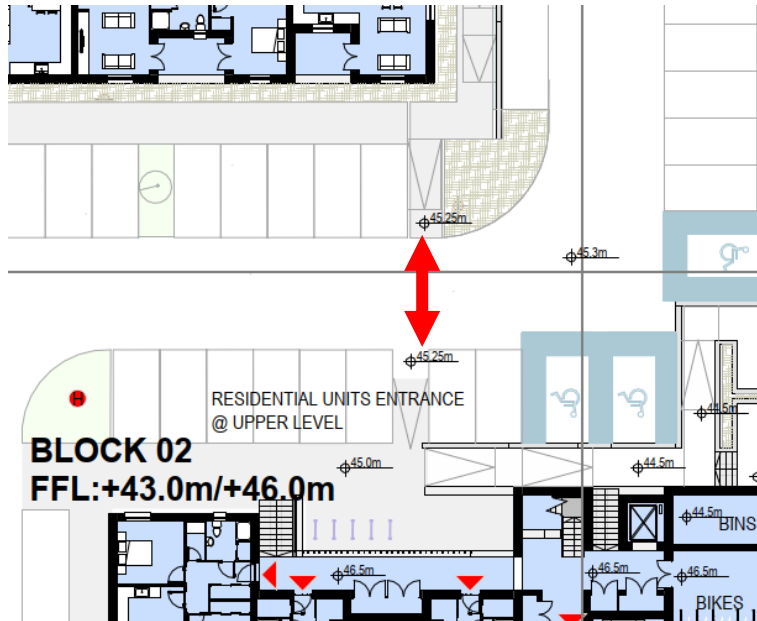
### 3.2.6 Pedestrian Crossings in areas of Vehicle Parking.

**Problem:** The proposed pedestrian crossing from Block 2 to Block 1 (and other locations) is shown within the car parking bays. There is concern that high sided vehicles parked within the bays may restrict inter-visibility to/from crossing pedestrians.

**Hazard:** Crossing pedestrians may be subject to vehicle strikes.

**Recommendation:** The design team should ensure suitable inter-visibility is achieved at all pedestrian crossing locations.

| TO BE COMPLETED BY DESIGNER | | | | TO BE COMPLETED BY<br>AUDIT TEAM LEADER |
|---|---|---|---|---|
| 3.2.6 | Yes | Yes | | |

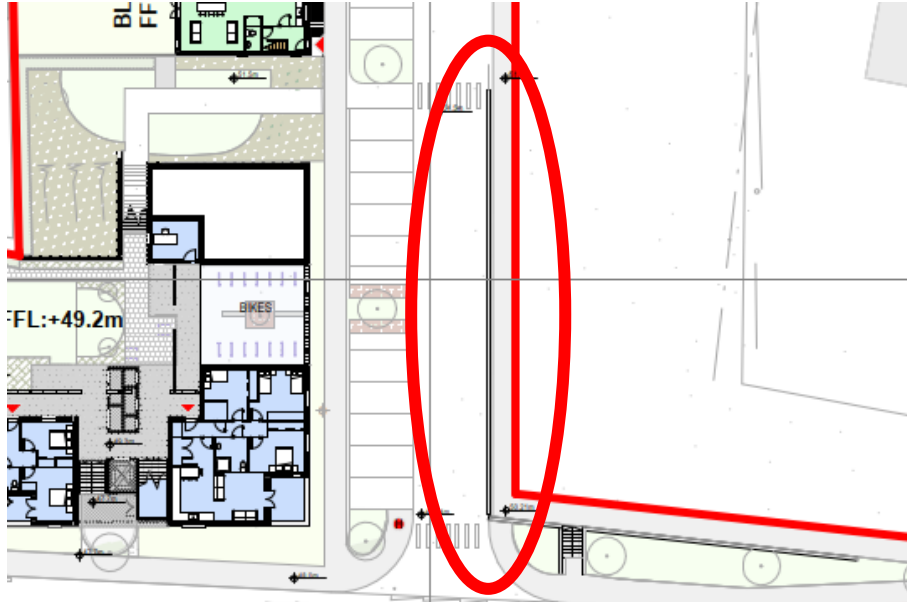
### 3.2.7 Walls Adjacent to Carriageway.

**Problem:** What appears to be boundary walls are shown located directly adjacent to proposed carriageways. The wall is also shown adjacent to a pedestrian crossing.

**Hazard:** Errant vehicles, possibly cyclists, may impact with the wall and sustain personal injury. Additionally, the wall may restrict inter-visibility to/from pedestrians waiting at the crossing.

**Recommendation:** Set the wall back to provide suitable clear zone and also adequate visibility for the pedestrian crossing.

| TO BE COMPLETED BY DESIGNER | | | | TO BE COMPLETED BY<br>AUDIT TEAM LEADER |
|---|---|---|---|---|
| 3.2.7 | Yes | Yes | | |

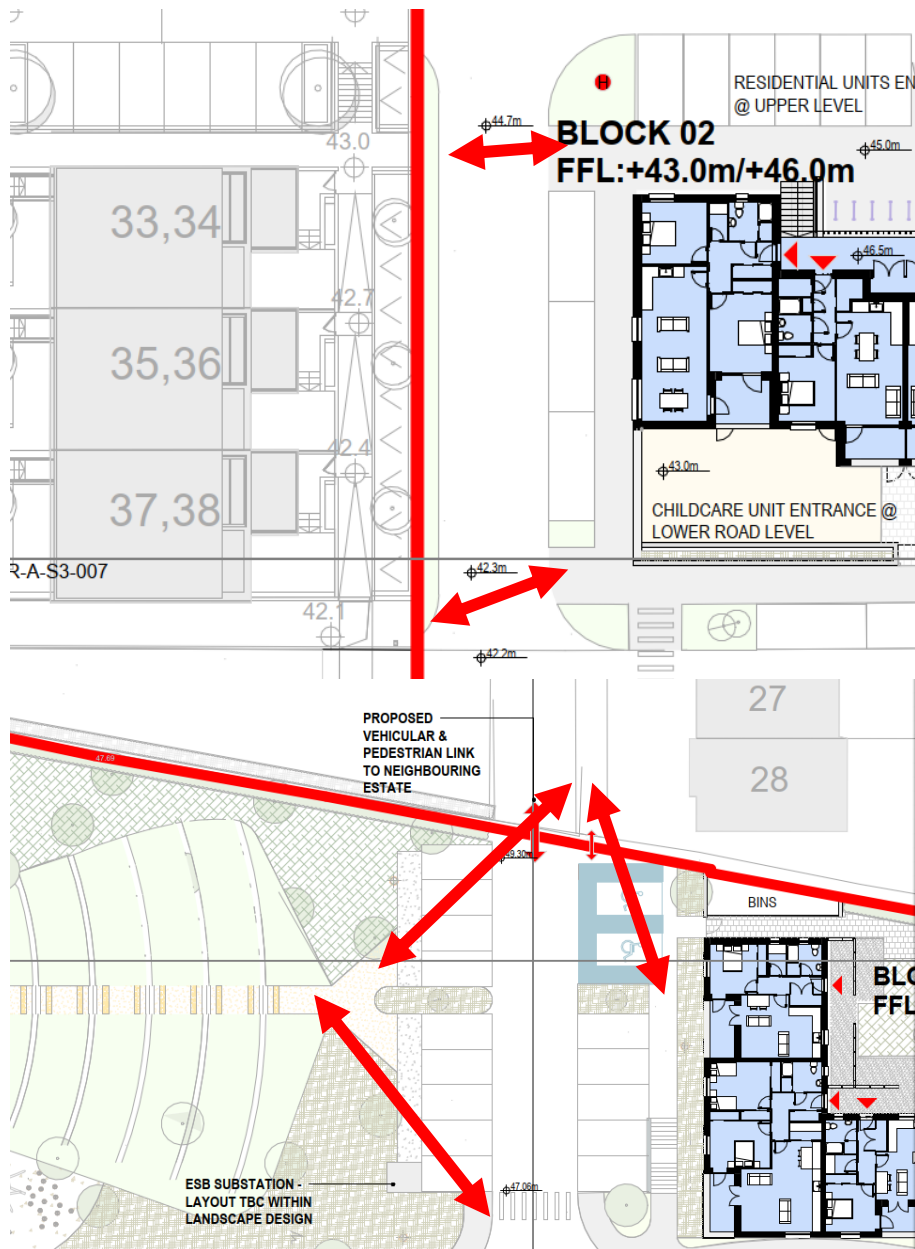
### 3.2.8 Footpath Connectivity

**Problem:** There are a number of locations where footpath links to existing infrastructure is shown or indicated by text, however the link is not direct or requires the pedestrian to temporarily enter the carriageway.

**Hazard:** The pedestrian may be struck by passing traffic.

**Recommendation:** The design team should review all locations where connectivity to the existing footpath infrastructure is proposed. These connections should be direct and incorporate an adequate width footpath with suitable gradients.

| TO BE COMPLETED BY DESIGNER | | | | TO BE COMPLETED BY<br>AUDIT TEAM LEADER |
|---|---|---|---|---|
| 3.2.8 | Yes | Yes | | |

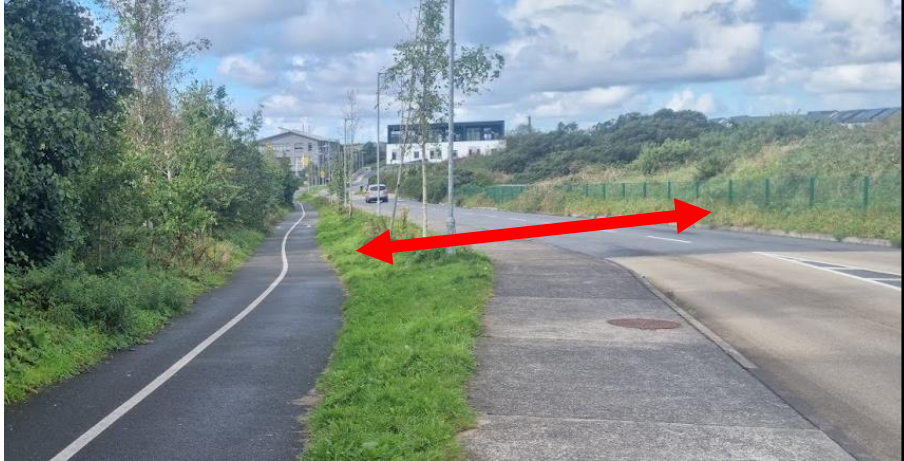
### 3.2.9 Connection to/from Ballyburke Cycle Track

**Problem:** There is an existing cycle track to the south of Ballyburke Road that is segregated from both the footpath and carriageway. The proposed development does not make allowance for cyclists to access / egress this track.

**Hazard:** Cyclists may decide to cycle on the footpath. Impact with pedestrians may result.

**Recommendation:** The design team should adjust the levels of the exiting cycleway and provide suitable carriageway crossings to permit development cyclists to access the existing facility.

| TO BE COMPLETED BY DESIGNER | | | | TO BE COMPLETED BY<br>AUDIT TEAM LEADER |
|---|---|---|---|---|
| 3.2.9 | No | No | Cyclists to use existing/proposed carriageways/footpaths to cycle/walk to next available existing connection point to existing cycleway. Connections to existing cycleway paths to be raised with GCC roads/transportation department to be considered in any future cycleway upgraded proposed in this area. | Yes |

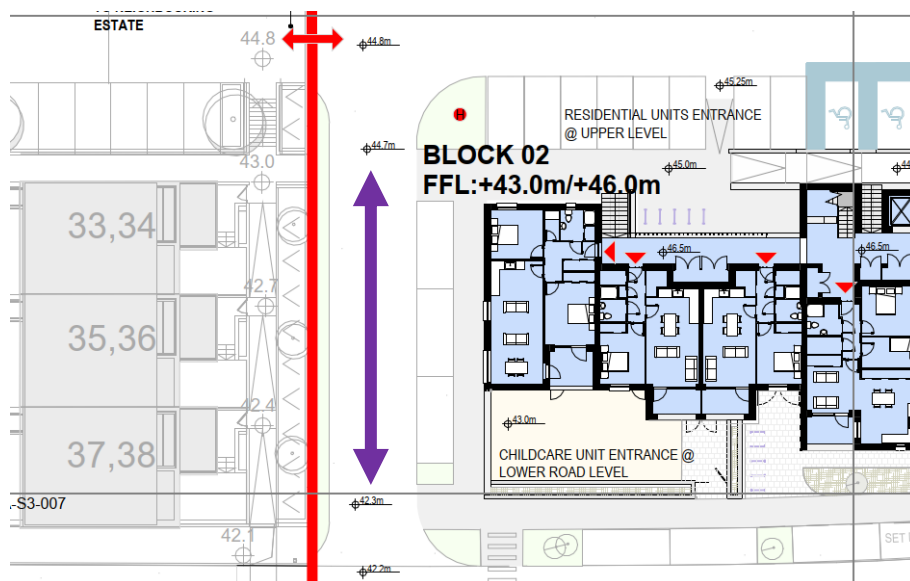
### 3.2.10 Road / Footpath Gradients

**Problem:** Some of the roads and footpaths appear to be very steep.

**Hazard:** There are a number of hazards associated with steep roads, including overshoot of junction, excessive cycle wobble into the path of motor vehicles, loss of wheelchair control, trips, slips and falls.

**Recommendation:** The carriageway and footpath should be amended to acceptable gradients and incorporate suitable dwell areas at the junctions.

| TO BE COMPLETED BY DESIGNER | | | | TO BE COMPLETED BY<br>AUDIT TEAM LEADER |
|---|---|---|---|---|
| 3.2.10 | No | No | Gradients of certain roadways required to deal with site constraints. Alternative part | |

| TO BE COMPLETED BY DESIGNER | | | | TO BE COMPLETED BY<br>AUDIT TEAM LEADER |
|---|---|---|---|---|
| | | | m accessible routes for traversing the site<br>provided elsewhere. | Yes, however gradients<br>are to be limited to the<br>recommendations of<br>DMURS |

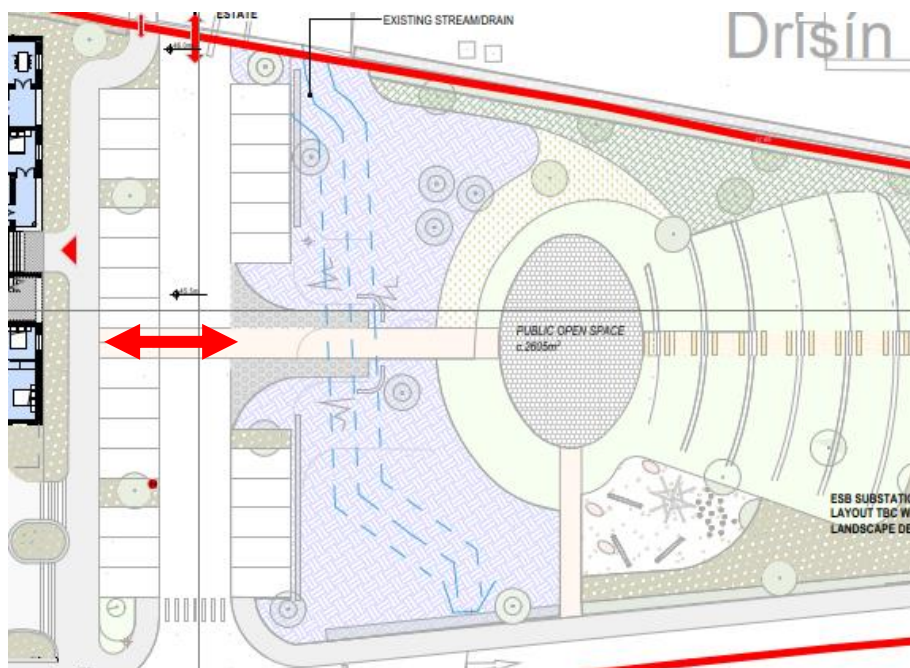
#### 3.3.1 Pedestrian Linkage to Public Open Space.

**Problem:** The pedestrian access from the west to the public open space forms a straight alignment from the footpath to the far side of the carriageway / car parking bays. There is concern that children may run from the public open space across the road to the footpath to the far side. There is no requirement for vehicle speeds to reduce in this area.

**Hazard:** Impact from passing vehicles may result.

**Recommendation:** Realign the route to the public open space such that a change in pedestrian direction is required and also incorporate traffic calming measures in this area.

| TO BE COMPLETED BY DESIGNER | | | | TO BE COMPLETED BY<br>AUDIT TEAM LEADER |
|---|---|---|---|---|
| 3.3.1 | Yes | Yes | | |

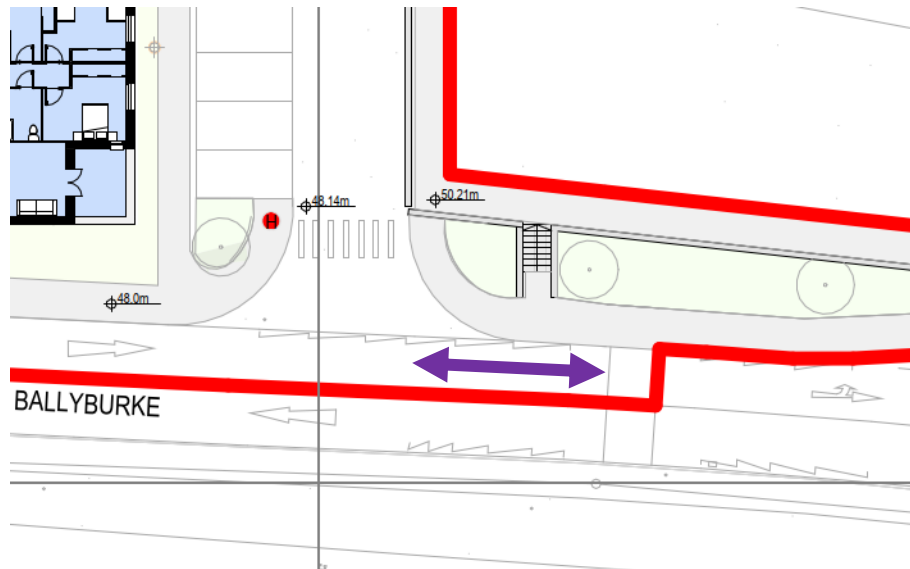
### 3.3.2 Junction proximity to Existing Zebra Crossing.

**Problem:** There is a road junction proposed in close proximity to the existing zebra crossing on Ballyburke Road. Motorists exiting the development junction left are likely to be concentrating to their right in order to observe safe gaps in traffic.

**Hazard:** The development motorists may proceed to turn left and impact with pedestrians who are commencing their crossing.

**Recommendation:** Increase the separation between the zebra crossing and the development junction.

| TO BE COMPLETED BY DESIGNER | | | | TO BE COMPLETED BY<br>AUDIT TEAM LEADER |
|---|---|---|---|---|
| 3.3.2 | Yes | Yes | | |
