Park Redevelopment, Woodquay,
Galway City

Quality Audit

Stage 1 & 2 Road Safety Audit

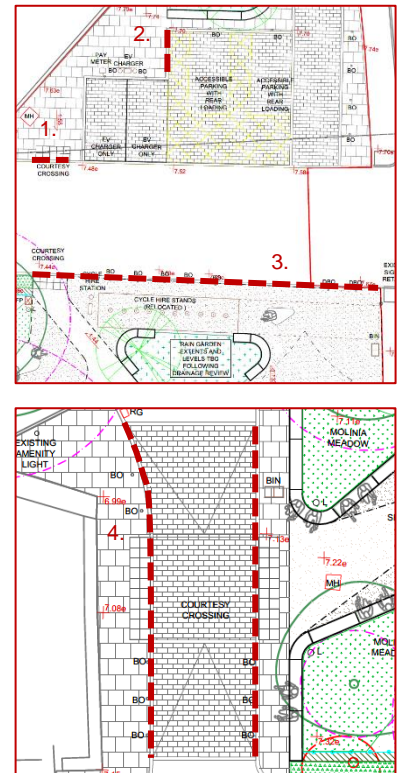
2.1 Kerb Heights

The proposed kerbs within the scheme have been indicated as having a varying height within the legend on the drawings provided and it is, therefore, unclear whether kerbs of an appropriate height would be provided at all locations, including the following:

1. All pedestrian crossings where the provision of kerbs with an upstand greater than 6mm may present trip hazards to pedestrians, or barriers to mobility impaired pedestrians, particularly wheelchair users.

2. Adjacent the mobility-impaired parking spaces at the southeastern corner of the scheme where the absence of a dropped kerb with an appropriate upstand could lead to mobility-impaired vehicle occupants experiencing difficulties entering/exiting their vehicle.

3. At the eastern and western boundary of Woodquay Park at its southern end, where the absence of full height kerbs, outside of pedestrian crossing points, may lead to visually-impaired pedestrians being unable to distinguish between the edge of the footpath/carriageway.

4. At the raised table, indicated at the northern boundary of Woodquay Park, where the provision of flush kerbs outside of the pedestrian crossing may lead to visually-impaired pedestrians being unable to distinguish between the edge of the footpath/carriageway.

Kerbs of a suitable height and type, appropriate for their location and use, should be provided throughout the scheme.

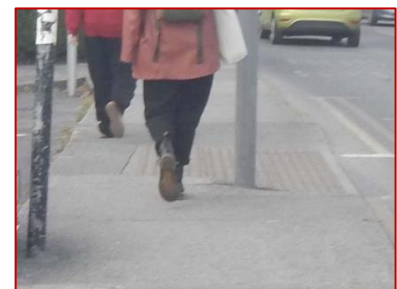
2.2 Incorrect Tactile Paving

It was noted during the site visit that the tactile paving layout at the existing signalised crossing on Headford Road, to the east of its junction with Riverside, is incorrect. This may lead to visually-impaired pedestrians misinterpreting the type of pedestrian crossing and impacting their ability to navigate the road layout.

Should it fall within the scope of the scheme, the tactile paving layout on both sides of this crossing should be updated to be 'L-shaped,' and red in colour, with the stem of the tactile paving located on the right-hand side and extending to the back of the footpath.

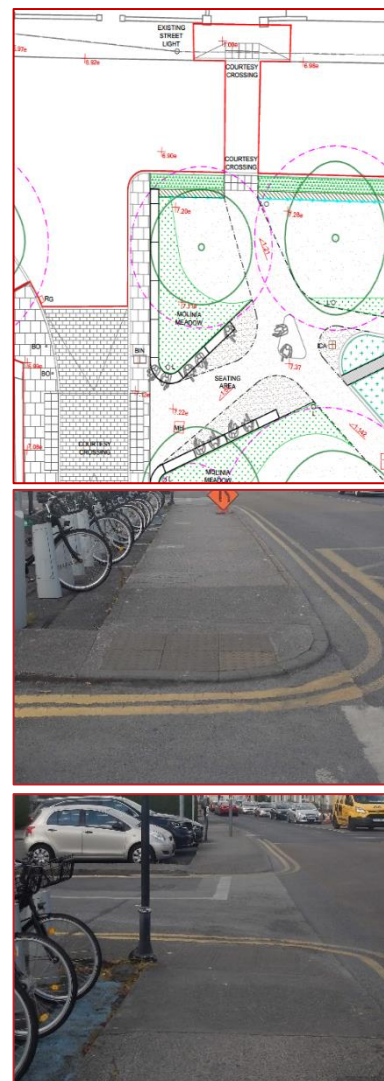
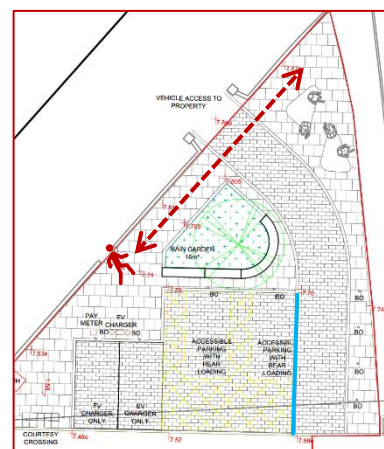
2.4 Layout of Vehicular Access Driveway

A new access lane has been indicated at the southeastern corner of the scheme to facilitate vehicular access to an existing property at this location. It is, however, unclear if there would be a level difference between the lane and the footpath which bounds it on both sides. Should there be a level difference between these two surfaces, the absence of a pedestrian crossing along the likely pedestrian desire line, adjacent the property boundary line, may lead to mobility and visually-impaired pedestrians experiencing difficulties navigating the road layout.

In addition, should there be a level difference, it is unclear if this kerb would extend across the southern side of the mobility-impaired parking space at this location. Should a kerb be provided across the southern side of the mobility-impaired parking space, this may result in the parking space being of an insufficient size and vehicle occupants may, therefore, experience difficulties entering/exiting their vehicle from this side.

Alternatively, should there be no level difference between the lane and the surrounding footpath, this may lead to visually-impaired pedestrians inadvertently entering the lane.

Should there be a level difference between the vehicular access lane and its surrounding footpath, a pedestrian crossing including tactile paving should be provided across the access and a flush kerb provided along the southern side of the mobility-impaired parking space.

Should there be no level difference, suitable measures should be provided to guide visually-impaired pedestrians through this area.

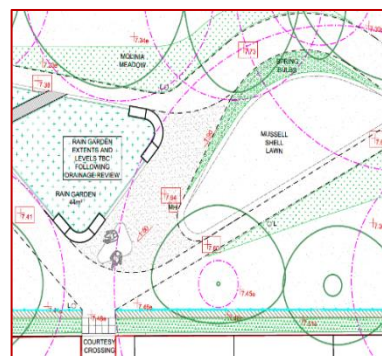
3.1 Width of Internal Paths

A new path network is proposed within Woodquay Park. No information in relation to the width of the paths has been provided, however, sections of the path have been measured as being approximately 1m wide. This width may lead to mobility-impaired pedestrians, particularly wheelchair users, experiencing difficulties when travelling through the park.

In addition, it is unclear if it is intended for the paths to be used by both pedestrians and cyclists. Should the path network be shared by pedestrians and cyclists, narrow paths may fail to accommodate the expected volumes of both of these road users.

If the paths within Woodquay Park are intended to be shared surfaces, they should be a minimum of 2.5m wide. If these are intended to be used only by pedestrians, they should be a minimum of 1.2m wide, but preferably 1.8m wide.

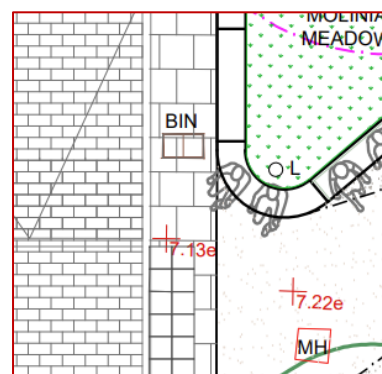
3.2 Bin within Footpath

A bin has been indicated in a central position within the proposed footpath at the northern boundary of Woodquay Park immediately to the east of the raised table pedestrian crossing. The bin may obstruct the path of pedestrians travelling within the footpath.

Relocate the bin to a location where it will not obstruct pedestrian movement.

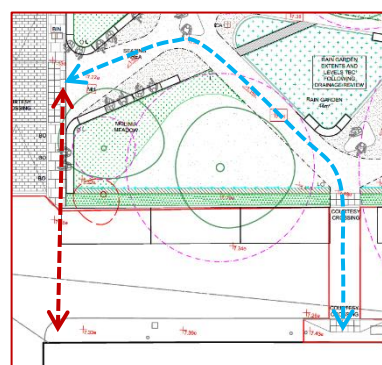
3.3 Pedestrian Desire Line Not Catered For

A new footpath is indicated at the northern boundary of Woodquay Park. No pedestrian crossings have been indicated at either end of the footpath to provide a connection across Corrib Terrace or Riverside, however, this would be the most direct route for pedestrians between these roads, particularly those who wish to travel south on Corrib Terrace. This may, therefore, lead to pedestrians choosing to cross Corrib Terrace or Riverside at the end of the proposed footpath, away from the proposed pedestrian crossing and where full height kerbs would likely be located. Full height kerbs along pedestrian desire lines may increase the risk of trips and falls and present barriers for elderly and mobility impaired pedestrians.

The pedestrian routes to the east and west at the park's northern end should be made unattractive to deter their use and thus pedestrians crossing Corrib Terrace or Riverside at these locations. This may be achieved by extending the grassed verges at either end of the footpath northwards across the proposed footpaths, or by an alternative appropriate measure.

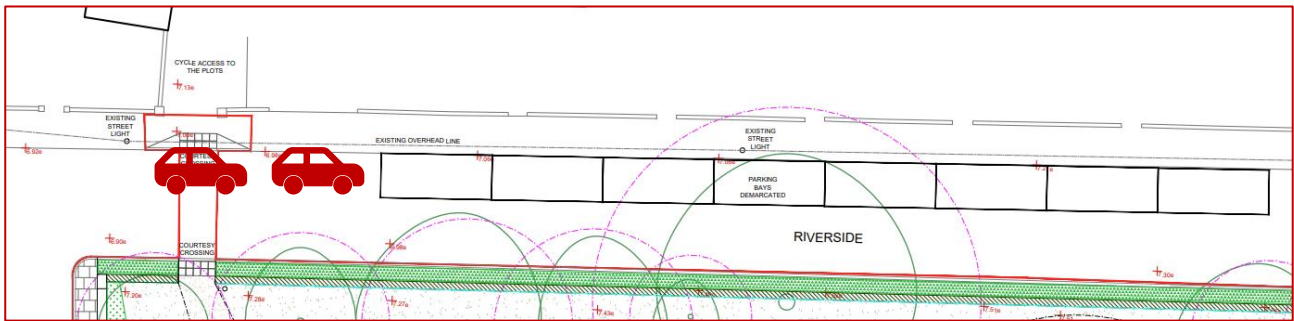
3.4 Informal Parking at Pedestrian Crossing

A new uncontrolled pedestrian crossing has been indicated on Riverside at the northeastern corner of the park, which would link a cycle access to 'The Plots' and the proposed Woodquay Park. There are a number of on-street parking bays located along the northeastern side of Riverside, which would be demarcated. No measures, however, have been indicated at the access to 'The Plots' to prohibit informal parking at this location, outside the demarcated parking spaces. Should these formal parking spaces be occupied, drivers may park adjacent to the access where they may encroach into, or block, the crossing. If a driver were to park at this location, this would obstruct pedestrian and cyclist movement across Riverside between the park and 'The Plots.'

Measures (e.g. double yellow lines) should be provided at this location to prohibit informal parking.

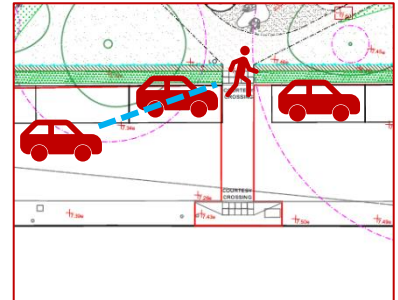
Should one, or both, of these parking spaces be occupied, this may lead to the inter-visibility between approaching drivers and pedestrians waiting at the eastern side of the crossing being restricted. This may lead to a pedestrian entering the carriageway when a driver may not anticipate them to do so resulting in a subsequent risk of vehicle-pedestrian collisions.

The parking spaces should be removed or relocated such that sufficient inter-visibility between a driver, approaching from either direction, and a pedestrian exiting the park at the crossing is provided at this location.

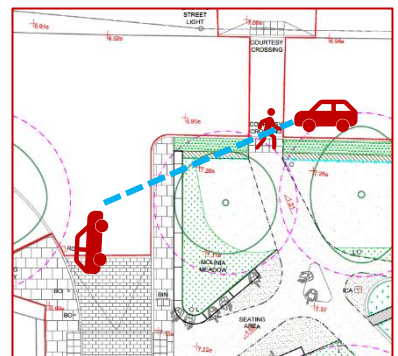
Information in relation to the intended height of the hedgerow has not been provided and, should it grow too high, this may lead to inter-visibility between drivers approaching this corner from each direction, or southbound drivers and pedestrians waiting at the western side of the crossing being restricted.

This may lead to a southbound driver cutting the corner ahead of an opposing driver turning onto Riverside resulting in a subsequent risk of low-speed head-on collisions, or to a pedestrian entering the carriageway when a driver may not anticipate them to do so and a subsequent risk of vehicle-pedestrian collisions.

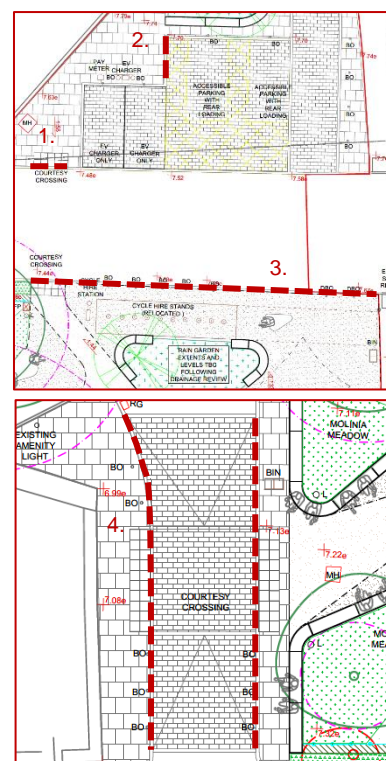
1. All pedestrian crossings where the provision of kerbs with an upstand greater than 6mm may present trip hazards to pedestrians, or barriers to mobility impaired pedestrians, particularly wheelchair users.

4. At the raised table, indicated at the northern boundary of Woodquay Park, where the provision of flush kerbs outside of the pedestrian crossing may lead to visually-impaired pedestrians inadvertently entering the carriageway where there is a risk of being struck by a vehicle.

Kerbs of a suitable height, appropriate for their location and use, should be provided throughout the scheme.

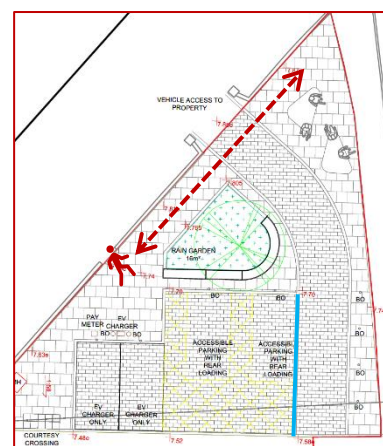
In addition, should there be a level difference, it is unclear if this kerb would extend across the southern side of the mobility-impaired parking space at this location. Should a kerb be provided across the southern side of the mobility-impaired parking space, this may result in the parking space being of an insufficient size and vehicle occupants may experience difficulties entering/exiting their vehicle from this side.

Alternatively, should there be no level difference between the lane and the surrounding footpath, this may lead to visually-impaired pedestrians inadvertently entering the lane where there is a risk of being struck by a vehicle.
