Park Redevelopment, Woodquay,
Galway City

Stage 1 & 2 Road Safety Audit

Document Ref:	P24110-PMCE-XX-XX-RP-SA-5_0001
---------------	--------------------------------

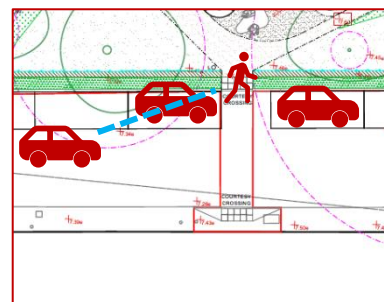
3.1.1 Inter-Visibility Restricted by Parking Spaces

Summary: Inter-visibility between drivers and pedestrians crossing Corrib Terrace from Woodquay Park may be restricted by parked cars on both sides of the crossing.

An uncontrolled pedestrian crossing has been indicated on Corrib Terrace. The pedestrian crossing point exiting Woodquay Park would, however, be located between two parking spaces.

Should one, or both, of these parking spaces be occupied, this may lead to the inter-visibility between approaching drivers and pedestrians waiting at the eastern side of the crossing being restricted. This may lead to a pedestrian entering the carriageway when a driver may not anticipate them to do so resulting in a subsequent risk of vehicle-pedestrian collisions.

The parking spaces should be removed or relocated such that sufficient inter-visibility between a driver, approaching from either direction, and a pedestrian exiting the park at the crossing is provided at this location.

3.1.1	Y	N	Location of crossing point has been moved east to improve visibility. A build-out has been incorporated to improve inter-visibility between drivers and pedestrians	Yes

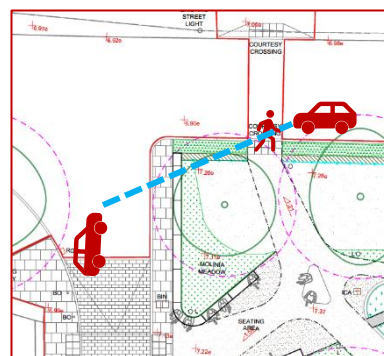
3.1.2 Inter-visibility Restricted by Hedge Line

Summary: Inter-visibility between drivers and all road users at the northeastern corner of Woodquay Park may be restricted by hedge planting/fencing.

A row of hedge planting, which would initially be supported by a timber post and rail fence, has been indicated around the border of Woodquay Park. A new uncontrolled pedestrian crossing has also been indicated on Riverside at the northeastern corner of the park.

Information in relation to the intended height of the hedgerow has not been provided and, should it grow too high, this may lead to inter-visibility between drivers approaching this corner from each direction, or southbound drivers and pedestrians waiting at the western side of the crossing being restricted.

This may lead to a southbound driver cutting the corner ahead of an opposing driver turning onto Riverside resulting in a subsequent risk of low-speed head-on collisions, or to a pedestrian entering the carriageway when a driver may not anticipate them to do so and a subsequent risk of vehicle-pedestrian collisions.

The hedgerow planting should be routinely maintained and cut to a height which provides sufficient inter-visibility between all road users at this location.

3.1.2	Y	N	Hedge planting has been removed from this location	Yes
3.1.3	Y	Y	LUC Hard Landscape drawings 12357-LUC-XX-00-DR-L-0106 and 12357-LUC-XX-00-DR-L-0107 provide full details of kerbs

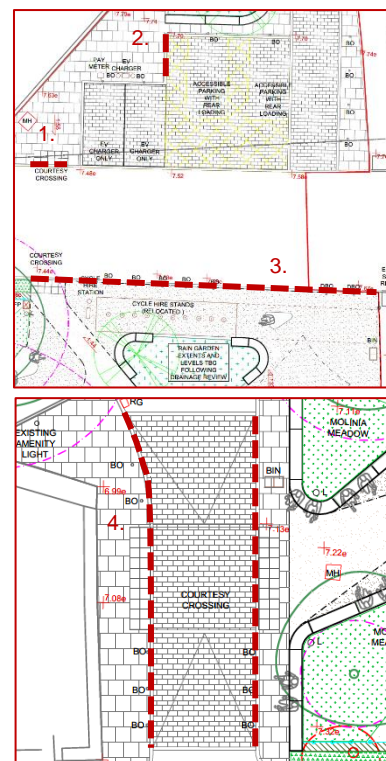
3.1.3 Kerb Heights

Summary: It is unclear if kerbs of an appropriate height would be provided at all locations within the scheme.

The proposed kerbs within the scheme have been indicated as having a varying height within the legend on the drawing provided and it is, therefore, unclear whether kerbs of an appropriate height would be provided at all locations, including the following:

1. All pedestrian crossings where the provision of kerbs with an upstand greater than 6mm may present trip hazards to pedestrians, or barriers to mobility impaired pedestrians, particularly wheelchair users.

2. Adjacent the mobility-impaired parking spaces at the southeastern corner of the scheme where the absence of a dropped kerb with an appropriate upstand could lead to mobility-impaired vehicle occupants experiencing difficulties entering/exiting their vehicle.

3. At the eastern and western boundary of Woodquay Park at its southern end, where the absence of full height kerbs, outside of pedestrian crossing points, may lead to visually-impaired pedestrians inadvertently entering the carriageway where there is a risk of being struck by a vehicle.

4. At the raised table, indicated at the northern boundary of Woodquay Park, where the provision of flush kerbs outside of the pedestrian crossing may lead to visually-impaired pedestrians inadvertently entering the carriageway where there is a risk of being struck by a vehicle.

Kerbs of a suitable height, appropriate for their location and use, should be provided throughout the scheme.

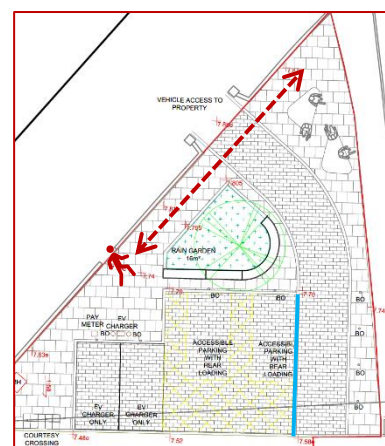
3.1.4 Layout of Vehicular Access Driveway

Summary: The layout of the proposed vehicular lane providing access to an existing property is unclear and may result in mobility and visually-impaired pedestrians experiencing difficulties navigating the road layout at this location.

A new access lane has been indicated at the southeastern corner of the scheme to facilitate vehicular access to an existing property at this location. It is, however, unclear if there would be a level difference between the lane and the footpath which bounds it on both sides. Should there be a level difference between these two surfaces, the absence of a pedestrian crossing along the likely pedestrian desire line, adjacent the property boundary line, may lead to mobility and visually-impaired pedestrians experiencing difficulties navigating the road layout.

In addition, should there be a level difference, it is unclear if this kerb would extend across the southern side of the mobility-impaired parking space at this location. Should a kerb be provided across the southern side of the mobility-impaired parking space, this may result in the parking space being of an insufficient size and vehicle occupants may experience difficulties entering/exiting their vehicle from this side.

Alternatively, should there be no level difference between the lane and the surrounding footpath, this may lead to visually-impaired pedestrians inadvertently entering the lane where there is a risk of being struck by a vehicle.

Should there be a level difference between the vehicular access lane and its surrounding footpath, a pedestrian crossing including tactile paving should be provided across the access and a flush kerb provided along the southern side of the mobility-impaired parking space.

Should there be no level difference, suitable measures should be provided to guide visually-impaired pedestrians through this area.

3.1.4	Y	Y	There is no level difference between surfaces. Hazard warning paving has been introduced at location indicated to raise awareness to visually-impaired

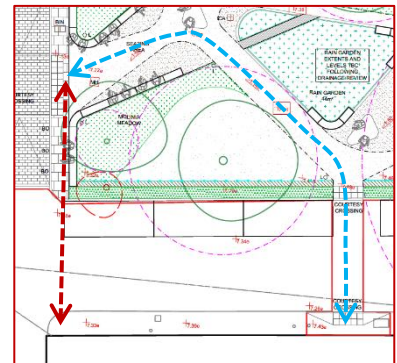
3.1.5 Unaccommodated Pedestrian Desire Line

Summary: *The provision of a footpath along the northern boundary of the park without associated pedestrian crossings at both ends may lead to pedestrians crossing Corrib Terrace or Riverside from this footpath where drivers may not anticipate them to do so.*

A new footpath is indicated at the northern boundary of Woodquay Park. No pedestrian crossings have been indicated at either end of the footpath to provide a connection across Corrib Terrace or Riverside, however, this would be the most direct route for pedestrians between these roads, particularly those who wish to travel south on Corrib Terrace. This may, therefore, lead to pedestrians choosing to cross Corrib Terrace or Riverside at the end of the proposed footpath, away from the pedestrian crossings, where drivers may not anticipate them to do so, resulting in an increased risk of vehicle-pedestrian collisions.

The pedestrian routes to the east and west at the park's northern end should be made unattractive to deter their use and thus pedestrians crossing Corrib Terrace or Riverside at these locations. This may be achieved by extending the grassed verges at either end of the footpath northwards across the proposed footpaths, or by an alternative appropriate measure.

3.1.5	Y	Y	Planting has been extended across to block the ends of the routes	
3.1.6	Y	Y	Paths are only intended to be used by pedestrians. All paths widened to 1.2m minimum. Main paths are 2.0m wide.

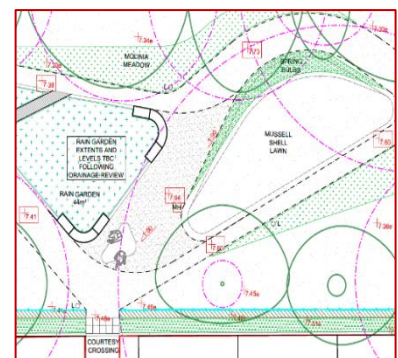
3.1.6 Width of Internal Paths

Summary: *The width of the paths within Woodquay Park may not be sufficient to accommodate its intended users.*

A new path network is proposed within Woodquay Park. No information in relation to the width of the paths has been provided, however, sections of the path have been measured as being approximately 1m wide. This width may lead to mobility-impaired pedestrians, particularly wheelchair users, experiencing difficulties when travelling through the park.

In addition, it is unclear if it is intended for the paths to be used by both pedestrians and cyclists. Should the path network be shared by pedestrians and cyclists, narrow paths may result in an increased risk of conflicts between these road users.

If the paths within Woodquay Park are intended to be shared surfaces, they should be a minimum of 2.5m wide. If these are intended to be used only by pedestrians, they should be a minimum of 1.2m wide, but preferably 1.8m wide.

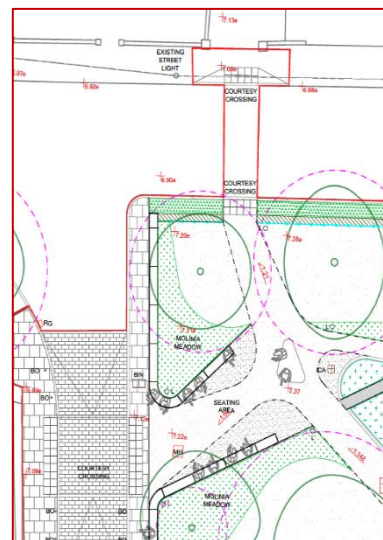
3.1.7 Depth of Tactile Paving

Summary: The depth of tactile paving provided at various locations would not be sufficient for an in-line pedestrian crossing.

New uncontrolled pedestrian crossings have been indicated at various locations within the scheme. A number of these crossings may be considered as in-line pedestrian crossings, where pedestrians cross the road in their direction of travel, due to the alignment of the paths within Woodquay Park on their approach to the crossings. These locations include the raised table crossing and the northern crossing on Riverside.

The tactile paving indicated at these crossings is not of a sufficient depth for an in-line pedestrian crossing and this may lead to a visually-impaired pedestrian stepping over the tactile paving and inadvertently entering the carriageway where there is an increased risk of being struck by a vehicle.

In addition, the existing tactile paving at the crossing of Corrib Terrace and Riverside, at their junctions with Headford Road, are also not deep enough for an in-line pedestrian crossing.

Tactile paving at all in-line pedestrian crossings should be a minimum of 1.2m in depth.

3.1.7	Y	Y	Tactile paving at all in-line crossings extended to 1.2m depth	
3.1.8	Y	Y	Bollards have been repositioned 450mm away from edge of carriageway and reflective strips included within specification shown on Hard Landscape plans 12357-LUC-XX-00-DR-L-0106 and 12357-LUC-XX-00-DR-L-0107

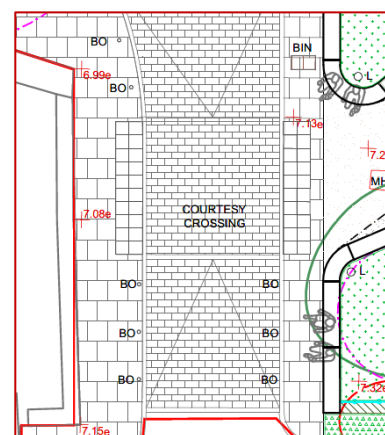
3.1.8 Visibility of Bollards

Summary: It is unclear if the proposed bollards would be sufficiently visible during the hours of darkness.

A number of stainless steel bollards have been indicated within the scheme, including on the western side of Riverside and on both sides of the proposed raised table at the park's northwestern boundary. Should the bollards not include reflective measures, there is a risk that they would not be sufficiently visible during the hours of darkness.

In addition, it is unclear if the bollards would be sufficiently setback from the edge of the carriageway.

If the bollards are not sufficiently visible to approaching drivers during the hours of darkness, or should they be located too close to the edge of the carriageway, there is a risk of vehicles striking the bollards and material damage collisions.

The proposed bollards should include reflective measures, such as a reflective band, and be located a minimum of 450mm from the edge of the carriageway.

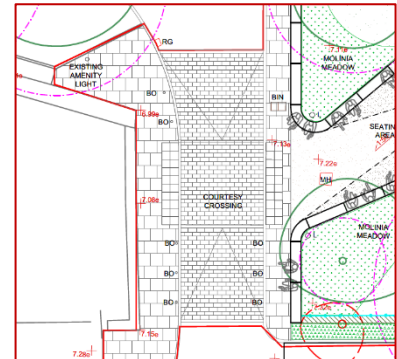
3.1.9 Absence of Drainage Measures

Summary: It is unclear if the carriageway would sufficiently shed surface water at the raised table.

A new raised table has been indicated at the northern boundary of Woodquay Park. There appears to be an existing gully at the northeastern corner of the raised table, however no additional drainage measures appear to be proposed at this location. The existing drainage measures may fail to sufficiently shed surface water which may accumulate at the bottom of the raised table. If the carriageway is not sufficiently drained there is a risk of ponding and loss of traction resulting in the potential for loss of control type incidents, particularly during wet and icy weather conditions.

Sufficient drainage measures should be provided at the raised table such that the carriageway on both sides sufficiently sheds surface water.

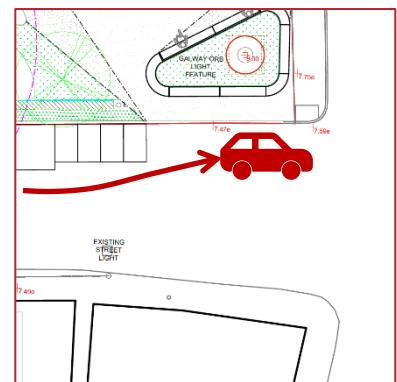
3.1.11 Location of Motorcycle Parking Spaces

Summary: It is unclear if the swept path of drivers taking up a position at the Stop line on Corrib Terrace would be accommodated due to the location of the motorcycle parking spaces.

A row of motorcycle parking spaces has been indicated on the western side of Corrib Terrace a short distance upstream of its junction with Headford Road. Due to the location of these parking spaces, it is unclear if a driver taking up a position at the Stop line would be able to do so comfortably if these spaces were occupied. Should sufficient space not be available for these drivers, this may result in material damage collisions between vehicles and parked motorcycles.

Confirm, via a swept path analysis, that a driver can safely position themselves at the Stop line when the motorcycle parking spaces are occupied.

To be Completed by Designer				To be Completed by Audit Team Leader
Paragraph No. in Safety Audit Report	Problem Accepted (Yes/No)	Recommended Measure(s) Accepted (Yes/No)	Describe Alternative Measure(s). Give reasons for not accepting recommended measure. Only complete if recommended measure is not accepted	Alternative Measures or Reasons Accepted by Auditors (Yes/No)
3.1.9	Y	Y	Additional gulleys shown on PUNCH drainage drawing 31101-PUNCH-01-XX-DR-C-0101	
3.1.10	Y	Y	No cycle access is proposed within the park.	
3.1.11	Y	Y	Refer to PUNCH swept path drawings 231101-PUNCH-01-XX-DR-C-0601, 0602, 0603. Parking spaces have been adjusted to ensure no clash with swept path of drivers taking up a position at the Stop line

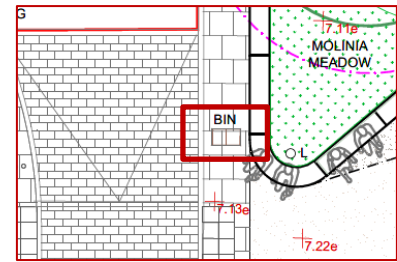
- 4.1 A bin has been indicated in a central position within the proposed footpath at the northern boundary of Woodquay Park immediately to the east of the raised table pedestrian crossing. The bin may obstruct the path of pedestrians travelling within the footpath and it should, therefore, be relocated.

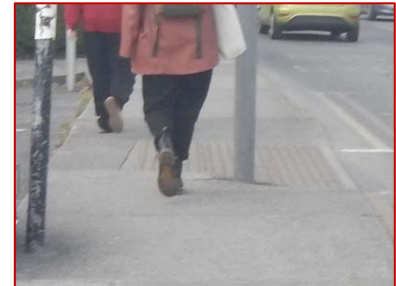
- 4.2 It was noted during the site visit that the tactile paving layout at the existing signalised crossing on Headford Road, to the east of its junction with Riverside, is incorrect. This may lead to visually-impaired pedestrians misinterpreting the type of pedestrian crossing and impacting their ability to navigate the road layout. Should it fall within the scope of the scheme, the tactile paving layout on both sides of this crossing should be updated to be 'L-shaped,' and red in colour, with the stem of the tactile paving located on the right-hand side and extending to the back of the footpath.

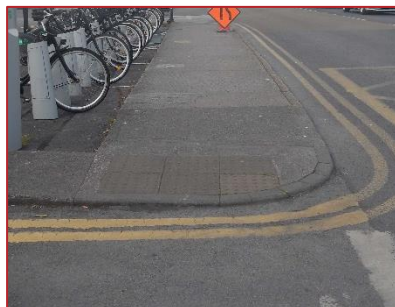
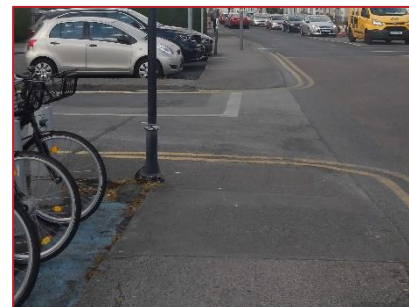
- 4.3 The tactile paving indicated at the in-line pedestrian crossings at Riverside and Corrib Terrace, where pedestrians cross the road in their direction of travel, would be of an insufficient depth for this type of crossing. This may lead to a visually-impaired pedestrian stepping over the tactile paving and inadvertently entering the carriageway where there is an increased risk of being struck by a vehicle. Tactile paving at all in-line pedestrian crossings should be a minimum of 1.2m in depth.
