## Arboricultural Impact Assessment Report

Galway City Council

Merlin Lands

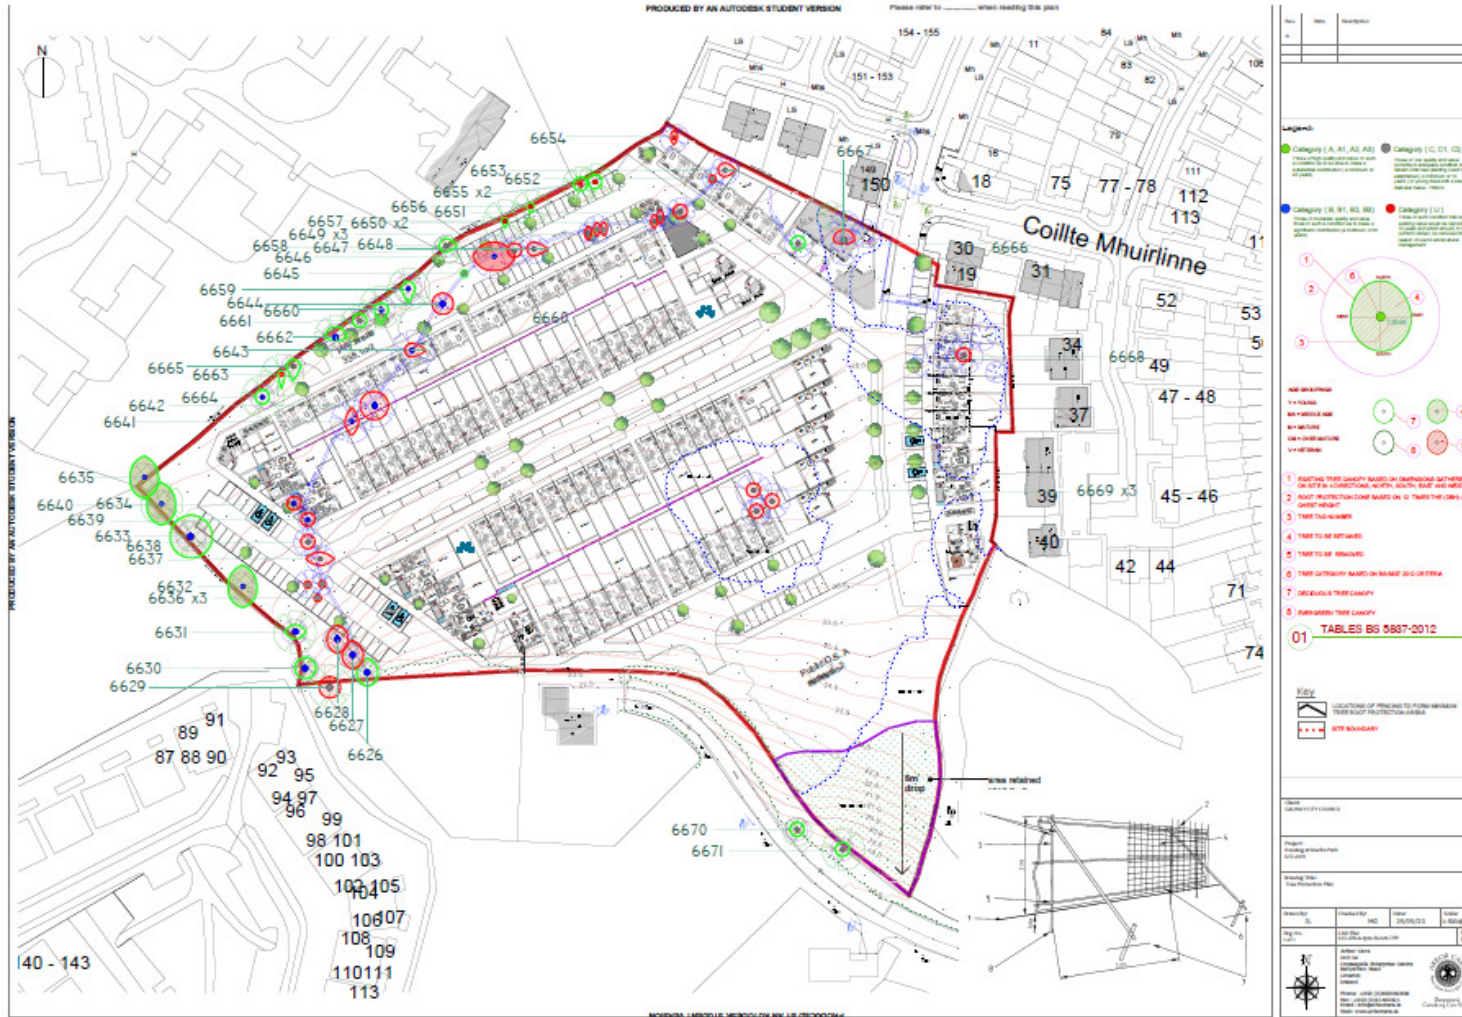
**Appendix 2. Tree Protection Plan**

The arboricultural impact of the proposed development on the site will initially be high 29 trees to facilitate the development and a further 7 trees are to be removed based on their condition. This totals 36 trees to be removed from the site. However of the 29 trees to be removed to facilitate the development the majority are of low quality trees.

Of the 36 trees to be removed, these consist of 0 no. Category A tree, 7 no. Category B and 22 no. Category C trees and 6 no. category U trees to be removed based on their condition.

A site specific Tree Protection Plan, please review appendix 2.

The erection of protective fencing is to be erected to the fence line shown in tree protection plan. The fencing must adhere with BS 5837: 2012 (Figure 3 and Figure 4 above). Signage must be placed on the fence to highlight its importance. Once the fencing is erected works can commence on-site. *This is not required at this stage*
