PRELIMINARY BAT ROOST ASSESSMENT  
REPORT FOR THE PROPOSED DEVELOPMENT  
OF A SOCIAL AND AFFORDABLE HOUSING  
SCHEME WITH CIVIC SPACE, BALLYBURKE  
ROAD, KNOCKNACARRRA , GALWAY, CO.  
GALWAY FOR GALWAY CITY  
COUNCIL\_ENV\_GCC\_005

Prepared By:  
Maurice O'Connor  
Envirico Ltd.  
Senior Project Manager  
moconnor@envirico.ie

JUNE 19, 2023  
ENVIRICO LTD.  
5A Courthouse Lane,  
Tralee,  
Co. Kerry  
V92 CP5W  
066 913 0116 / 086 603 2603

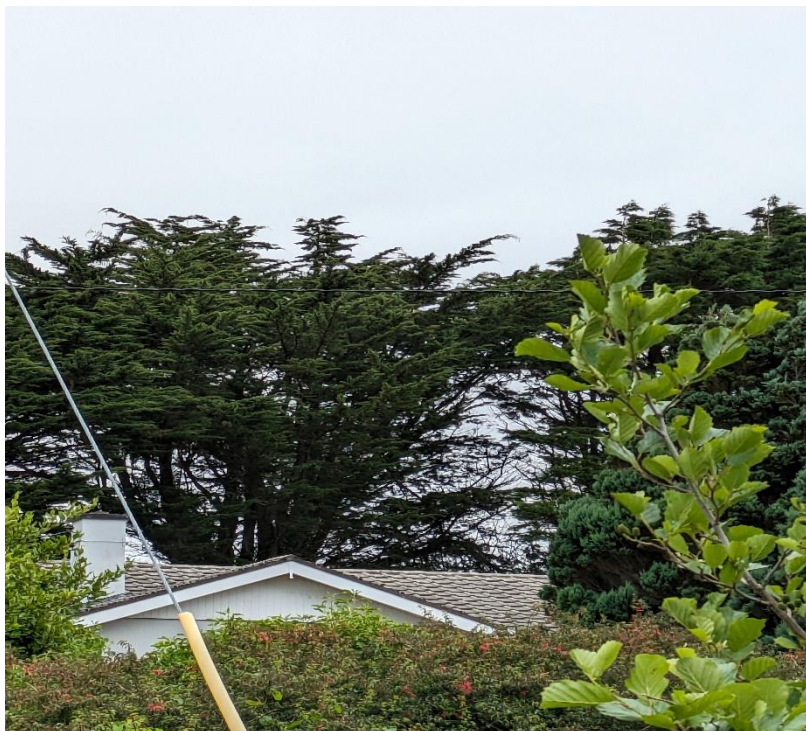
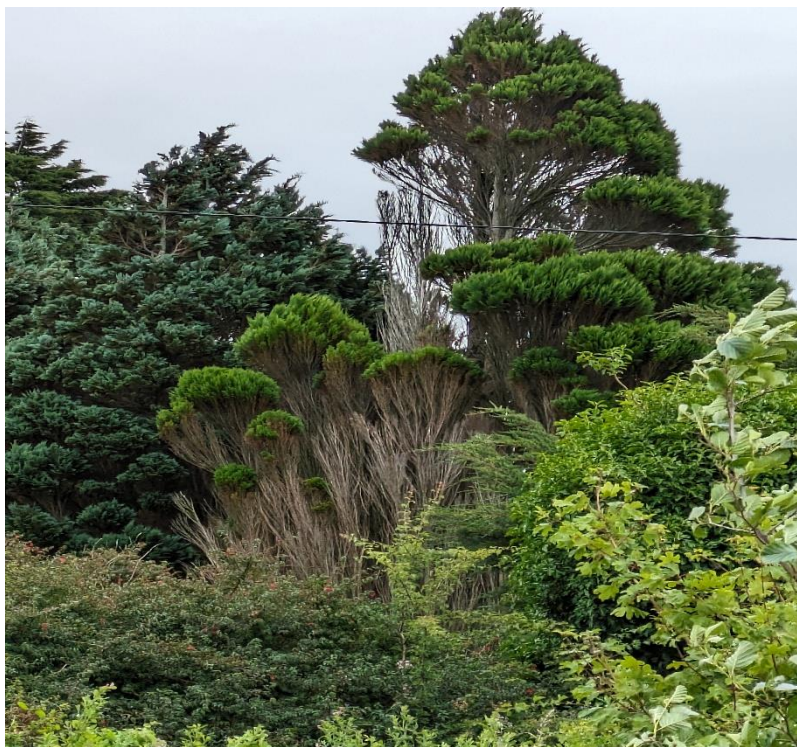
| Structure | Location | Description | Structure proposed to be removed? | Bat roost potential |
|---|---|---|---|---|
| <b>Treeline at east of site – by greenfield site and houses</b> | ITM<br>525408,<br>725041 | Non-native mature tree line of conifer species. These trees are ivy covered with numerous branches. Potential to support small roosts, but no bat activity observed during this survey. | Not known at this time of survey | Low |

*Photo 1: Treeline at east of site by greenfield site and houses*

*Photo 2: Treeline at east of site by greenfield site and houses*

- If trees on site must be felled, it should be completed in the period of late August to late October/early November, (during which bats are capable of flight and thus can avoid).
- A close-up inspection of the trees should be completed immediately prior to felling, utilising the appropriate equipment, (endoscope, torch and bat detector), and access to a hoist or teleporter is essential for the assessment of potential roosting features and crevices.

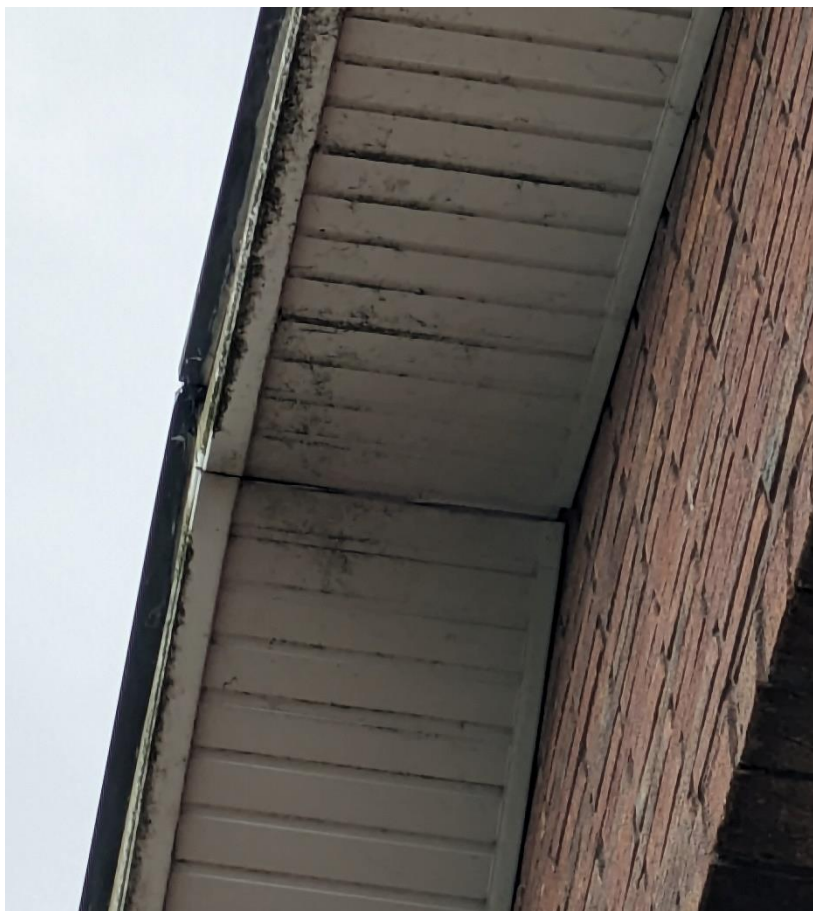
| Structure | Location | Description | Structure proposed to be removed? | Bat roost potential |
|---|---|---|---|---|
| <b>Gap in fascia at north facing gable of house</b> | ITM<br>525373,<br>725057 | Gap present in the fascia of the apex of the roof at the North facing apex. Potential access for bats to roost in the internal fabric of the roof structure. No signs of bat activity around this feature. | Yes | Low |
| <b>Gap between roof slates and fascia at same location</b> | ITM<br>525373,<br>725057 | Gap present between the roof slates and the fascia at the apex of the roof at the North facing gable of the building. Potential access for bats to the roof interior. No signs of bat activity around this feature. | Yes | Low |

*Photo 3: Gap in fascia and between fascia and brick wall in north facing gable of house*

Confirmatory surveys are required following evidence of potential bat presence found during the site walkovers. It is recommended that follow up Emergence/Re-entry Surveys are carried out at points of interest noted in Section 7. Owing to the general state of disrepair of some structures on site it is further recommended that any buildings due for renovation, repair, repointing or demolition are assessed internally for potential roost features. If buildings are to be demolished care must be taken and if a bat is identified or observed to be flying from the building when demolition occurs, all works must stop and the National Parks and Wildlife Services (NPWS) be called immediately.

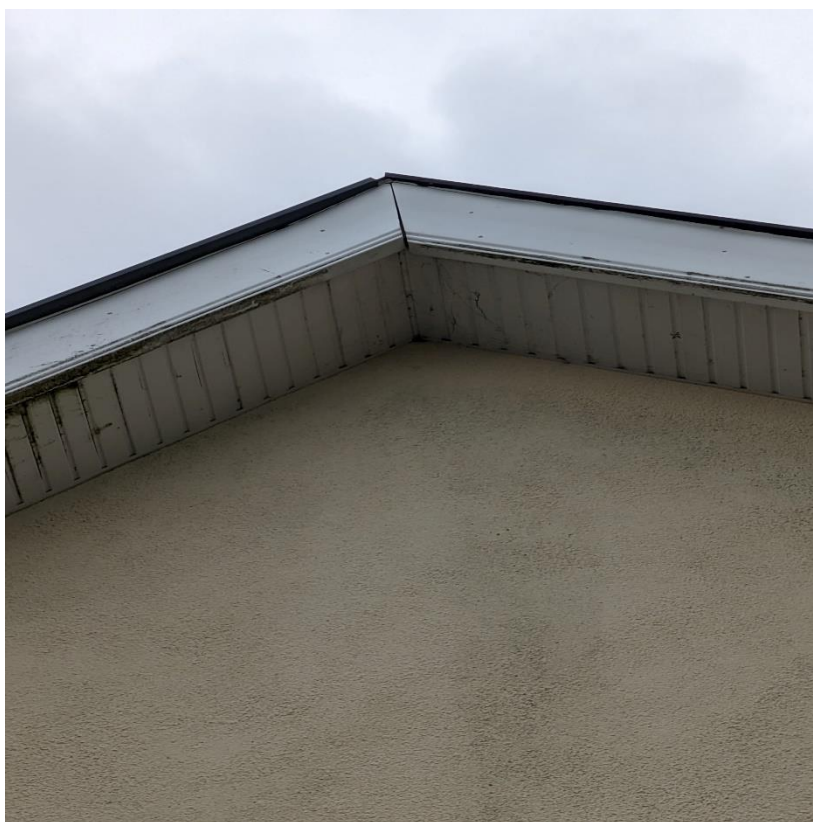
| Structure | Location | Description | Structure proposed to be removed? | Bat roost potential |
|---|---|---|---|---|
| <b>Gap in fascia at gable facing West</b> | ITM<br>525362,<br>725052 | Gap in the fascia at the apex of the roof at the West facing gable, there is a gap where the two fascia boards meet. Potential access for bats to enter the roof or crevice spaces. No signs of bat activity around this feature. | Yes | Low |

*Photo 4: Gap in fascia in gable facing west*

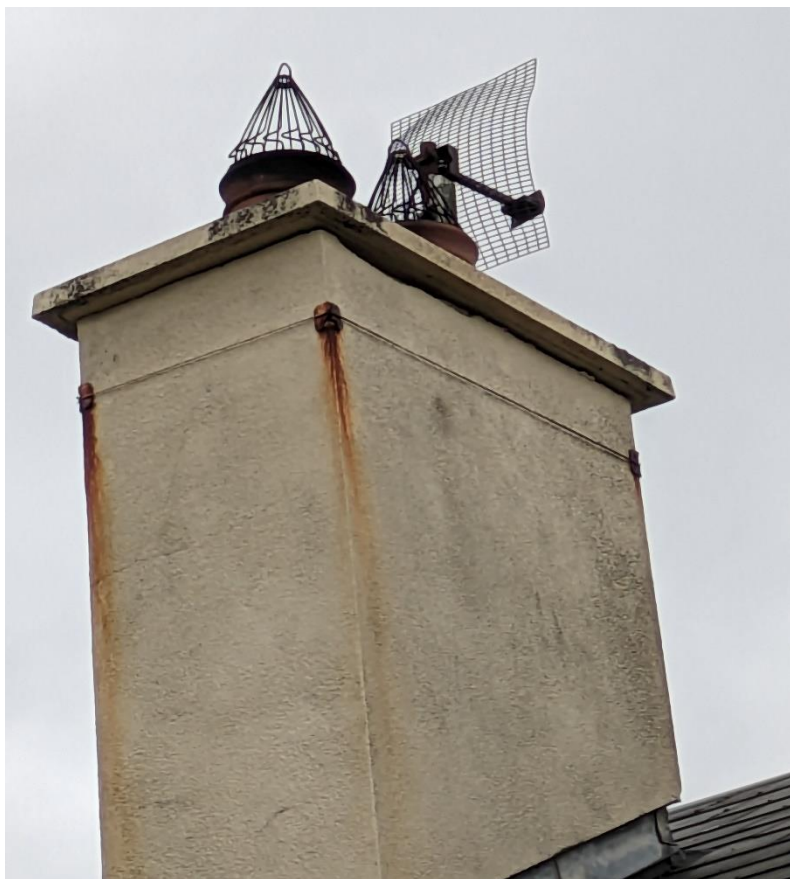
| <b>Gaps in chimney structure</b> | ITM<br>525368,<br>725047 | In the chimney structure, there appears to be crevices in the concrete where some concrete has deteriorated and fallen away. These crevices may support bat roosts but may not be deep enough to provide sufficient roosting habitat. | Yes | Low |

*Photo 5: Gaps in structure of chimney*

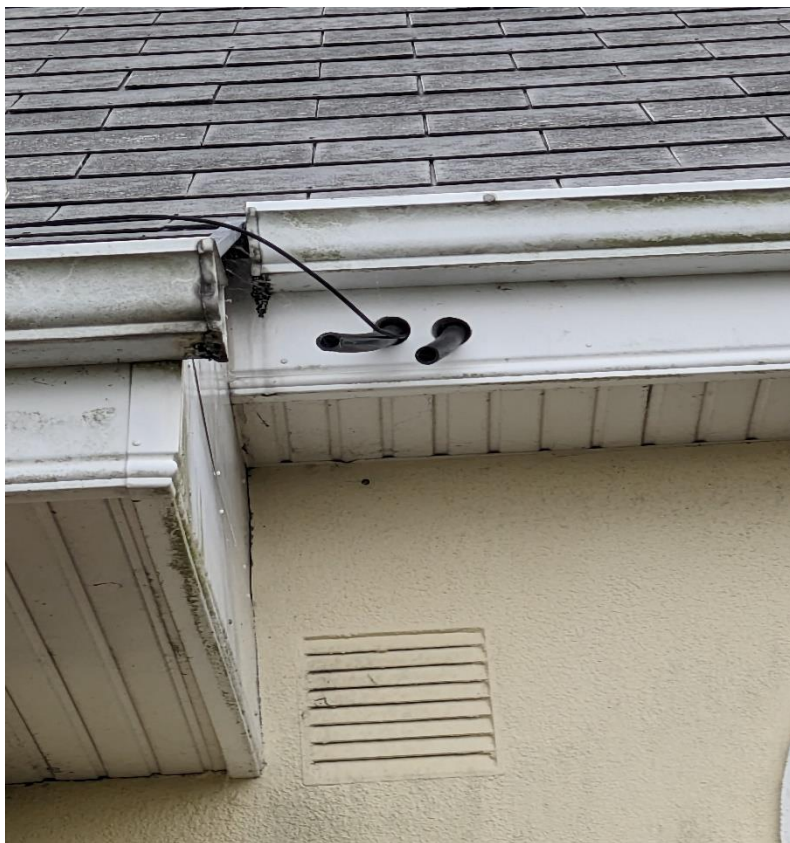
| <b>Holes in fascia</b> | ITM<br>525374,<br>725043 | At the back of the house (South facing gable), there are two holes drilled into the fascia for two pipes. The holes potentially may be of a large enough diameter for bats to enter the fascia to roost. However, no signs of bat activity (staining, droppings etc) were observed. | Yes | Low |

*Photo 6: Holes for 2 outlet pipes*

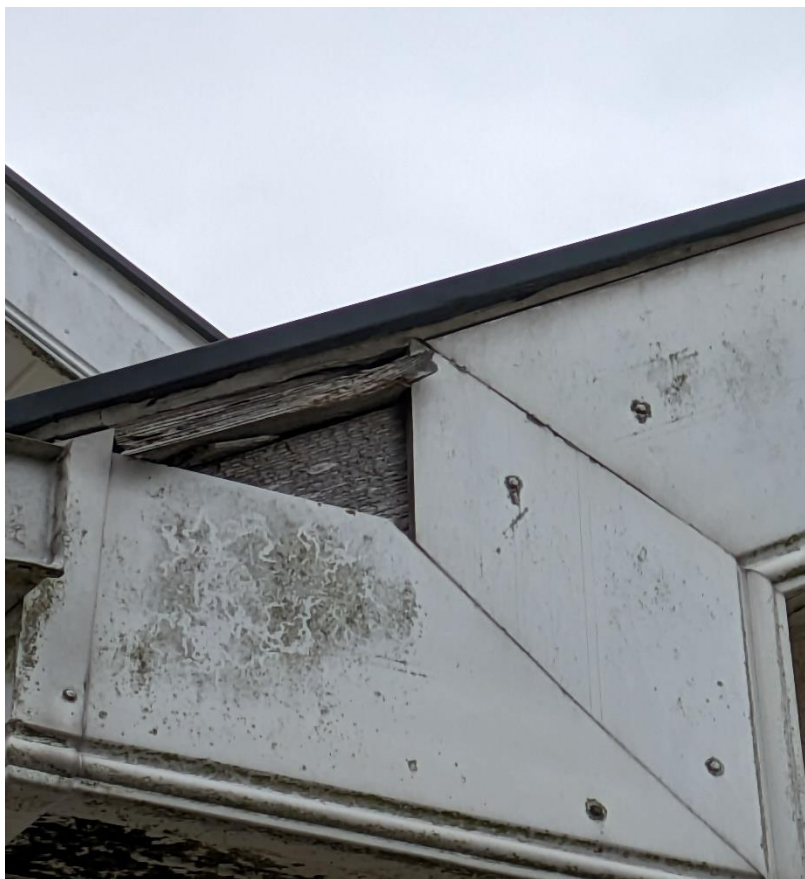
| <b>Break in fascia material</b> | ITM<br>525387,<br>725050 | At the east facing gable of the house, there is a section of fascia that is broken away. This may provide potential for bats to enter the fabric of the building to roost. No signs of bat activity observed | Yes | Low |

*Photo 7: Missing piece of fascia on east facing gable of house*

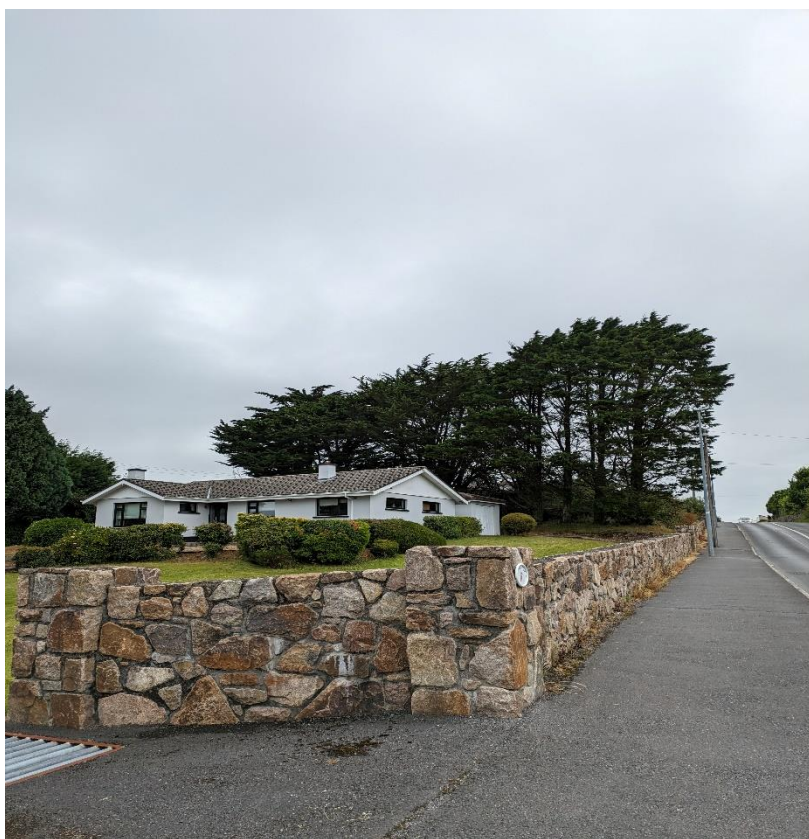
| <b>Ivy covered trees</b> | ITM<br>525405,<br>725051 | In the garden of the house, there are ivy covered non-native conifer trees. They may provide some potential, however, due to the presence of foliage, this was difficult to observe. No signs of bat activity in these features. | Not known at this time of survey | Low |

*Photo 8: Non-native coniferous treeline*
