**GALWAY CITY COUNCIL
PEDESTRIAN CROSSING
LIOSBAN ROAD
STAGE 1/2 ROAD SAFETY AUDIT**

PEDESTRIAN CROSSING LIOSBAN ROAD

STAGE 1/2 ROAD SAFETY AUDIT

Document Control Sheet	
Document Reference	11266 TR02 RSA
Report Status	Final
Report Date	December 2023
Current Revision	A
Client:	Galway City Council
Client Address:	City Hall, College Road, Galway
Project Number	11266

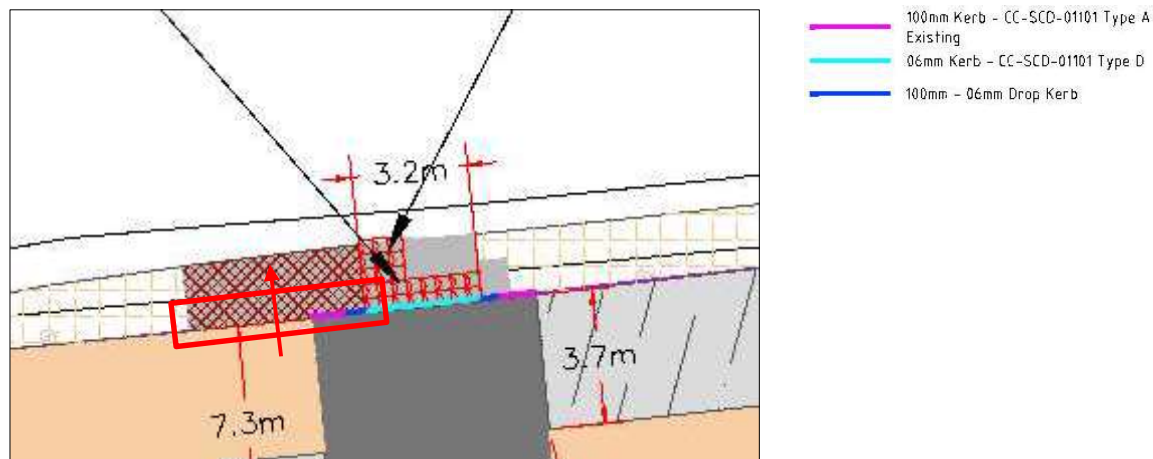
Figure 2-1: Proposed Kerbing (Drawing 11266-6110-D02)

Proposed Kerbing

It was noted the proposed kerbing does provide access to the existing gate. The Audit Team are concerned drivers may increase speed on approach to mount the kerb. This may result in a collision between a vehicle and a VRU.

The design team should provide 25mm mountable kerbing across the existing access.

2.3	Yes	Yes			
2.4	Yes	No	Bollards with retention sockets to be placed along back of kerb to prevent vehicle parking along crossing and in front of gate and also the gate is used very infrequently so it is envisaged that the operators will remove bollards and open gate before attempting to enter through gates.

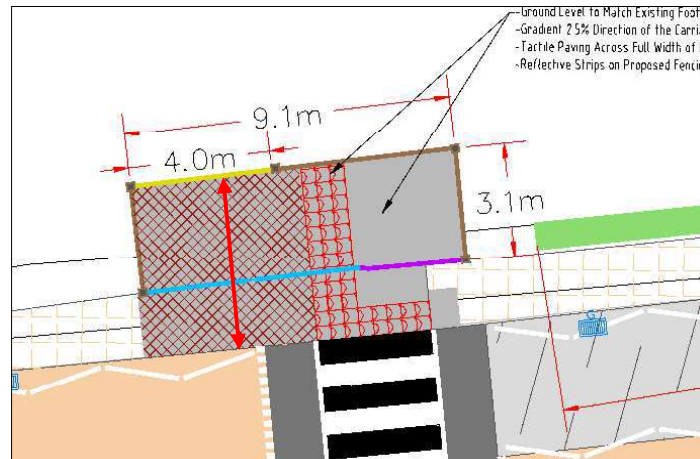
Figure 2-2: Proposed Gate Set- Back (Drawing 11266–6135)

Proposed Gate Location

The Audit Team observed the proposed gate is approx. 5.1m from the road edge. The Audit Team are concerned a vehicle utilising the gate will not have sufficient room to set-down. The Audit Team are concerned a vehicle may partially set down on the road or proposed crossing this may lead in a rear end collision or obscure a VRU attempting to use the crossing .

The design team should ensure the gate is set back an adequate distance for a vehicle to safely set down away from the crossing point.

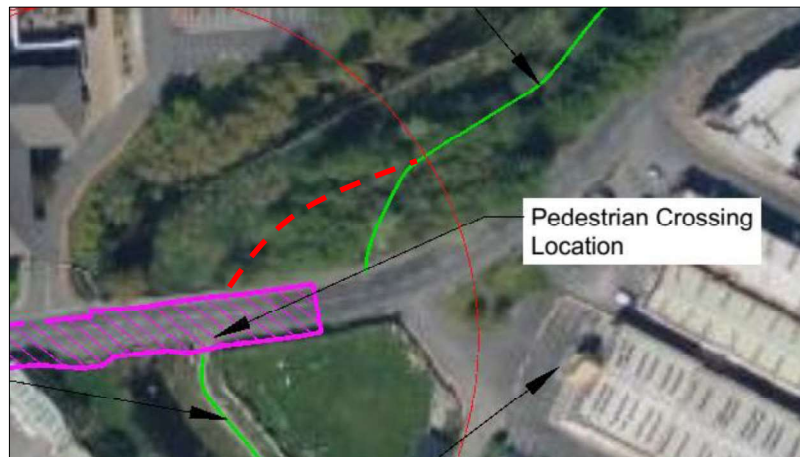
Figure 2-3: Existing Terryland forest walk (Drawing 11266-6100)

Connectivity

The Audit Team observed the proposed scheme does not incorporate a direct link from the crossing to the existing walkway. The Audit Team are concerned the proposed works will encourage pedestrian to enter the unpathed area through the upgraded gated and slip or trip on the uneven ground surface. The lack of a direct link may also discourage pedestrians approaching from the north side from using the crossing and lead to pedestrian crossing movements on the bend with reduced visibility where drivers are not anticipating any crossing movements to occur.

The design team should provide a link from the crossing to the existing forest walk.

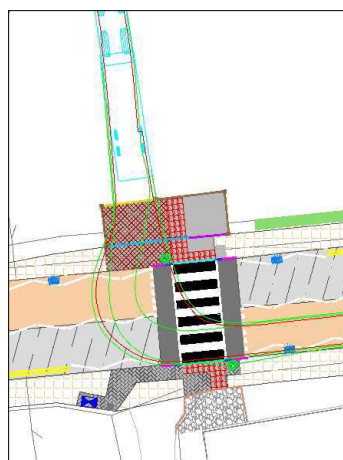
Figure 2-4: Vehicle Tracking (Drawing 11266-6140)

Vehicles Tracking

The Audit Team observed the vehicle tracking undertaken overruns into the footway. The Audit Team are concerned the proposed design has not allowed for safe access and egress from the gate. This may result in a collision between a vehicle and a VRU.

The design team to provide sufficient room for all turning manoeuvres.

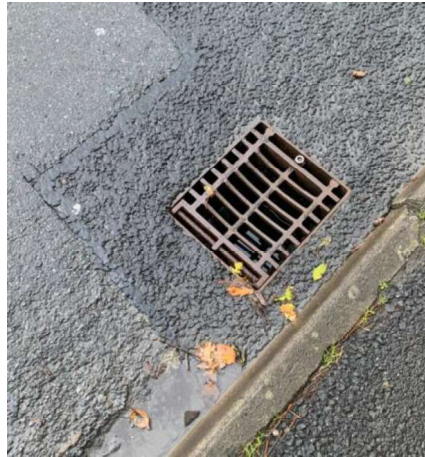
Plate 3-1: Existing Gullies

It was noted on site existing gullies are not cycle friendly.

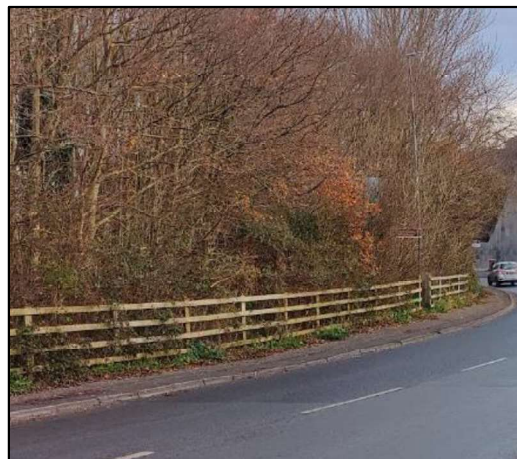
Plate 3-2: Existing Vegetation

It was noted on site vegetation and trees were overhanging the existing footpath potentially restricting visibility on the inside of the bend.

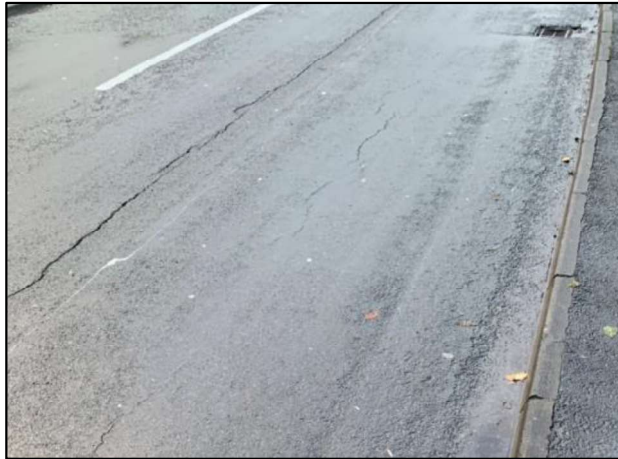
Plate 3-3: Pavement Condition

It was noted on site the existing carriageway and footway were experiencing signs of deterioration that could lead to unsafe conditions if left untreated.

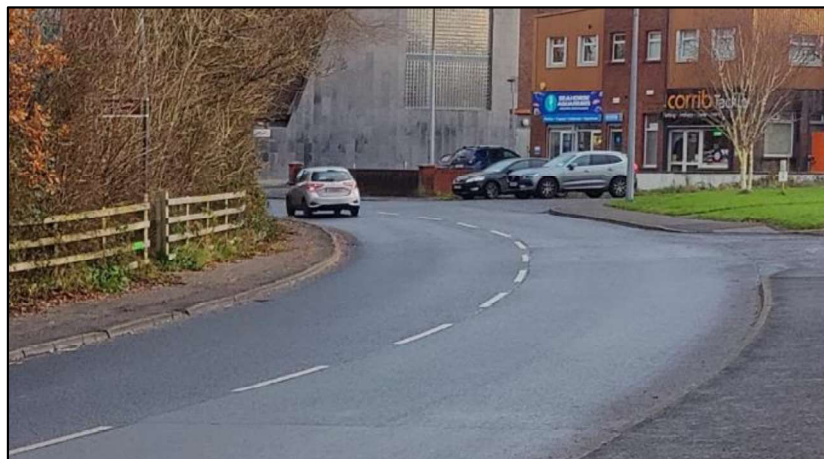
Plate 3-5: Existing Centreline

It was noted on site the existing carriageway east of the proposed scheme is marked with a full broken centreline indicating safe overtaking on a relatively sharp bend with multiple access/egress points.
