Bat Survey
Church House
Nuns Island
Co. Galway
2022

Ecological Services

Barbara McInerney

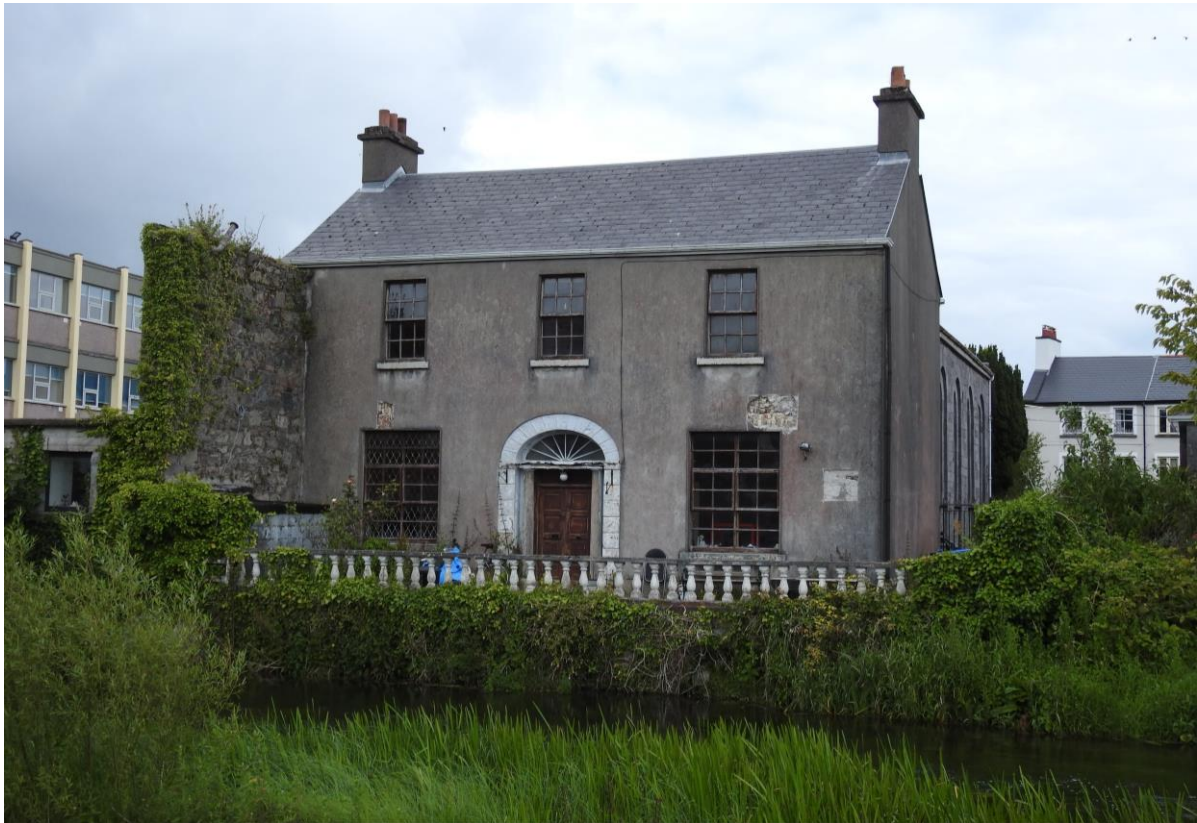
Fig.2: Front or west facing view of Church House, Galway.

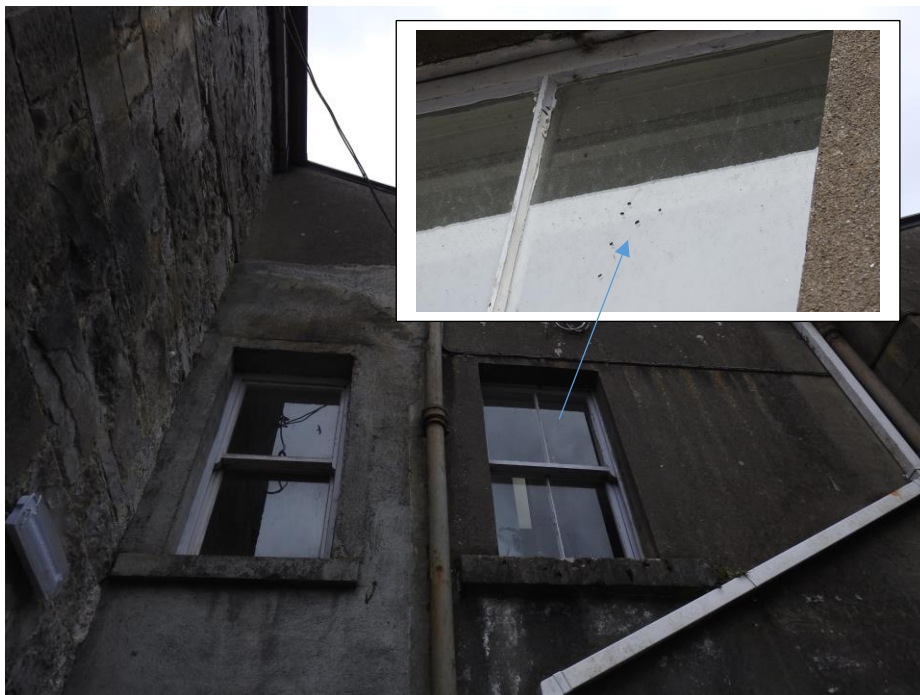
Fig 3: South view of the connecting building between the Nuns Island Theatre and Church House.

Note bat droppings on the window pane.

During the buildings inspection, potential roost points were searched for. Areas with gaps or cracks were noted. On the north side of the connecting building, an upper window was noted to have bat dropping stuck to the glass. See Fig 3. This indicated that bats were roosting somewhere in that area. It was because of these droppings that the infra-red camera was positioned at this location during the emergence survey. A theatre group present at the time of inspection had seen bats within the theatre.

There are no bats using Church House, Nun's island, therefore works *within* this building will not affect any bat species. However as the connecting structure between the house and Theatre building is proposed for removal, care should be taken not to disturb roosting bats at the Theatre during works.

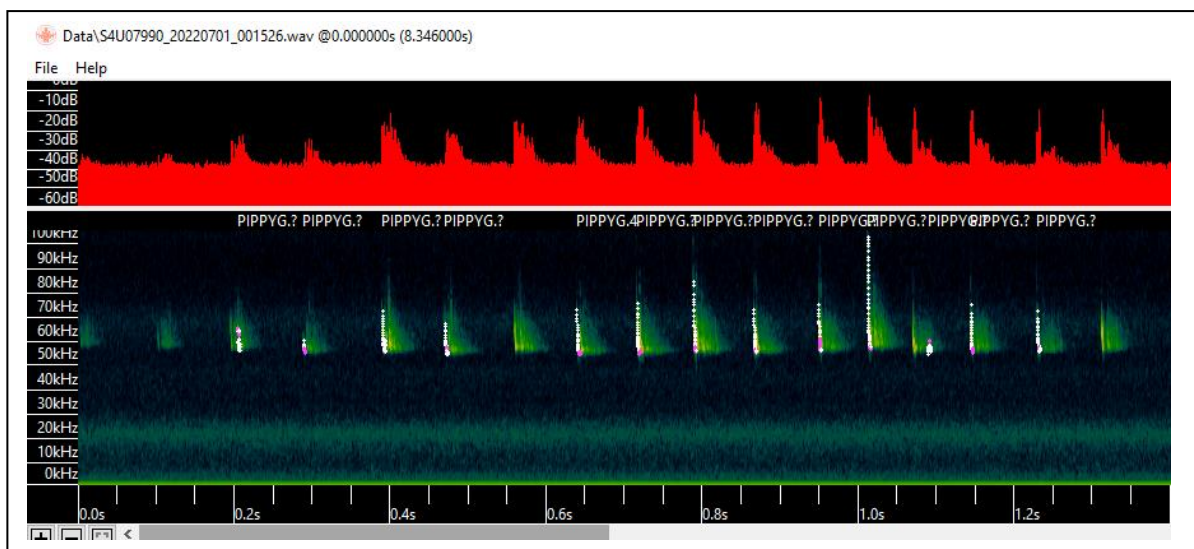
Fig.4: Sonogram of a Soprano pipistrelle recorded at Church House. This is an image representing the sound a bat emits when echo locating, when they are commuting, foraging and communicating with each other.

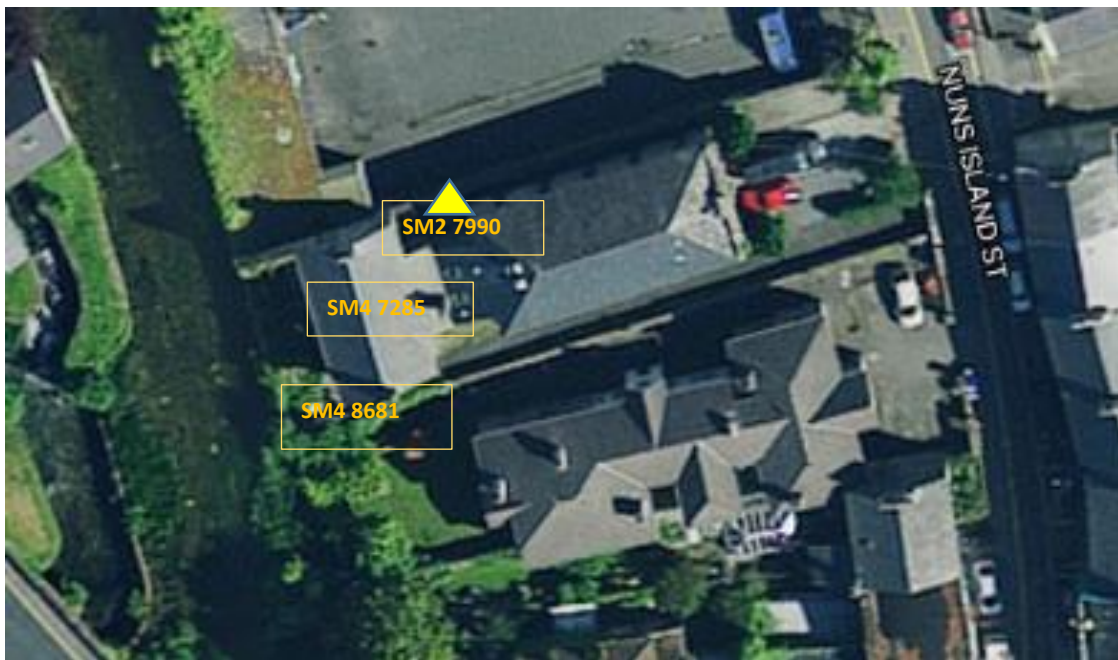
A bat survey was carried out at dusk on 30/06/2022. Three “Song Meter 4” (SM4) static bat detectors were deployed at points around the house with the aim of capturing bat activity during the night. (Song Meter 7285 on the upper floor corridor inside the house, Song Meter 8681 at the south west external corner and Song Meter 7285 outside the connector building on the north side). An infra-red camera was used to view aspects of the house for signs of emerging/re entering bats. An Echo Meter Touch detector was used during these surveys.

Fig. 5: Song Meter and infra-red camera

locations at Church House

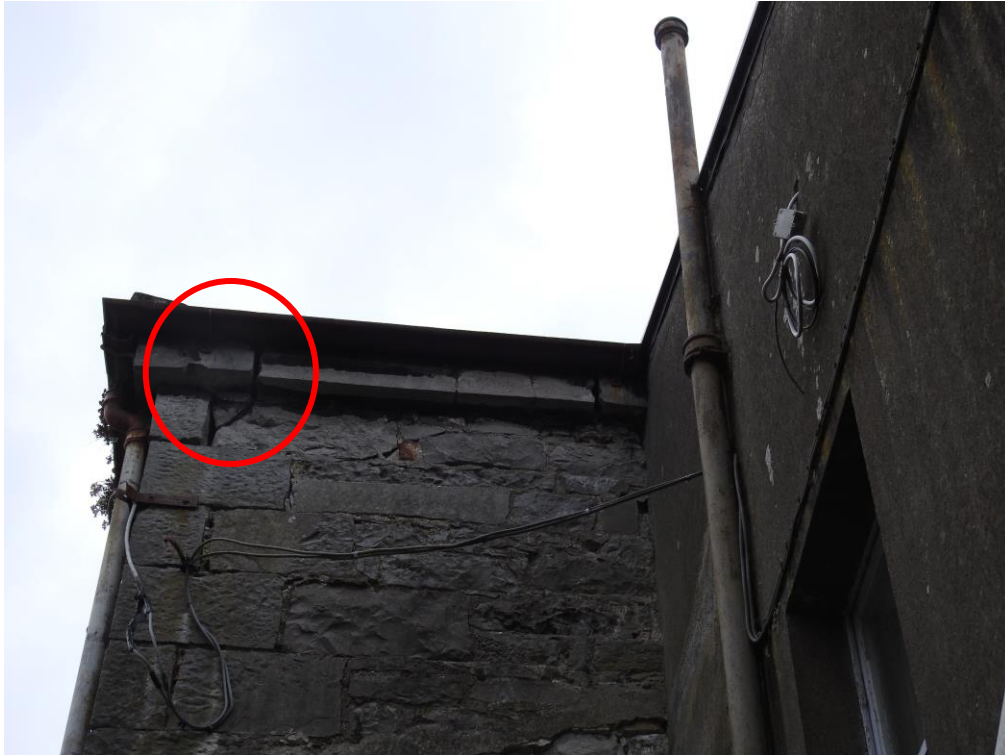
01/07/2022: On inspection of the infra-red camera footage after the dusk survey of the 30/06/2022 it was clear that there was a Soprano Pipistrelle bat roost in the North West corner of the Nuns Island Theatre building. See Fig 6 & 7. This was surveyed at dawn and a total of 22 bats were counted.

Fig.6: Location of a Soprano Pipistrelle bat roost in the North West corner of Nuns Island Theatre building.

There is a Soprano Pipistrelle roost in the North West corner of the adjacent Nuns Island Theatre building. Max count 26 bats. See Fig 6 & 7.

- Demolition works and any scaffolding needed on the west side of this site should occur over the winter months when Soprano Pipistrelle bats are in hibernation. Access to their roost point should not be blocked / hindered during the maternity season. See Fig 6 & 7 for location.

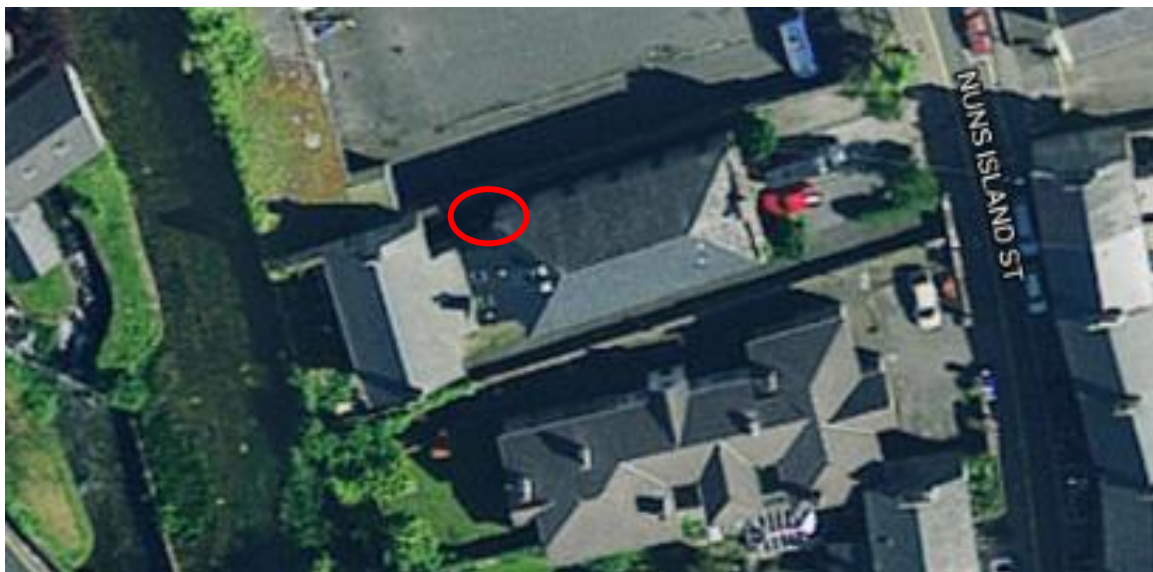
Fig 7: Ariel view of Church House and Nuns Island Theatre, showing location of the Soprano Pipistrelle Bat roost.
