| revision: | description: | date: |
|---|---|---|
| 3 | Part VIII – Planning Submission | 10/02/2022 |

## PART VIII – DESIGN STATEMENT

**Culturally Appropriate Traveller Group Housing Scheme,  
Circular Road, Galway.**

**Galway City Council & Cena Culturally Appropriate Homes Ltd.**

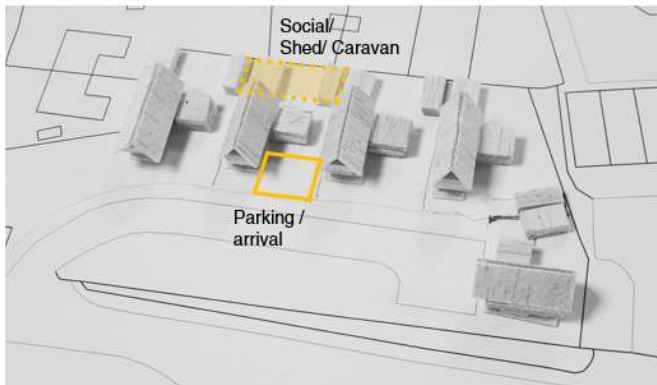
The initial concept model studies compare single, and two-storey house types on the site.

It was immediately apparent that this would have a very significant impact on the available external space: a two storey house takes half the footprint of a single-storey chalet.

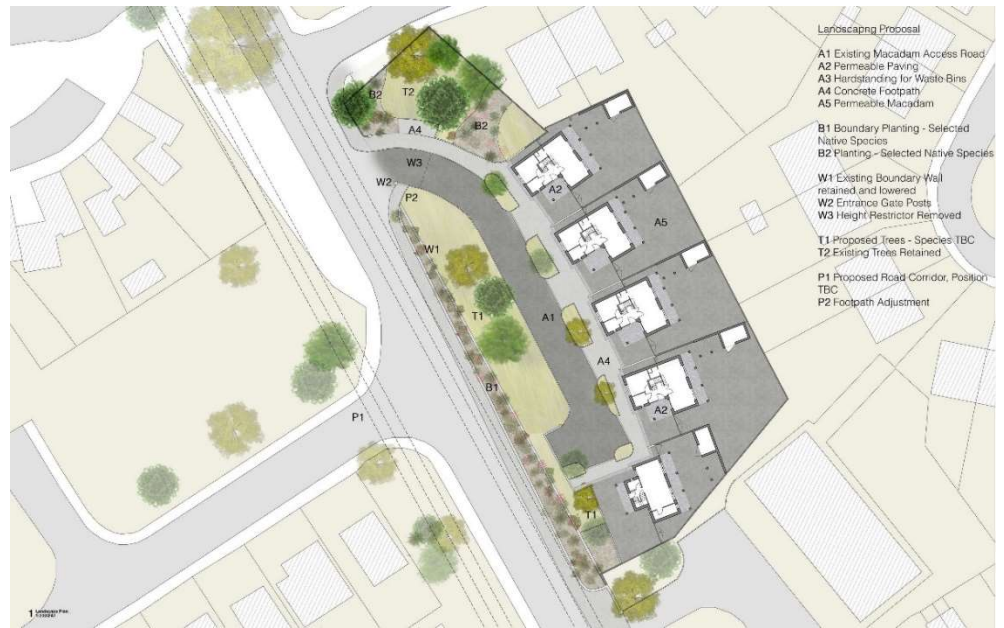
Extract from Landscape Proposal: Circular Road Group Housing

The landscape strategy has been prepared to retain as many trees, hedgerows, and existing vegetation as possible. The principal strategy promotes the breaking down of the high concrete block boundary wall to Circular Road, which currently isolates the subject site and its residents. This will offer an opportunity to embrace and augment the amenity of the existing tree-planted Claremont open space and provide a visually coherent termination of the vista along Claremont Park, making a positive contribution to the established suburban character of the surrounding area.

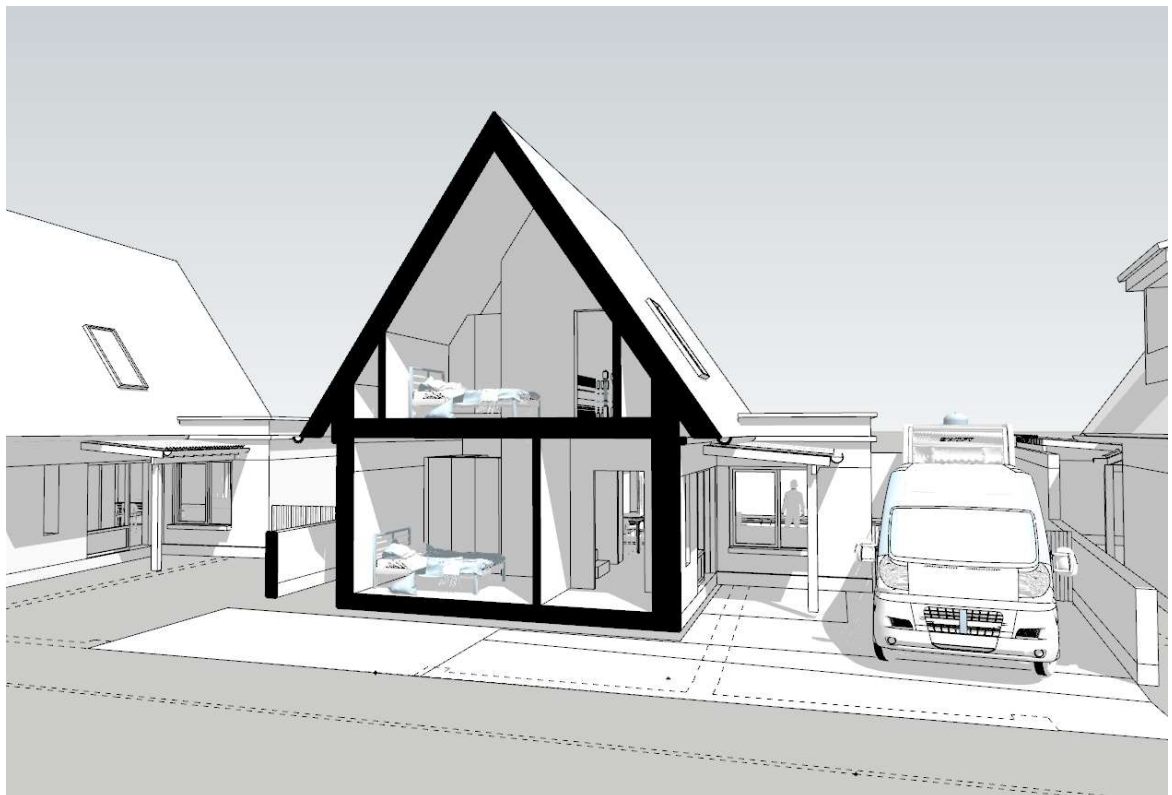
*Cut-away Section showing downstairs bedroom and main bedroom in the roof space.*

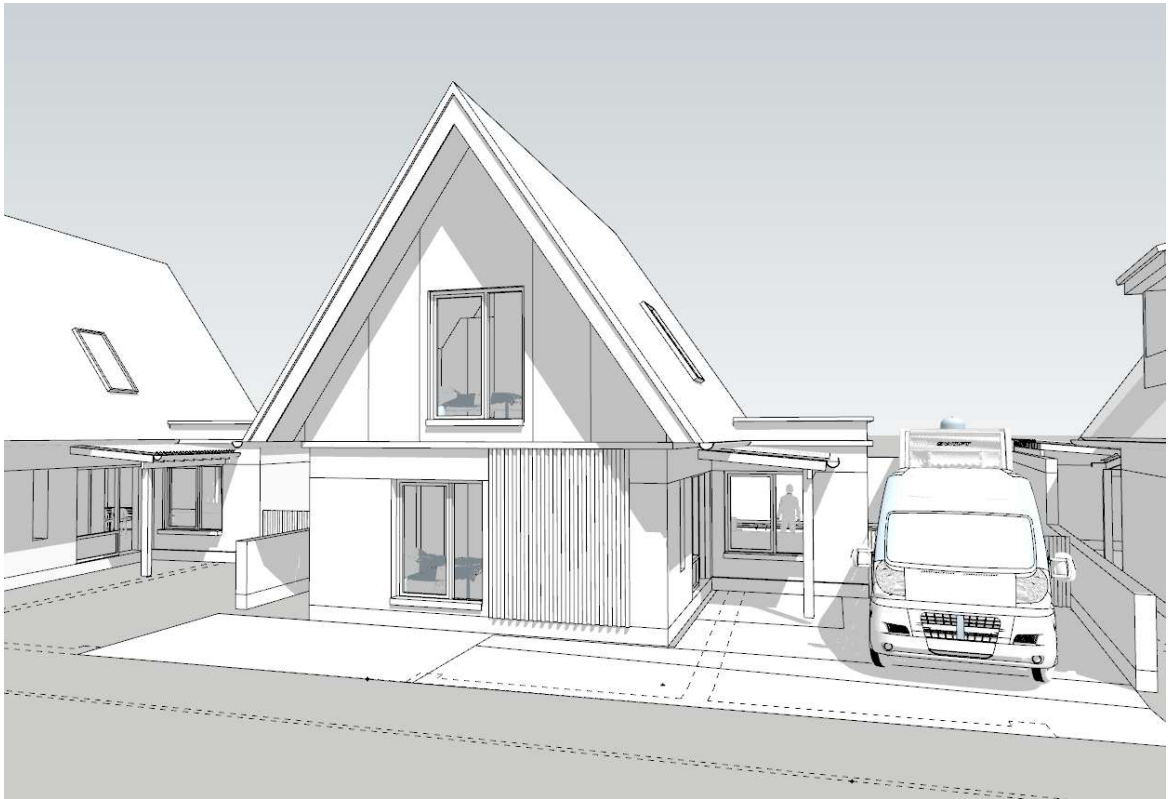
The roof is allowed to overhang at the gable ends, to recall the form of the travellers' wagon, as they face onto the central shared green.

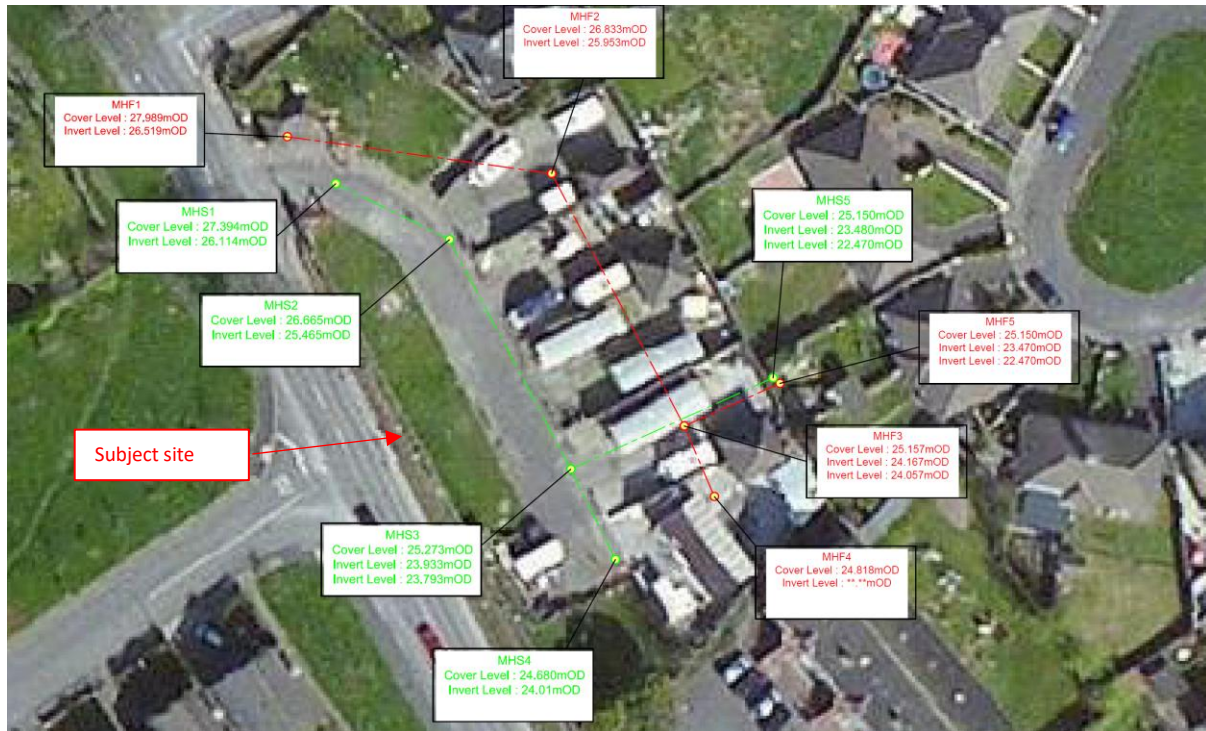
The site is served by a separate foul- & surface water system, which falls in an easterly direction into the Cluainin estate. The subject site is at the apex/start of the drainage run for both foul- & surface water as indicated below.

Fig. 8 Extract from CCTV survey information on foul- & surface water drainage for the subject site, discharging to the east into Cluainin estate
