# **Proposed New Lawn Cemetery, Old Dublin Road, Galway. Tier 2 Hydrogeological Risk Assessment**

**Report for:**  
Galway City Council

**Date:**  
11<sup>th</sup> October 2022

**Report No.:**  
BRE20007Rp01A01

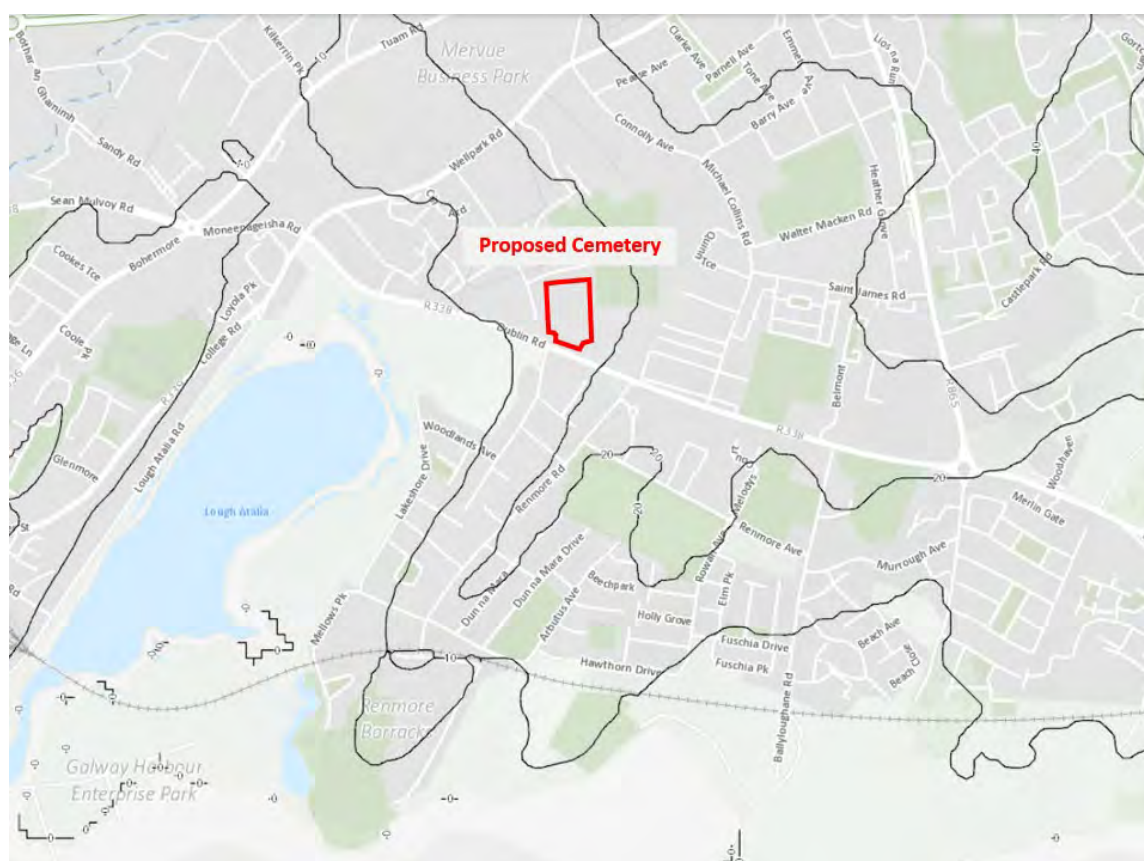
**Figure 3.2 Topographical Contours**

The topographical relief across the general area ranges between 15 mOD<sup>5</sup> and 20 mOD and generally falls in a southwestern direction towards Lough Atalia (see Figure 3.2). The land surface is low lying and relatively flat.

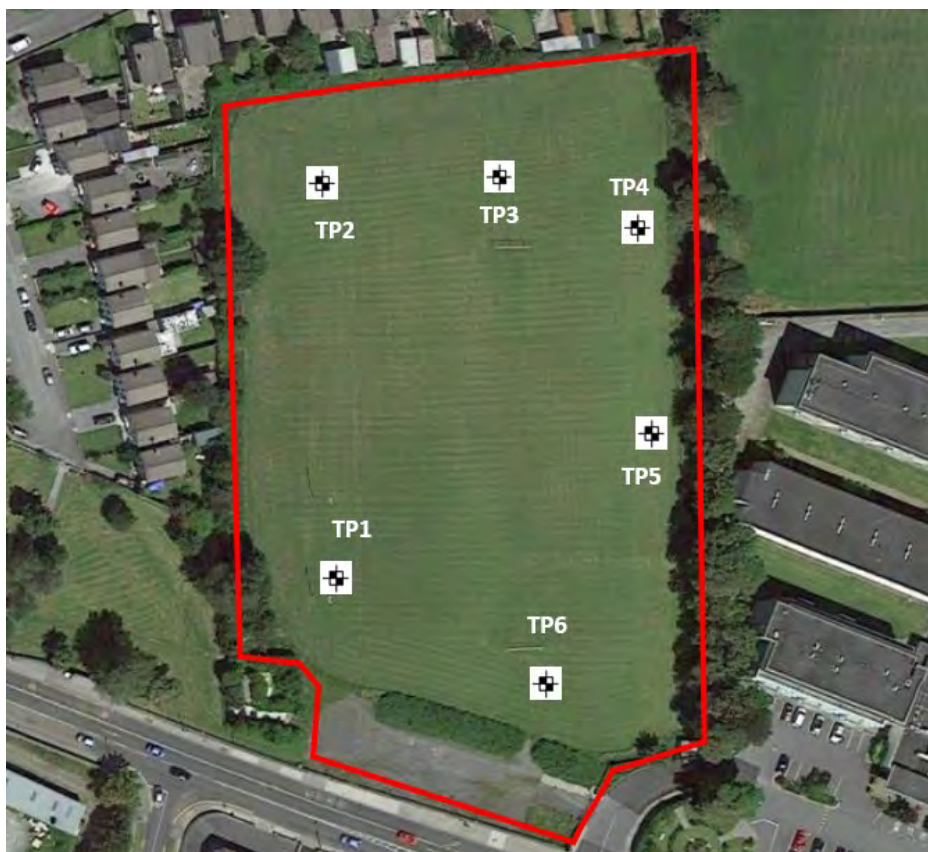
**Figure 4.9**      **2020 Trial Pit Locations**

The total depth of the trial pits ranged between 2.0 and 3.0m. The ground conditions generally comprised 0.15 to 0.2m of topsoil overlying silty sandy gravelly clay with occasional cobbles and infrequent boulders. Organic material was recorded within dark brown sandy silty clay below the topsoil in TP1, TP3, TP4 and TP5 at depths ranging between 0.5 and 0.8m. The subsoil thickness ranged between 1.6 and 2.85m.

All 5 no. trial pits terminated in 'hard' material which the trial pit photographs suggest as comprising of stiff grey boulder clay. Possible weathered limestone bedrock was recorded in TP2 from 1.75 to 2.0m and this trial pit terminated on possible limestone bedrock at 2.0m. Bedrock was not confirmed, but rather suggested, based on the inability of the 8-tonne excavator to excavate further.

Groundwater was not encountered in any of the trial pits. All site investigation logs are presented in Appendix A.

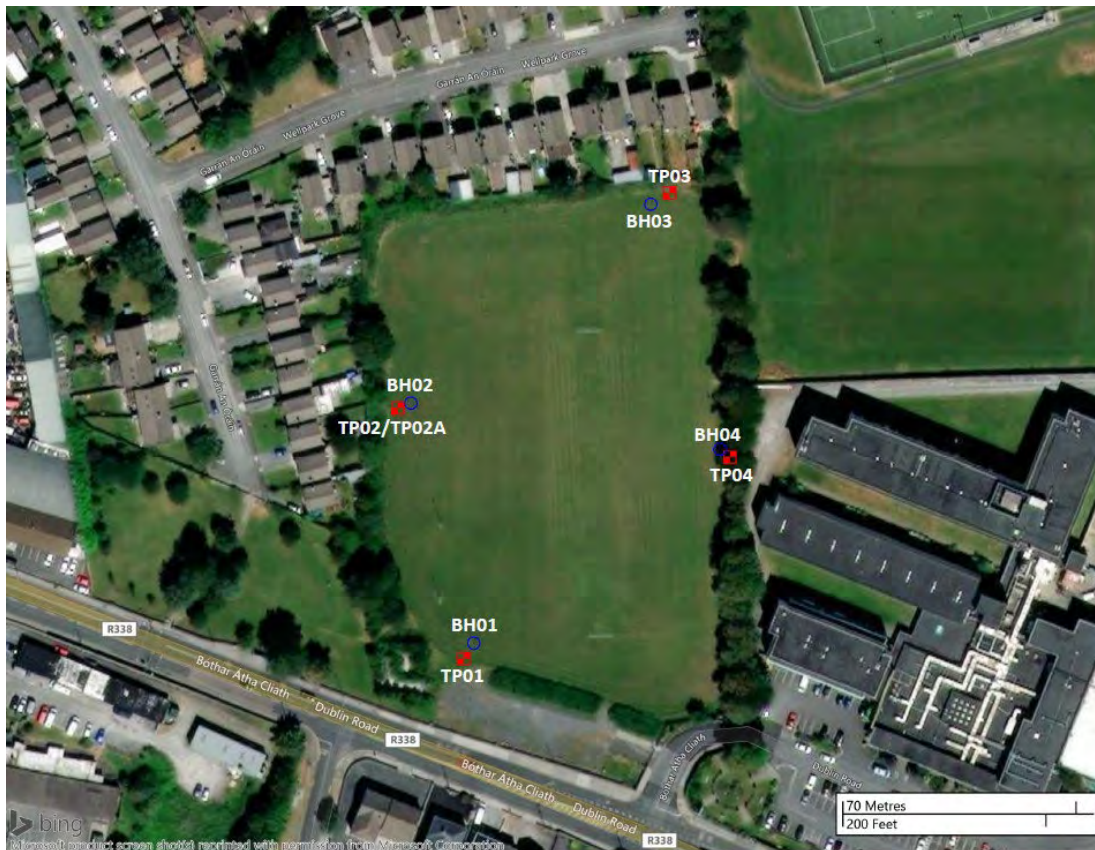
**Figure 5.1 November 2020 Site Investigation Locations**

An intrusive site investigation was undertaken by Causeway Geotech site investigation contractors between the 3<sup>rd</sup> and 17<sup>th</sup> November 2020. The works were supervised by a BREL hydrogeologist, who also undertook on-going monitoring at the site. The scope of the works comprised the following:

- ☒ Drilling of 4 no. boreholes (i.e. BH01 to BH04) to depths ranging between 10 and 15 mbgl.
- ☒ Installation of groundwater monitoring wells within each borehole screened within the limestone bedrock.
- ☒ The excavation of 5 no. trial pits (i.e. TP01 to TP04),
- ☒ infiltration/percolation testing within the trial pits,
- ☒ Groundwater sampling and laboratory testing; and,
- ☒ Automated groundwater level monitoring over time.

All 2020 site investigation locations are presented on Figure 5.1. All borehole and trial pit logs are presented in Appendix B.

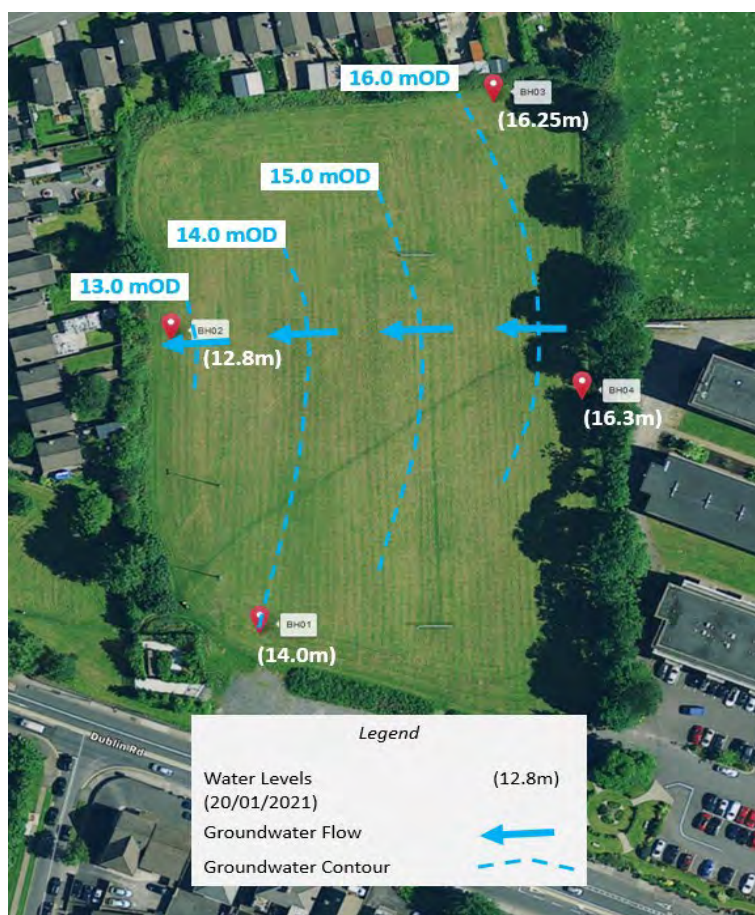
Figure 5.6 Groundwater Contours and Flow Direction (20/01/2021)

A number of groundwater contour plots were developed representing high water levels, low water levels and periods immediately after notable rainfall events (Figure 5.5, 5.6 and 5.7).

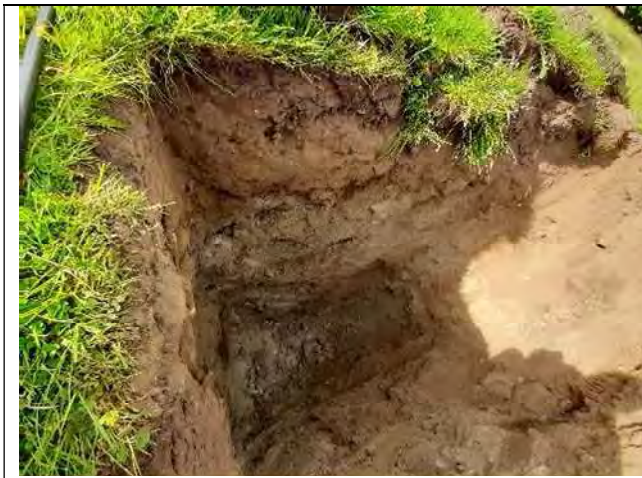
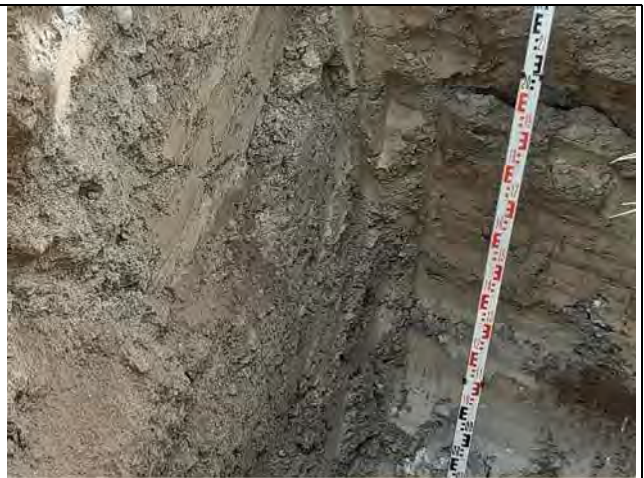
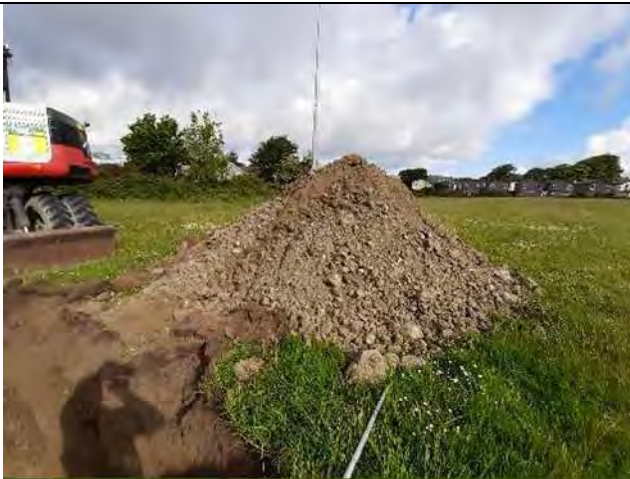
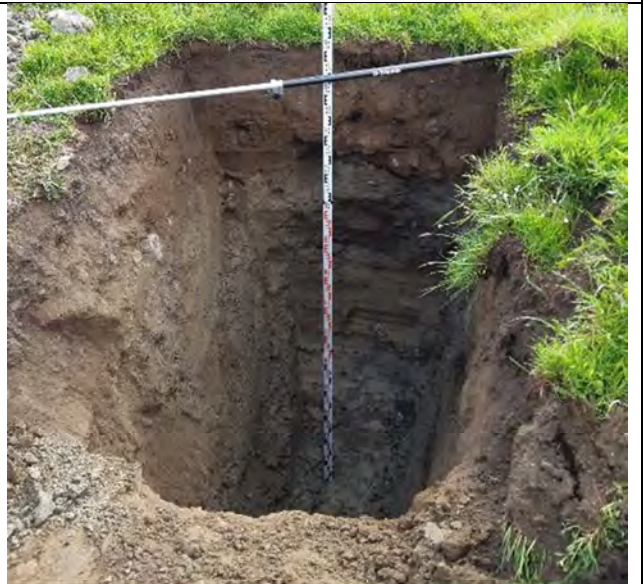
## TP 1: Images

No Groundwater or water infiltration present

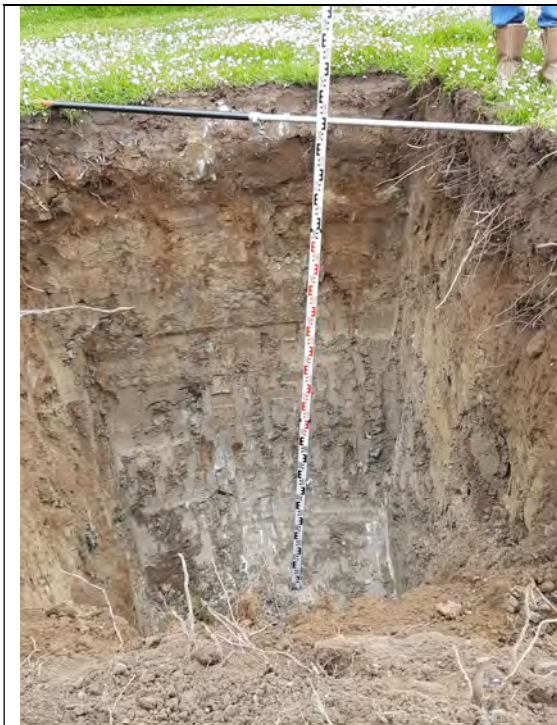
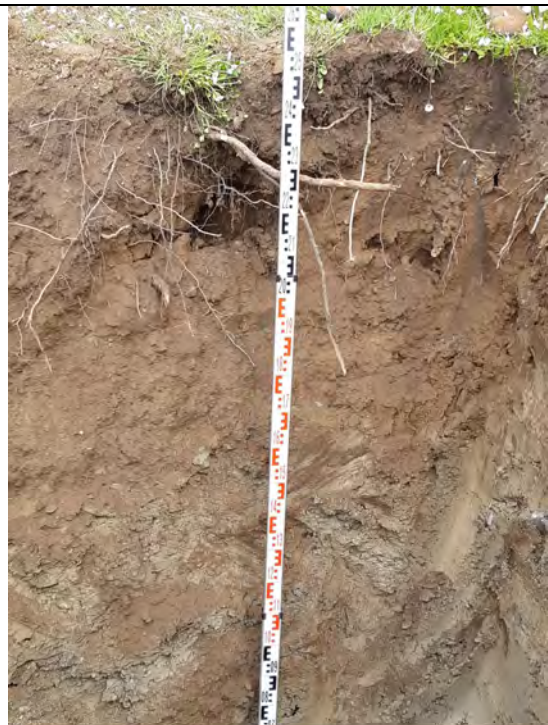
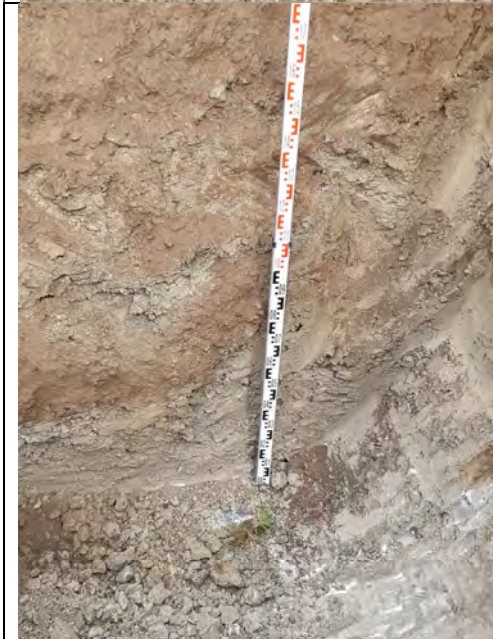
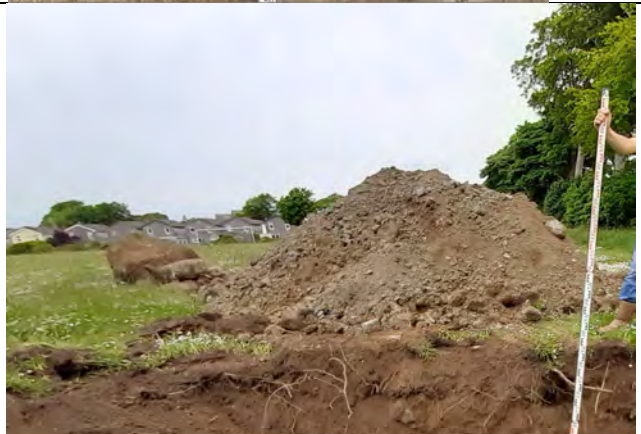
No Groundwater or water infiltration present. Large > 1cum boulder encountered (refer image below)
