# KEERAUN SOCIAL HOUSING GALWAY

## Stage 1 Road Safety Audit

MGC0716-RPS-00-XX-RP-C-  
RP0006  
Stage 1 RSA  
S4.P01  
31<sup>st</sup> August 2021

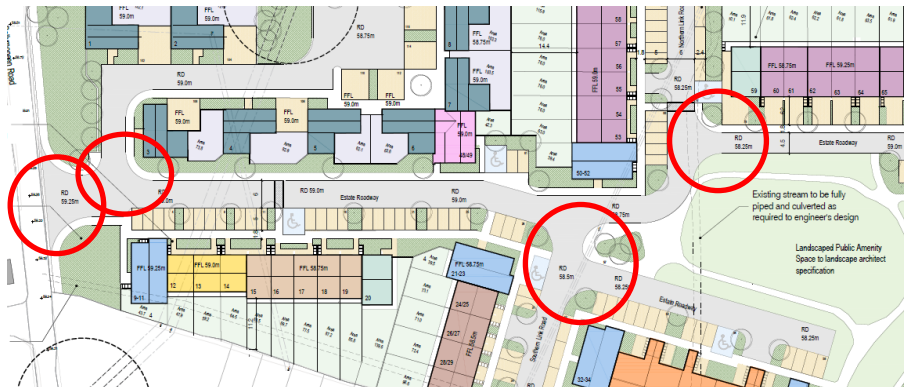
### 4.1 Problem

**Summary:** Risk of driver confusion and erratic manoeuvres due to a lack of junction control

At this stage in the design process, the road markings and signage for the internal road layout of the development have not been developed. It is unclear as to the type of junction control proposed at the internal road junctions and the junction with Ballymoneen Road.

Insufficient or inappropriate junction control could lead to possible driver confusion and erratic manoeuvres in the carriageway, resulting in collisions.

The appropriate junction control should be provided throughout the development.

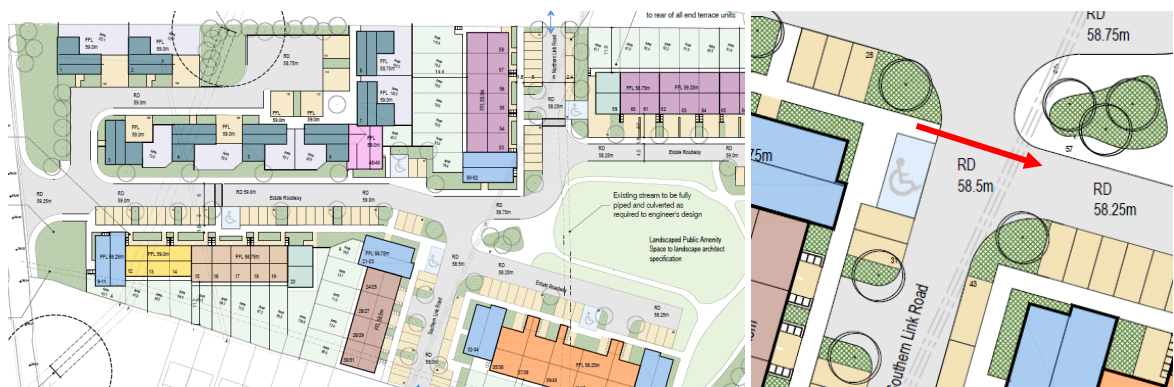
### 4.2 Problem

**Summary:** Risk of vehicle-pedestrian collisions due to a lack of pedestrian crossings

It is unclear as to the exact location of some of the pedestrian crossings at the junction with Ballymoneen Road and within the internal road network. Pedestrian crossings located at inappropriate locations could lead to pedestrians crossing in unsafe locations, resulting in possible vehicle-pedestrian collisions.

Additionally at one internal road junction, it appears a pedestrian crossing may be proposed which does not connect to a footpath on the opposite side of the carriageway. This could lead to a pedestrian walking in the carriageway where they are at an increased risk of being struck by a vehicle.

Appropriate pedestrian crossings should be provided throughout the development.
