Housing Development,  
Cappagh Road,  
Co. Galway  
Stage 1  
Road Safety Audit

## Document Control Sheet

| Document Reference | TR01 Road Safety Audit |
| Project Reference | 12031 |

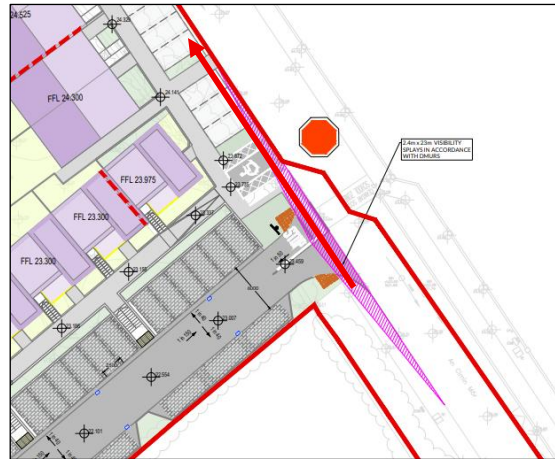
Figure 2-2: Footpath – Road Edge

### Entrance B Existing Footpath

The Audit Team noted on the design drawings the removal of the existing footpath. The Audit Team is concerned the desire line for Vulnerable Road User (VRU) is not being met. This may result in VRU walking behind vehicles utilising the perpendicular parking increasing the potential for a collision between a VRU and a vehicle.

### Recommendation

The design team should retain the existing footpath along the road edge.

| Paragraph No. in Safety Audit Report | Problem accepted (yes/no) | Recommended Measures Accepted (yes /no) | Alternative Measures (describe). Give reason for not accepting recommended measure | Alternative Measures or reasons accepted by auditors (yes /no) |
|---|---|---|---|---|
| 2.2 | Yes | Yes | | |

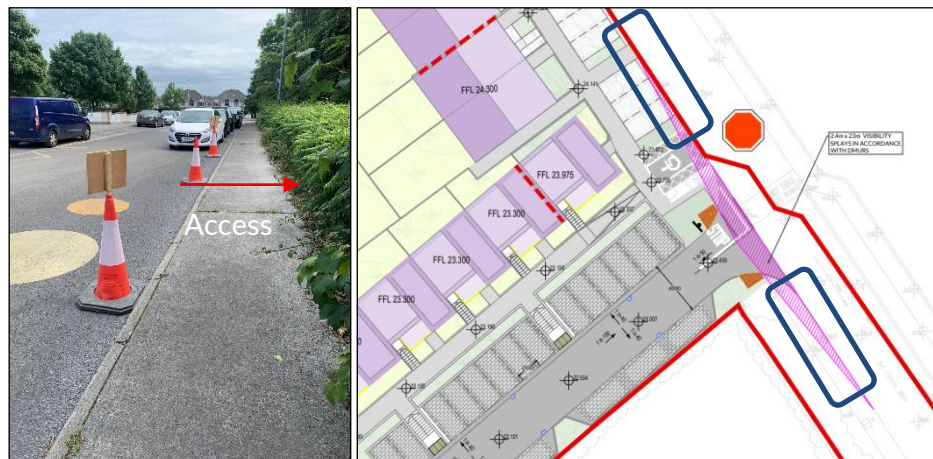
Figure 2-3: Proposed Site Entrance

### Entrance B Visibility Splay

The Audit Team observed onsite the proposed entrance B to the development. The Audit Team are concerned that visibility will be obstructed to the right due to kerbside parking and to the left due to car parking in the proposed perpendicular parking. Inadequate visibility may result in vehicles entering the carriageway and in a side swipe type collision.

### Recommendation

The design team should ensure visibility splay is provided as per standard.

| Paragraph No. in Safety Audit Report | Problem accepted (yes/no) | Recommended Measures Accepted (yes /no) | Alternative Measures (describe). Give reason for not accepting recommended measure | Alternative Measures or reasons accepted by auditors (yes /no) |
|---|---|---|---|---|
| 2.3 | Yes | Yes | | |

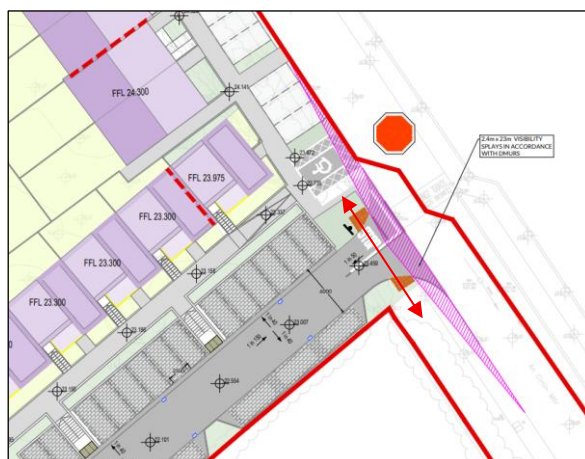
Figure 2-4: Tactile Pavement Alignment at Proposed Site Entrance

### Entrance B Tactile Paving

The Audit Team noted on the design drawings the proposed crossing location. The Audit Team are concerned that the proposed crossing directs VRU into the grassed area or a parking vehicle. This may lead to confusion by the visually impaired VRU, directing them into the path of a parked/moving vehicle which may result in a potential collision.

### Recommendation

The design team should ensure VRU are led to a footway at the pedestrian crossing.

| Paragraph No. in Safety Audit Report | Problem accepted (yes/no) | Recommended Measures Accepted (yes /no) | Alternative Measures (describe). Give reason for not accepting recommended measure | Alternative Measures or reasons accepted by auditors (yes /no) |
|---|---|---|---|---|
| 2.4 | Yes | Yes | | |

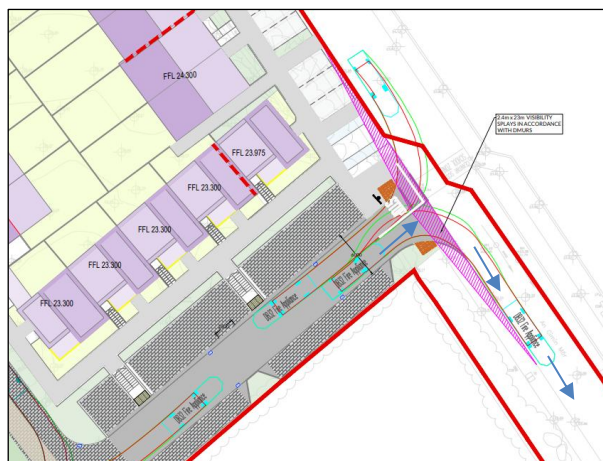
Figure 2-5: AutoTrack Analysis at Proposed Site Entrance

### Entrance B Swept Path Analysis

The Audit Team noted on the design drawings the undertaken swept path analysis at the junction. The Audit Team are concerned that AutoTrack analysis was carried out on the incorrect side of the road, which does not accurately represent the intended vehicle movement. This may result in inadequate turning space and or kerb overruns, increasing the risk of a collision with another road users.

### Recommendation

The design team should update the swept path analysis for all emergency vehicles and ensure the vehicles remain within the carriageway

| Paragraph No. in Safety Audit Report | Problem accepted (yes/no) | Recommended Measures Accepted (yes /no) | Alternative Measures (describe). Give reason for not accepting recommended measure | Alternative Measures or reasons accepted by auditors (yes /no) |
|---|---|---|---|---|
| 2.5 | Yes | No | The swept path analysis has been updated, and vehicles retain within the carriageway' | Yes |

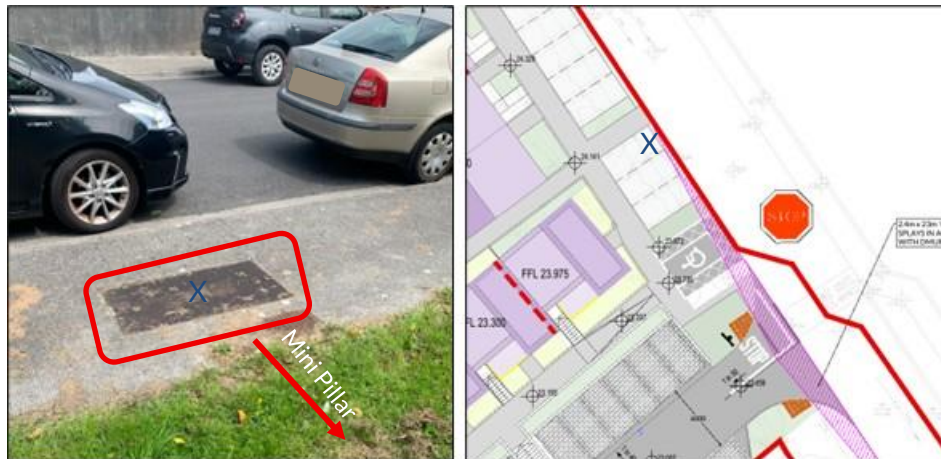
Figure 2-6: ESB Utilities

### Utilities

The Audit Team observed onsite existing an ESB chamber and mini pillar in the footpath where development parking is proposed. The Audit Team is concerned that the ESB chamber and mini pillar hasn't been accounted for in the proposed design. If not addressed the utilities may become at trip hazard if not flush with the pavement.

### Recommendation

The design team should ensure all utilities are accommodated for in the proposed works.

| Paragraph No. in Safety Audit Report | Problem accepted (yes/no) | Recommended Measures Accepted (yes /no) | Alternative Measures (describe). Give reason for not accepting recommended measure | Alternative Measures or reasons accepted by auditors (yes /no) |
|---|---|---|---|---|
| 2.6 | Yes | Yes | | |

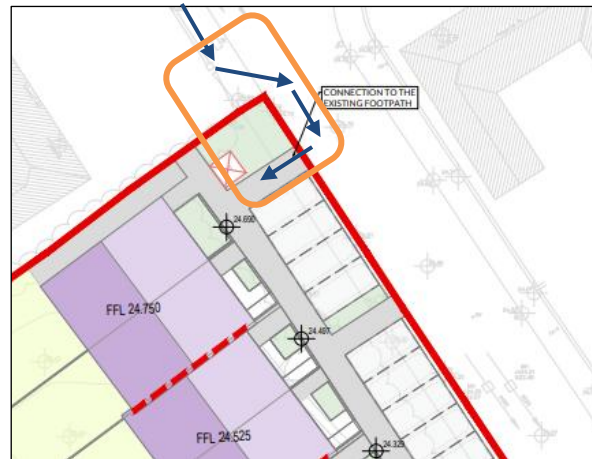
Figure 2-7: Footpath - Housing Development

### Entrance B Footpath – Commencement

The Audit Team noted on the design drawings the commencement of the public footpath. The Audit Team are concerned that a VRU who is wheel chair bound will have to enter the carriageway to continue utilising the footpath. Increasing the potential for a collision between a VRU and a vehicle.

### Recommendation

The design team should ensure a continuous footpath is provided for along the road edge.

| Paragraph No. in Safety Audit Report | Problem accepted (yes/no) | Recommended Measures Accepted (yes /no) | Alternative Measures (describe). Give reason for not accepting recommended measure | Alternative Measures or reasons accepted by auditors (yes /no) |
|---|---|---|---|---|
| 2.7 | Yes | Yes | | |

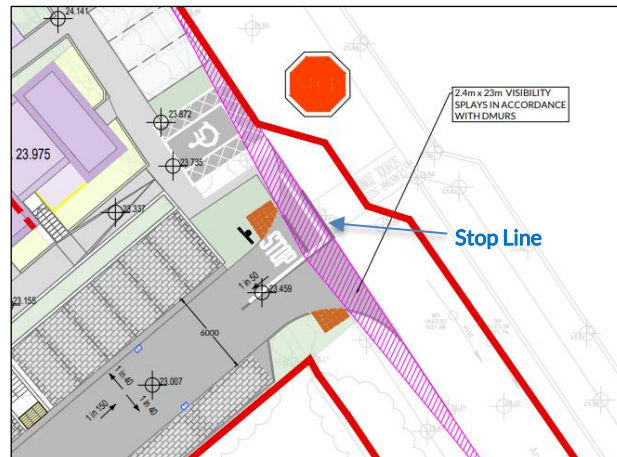
Figure 2-8: Proposed Stop Line

### Entrance B Stop Line - Position

The Audit Team noted on the design drawings the location of the proposed stop line. The Audit Team is concerned that the stop line too close to the road edge. During low light foggy condition, vehicles may overrun the junction. This may result in a side impact type collision with approaching vehicles.

### Recommendation

The design team should ensure all road markings are in line with the Traffic Signs Manual (TSM).

| Paragraph No. in Safety Audit Report | Problem accepted (yes/no) | Recommended Measures Accepted (yes /no) | Alternative Measures (describe). Give reason for not accepting recommended measure | Alternative Measures or reasons accepted by auditors (yes /no) |
|---|---|---|---|---|
| 2.8 | Yes | Yes | | |

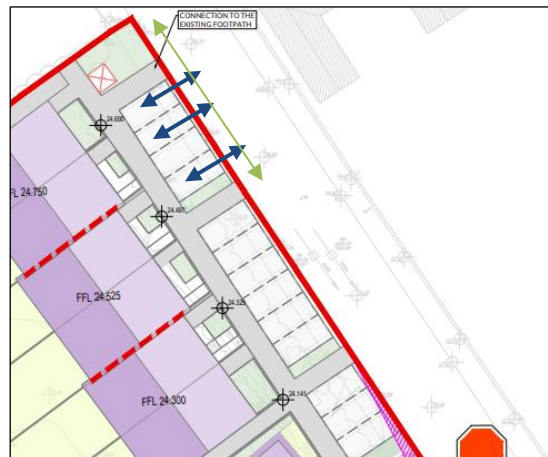
Figure 2-9: Proposed Parking Spaces

### Entrance B Perpendicular Parking Spaces

The Audit Team noted on the design drawings the location of the proposed parking. The Audit Team is concerned that the parking will result in drivers driving into the parking spaces, creating blind spots when vehicles reverse out on the mainline. This may result in a side impact type collision with approaching vehicles and/or a collision with VRU walking along the road edge to footpath.

### Recommendation

The design team should prevent parking reversing out onto the mainline.

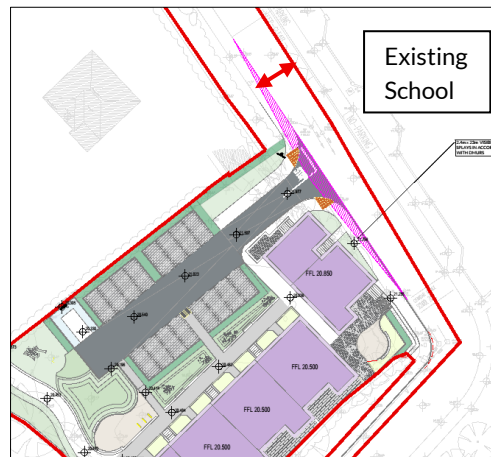
Figure 2-10: No Existing Crossing from School to Proposed Site

### Connectivity

The Audit Team observed onsite the location of the existing school. The Audit Team are concerned the desire line between the two residential sites, sites A and B and the existing school has not been incorporated in the design. This may result in a collision between a VRU and a vehicle.

### Recommendation

The design team should ensure a pedestrian crossing is provided.

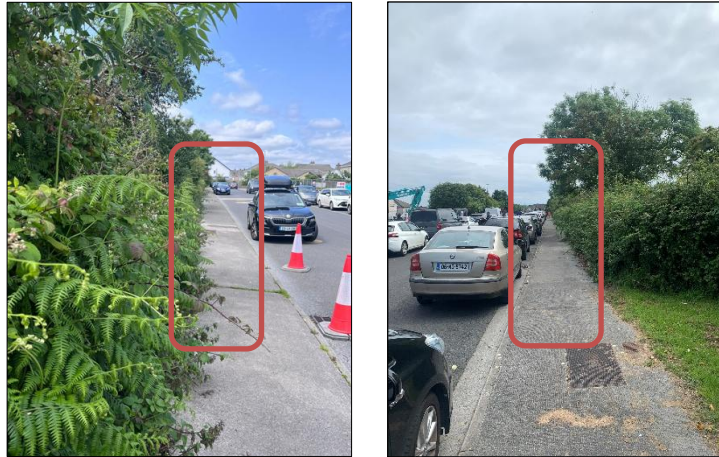
Figure 2-11: Existing Foliage

### Foliage Obstruction

The Audit Team observed onsite the existing vegetation encroaching the existing footway. The Audit Team noted the vegetation reduces the width of the existing footpath obstructs. This may result in VRU entering the carriageway to pass one another, resulting in a collision with a vehicle.

### Recommendation

The design team should ensure the vegetation does not obstruct the footpath.

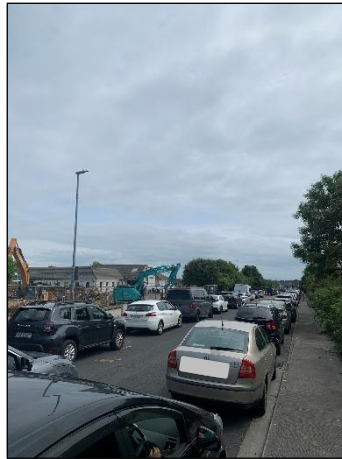
Figure 2-12: Parking Beside Proposed Site

### Parking along An Cimín Mór

The Audit Team observed onsite parking along both sides of An Cimín Mór. The Audit Team are concerned this could obstruct the entrance and prevent vehicles gaining access into the proposed development. This may obstruct emergency vehicles entering the development.

### Recommendation

The design team should restrict parking along the road edge of the proposed development.

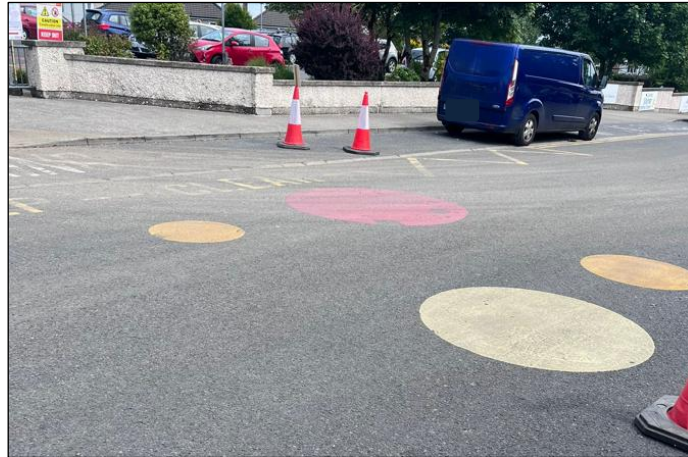
Figure 3-1: Road Markings

##### Road Markings

The Audit Team observed onsite the school specific road markings are worn.

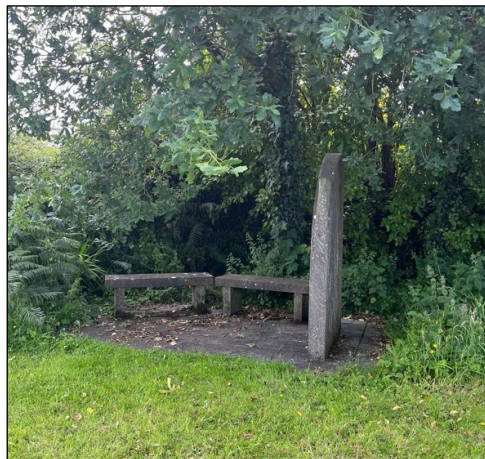
Figure 3-2: Monument/Memorial

##### Monument

The Audit Team observed onsite an existing monument/memorial.

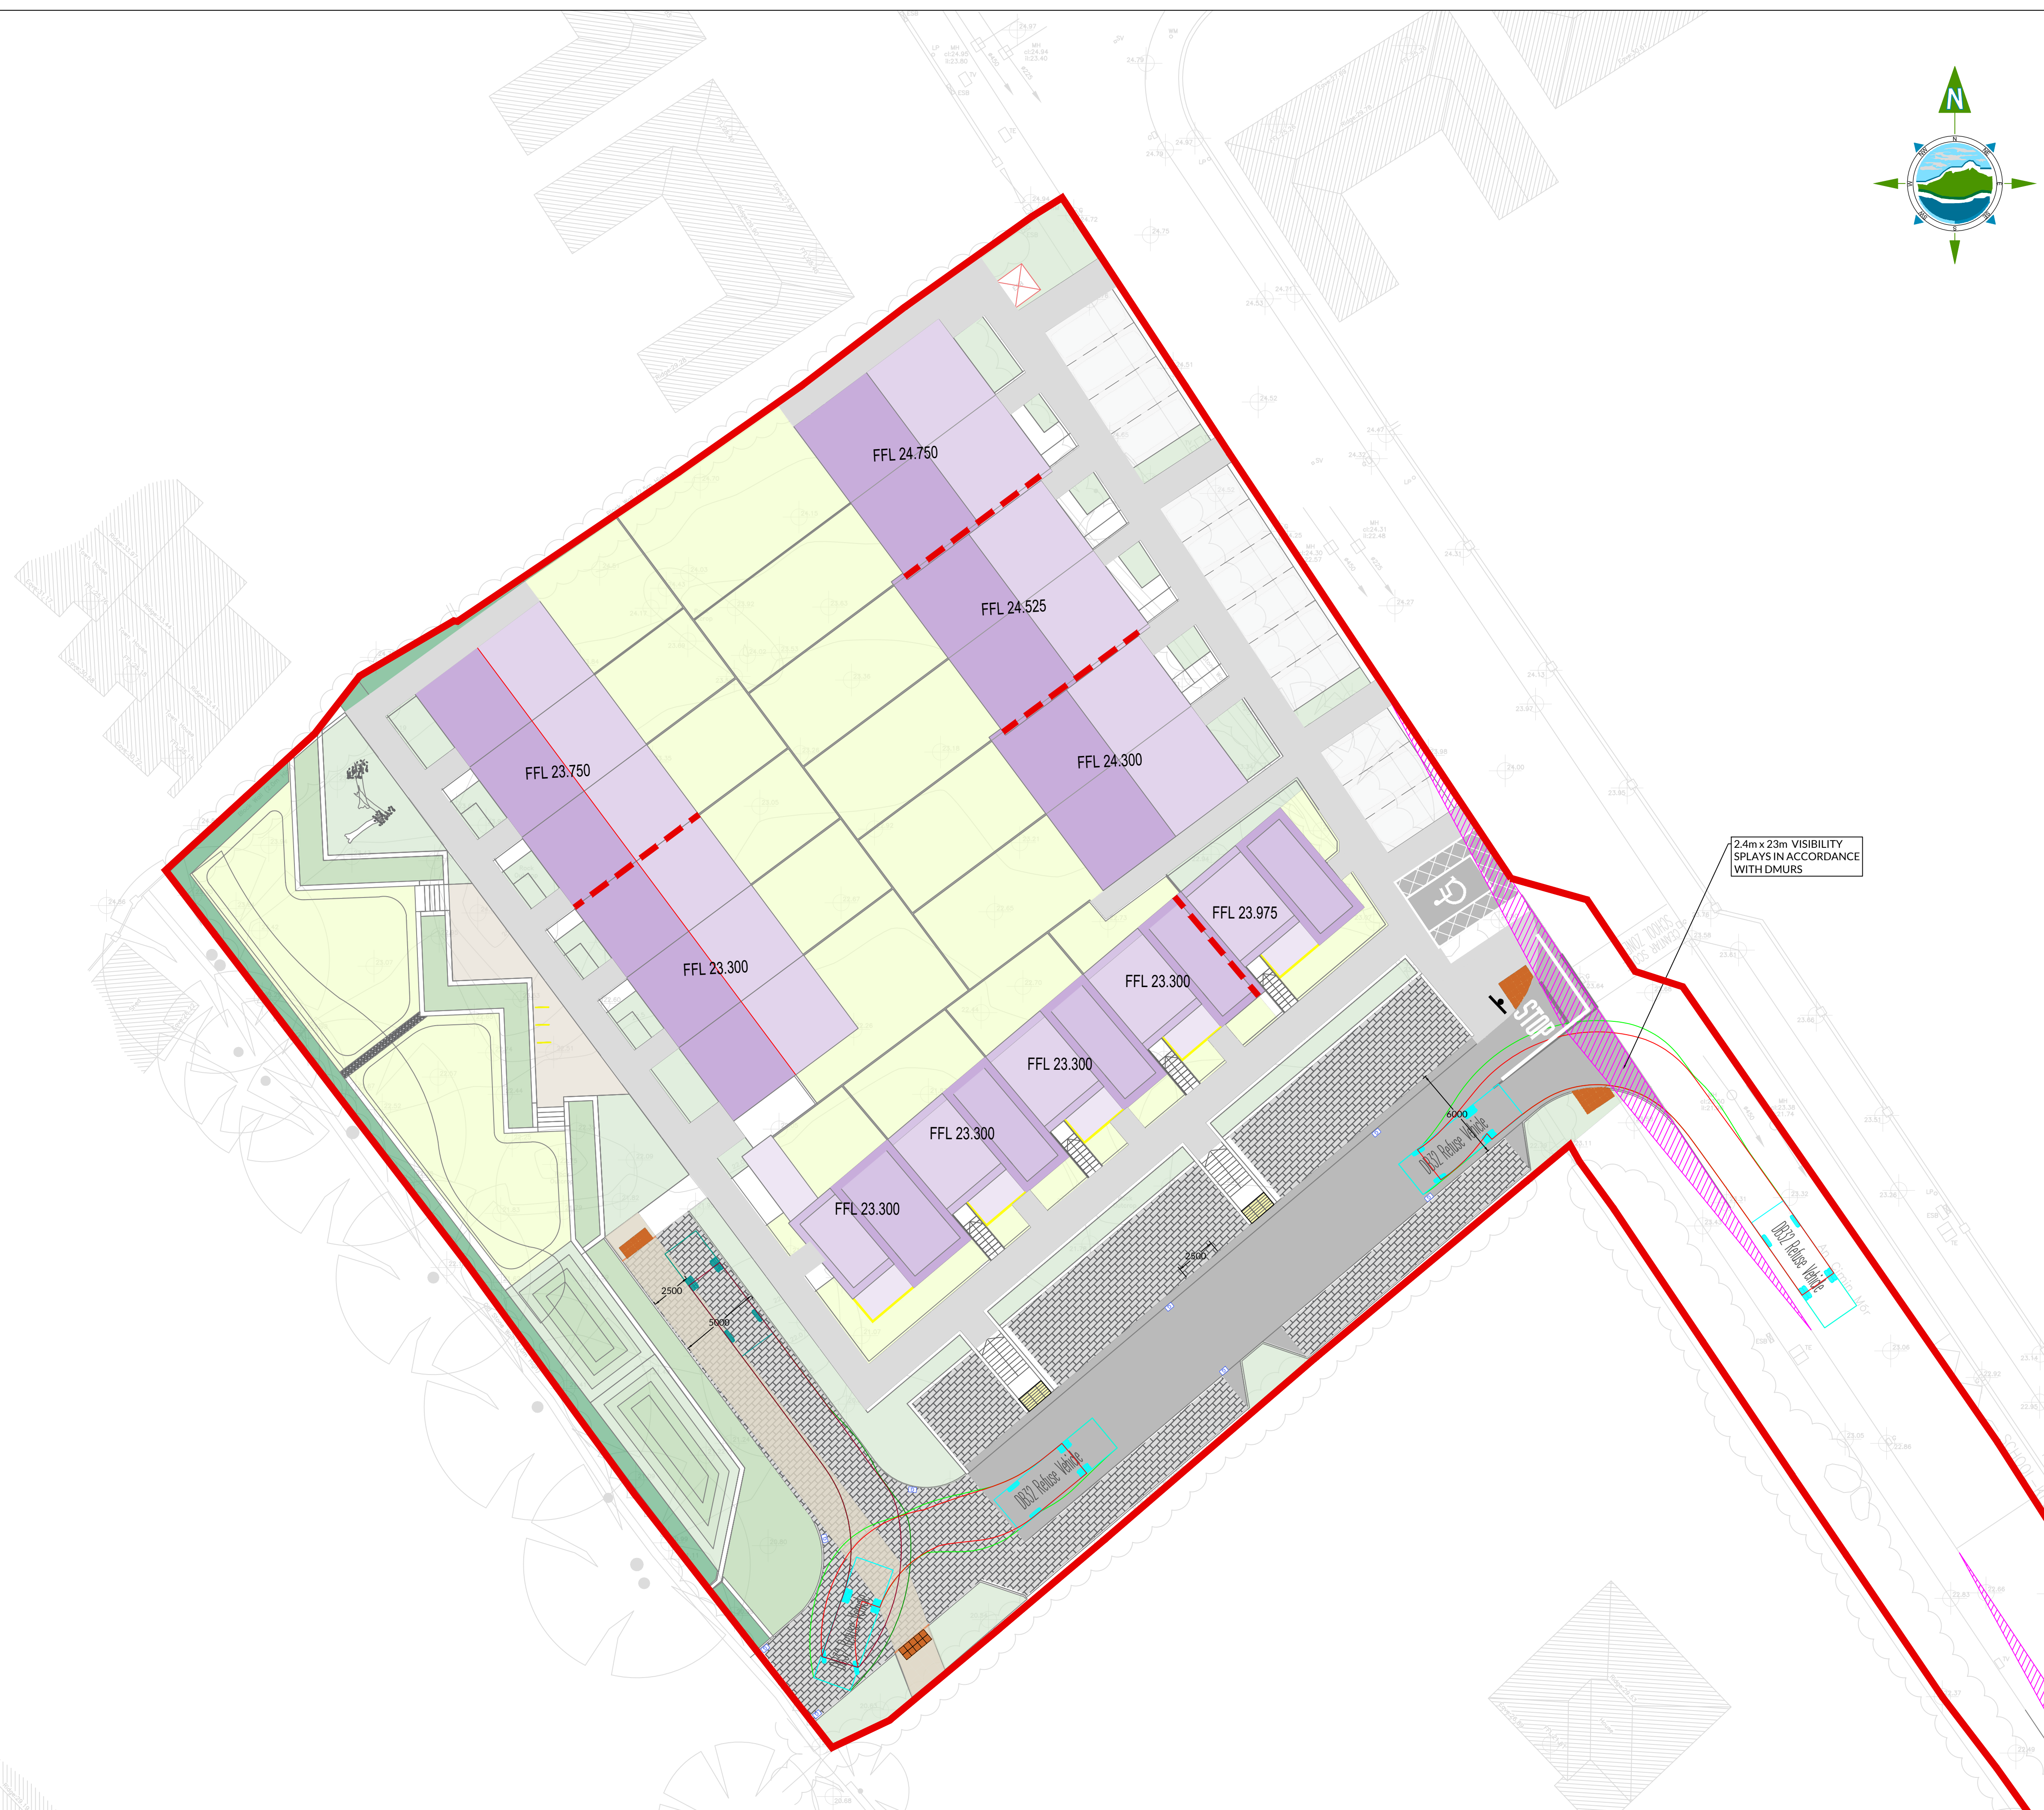
Site B Refuse Vehicle Swept Path Analysis

DB32 Refuse Vehicle  
Overall Length 7.900m  
Overall Width 2.400m  
Overall Body Height 3.183m  
Min Body Ground Clearance 0.388m  
Max Track Width 2.400m  
Lock-to-lock time 6.00s  
Curb to Curb Turning Radius 9.625m

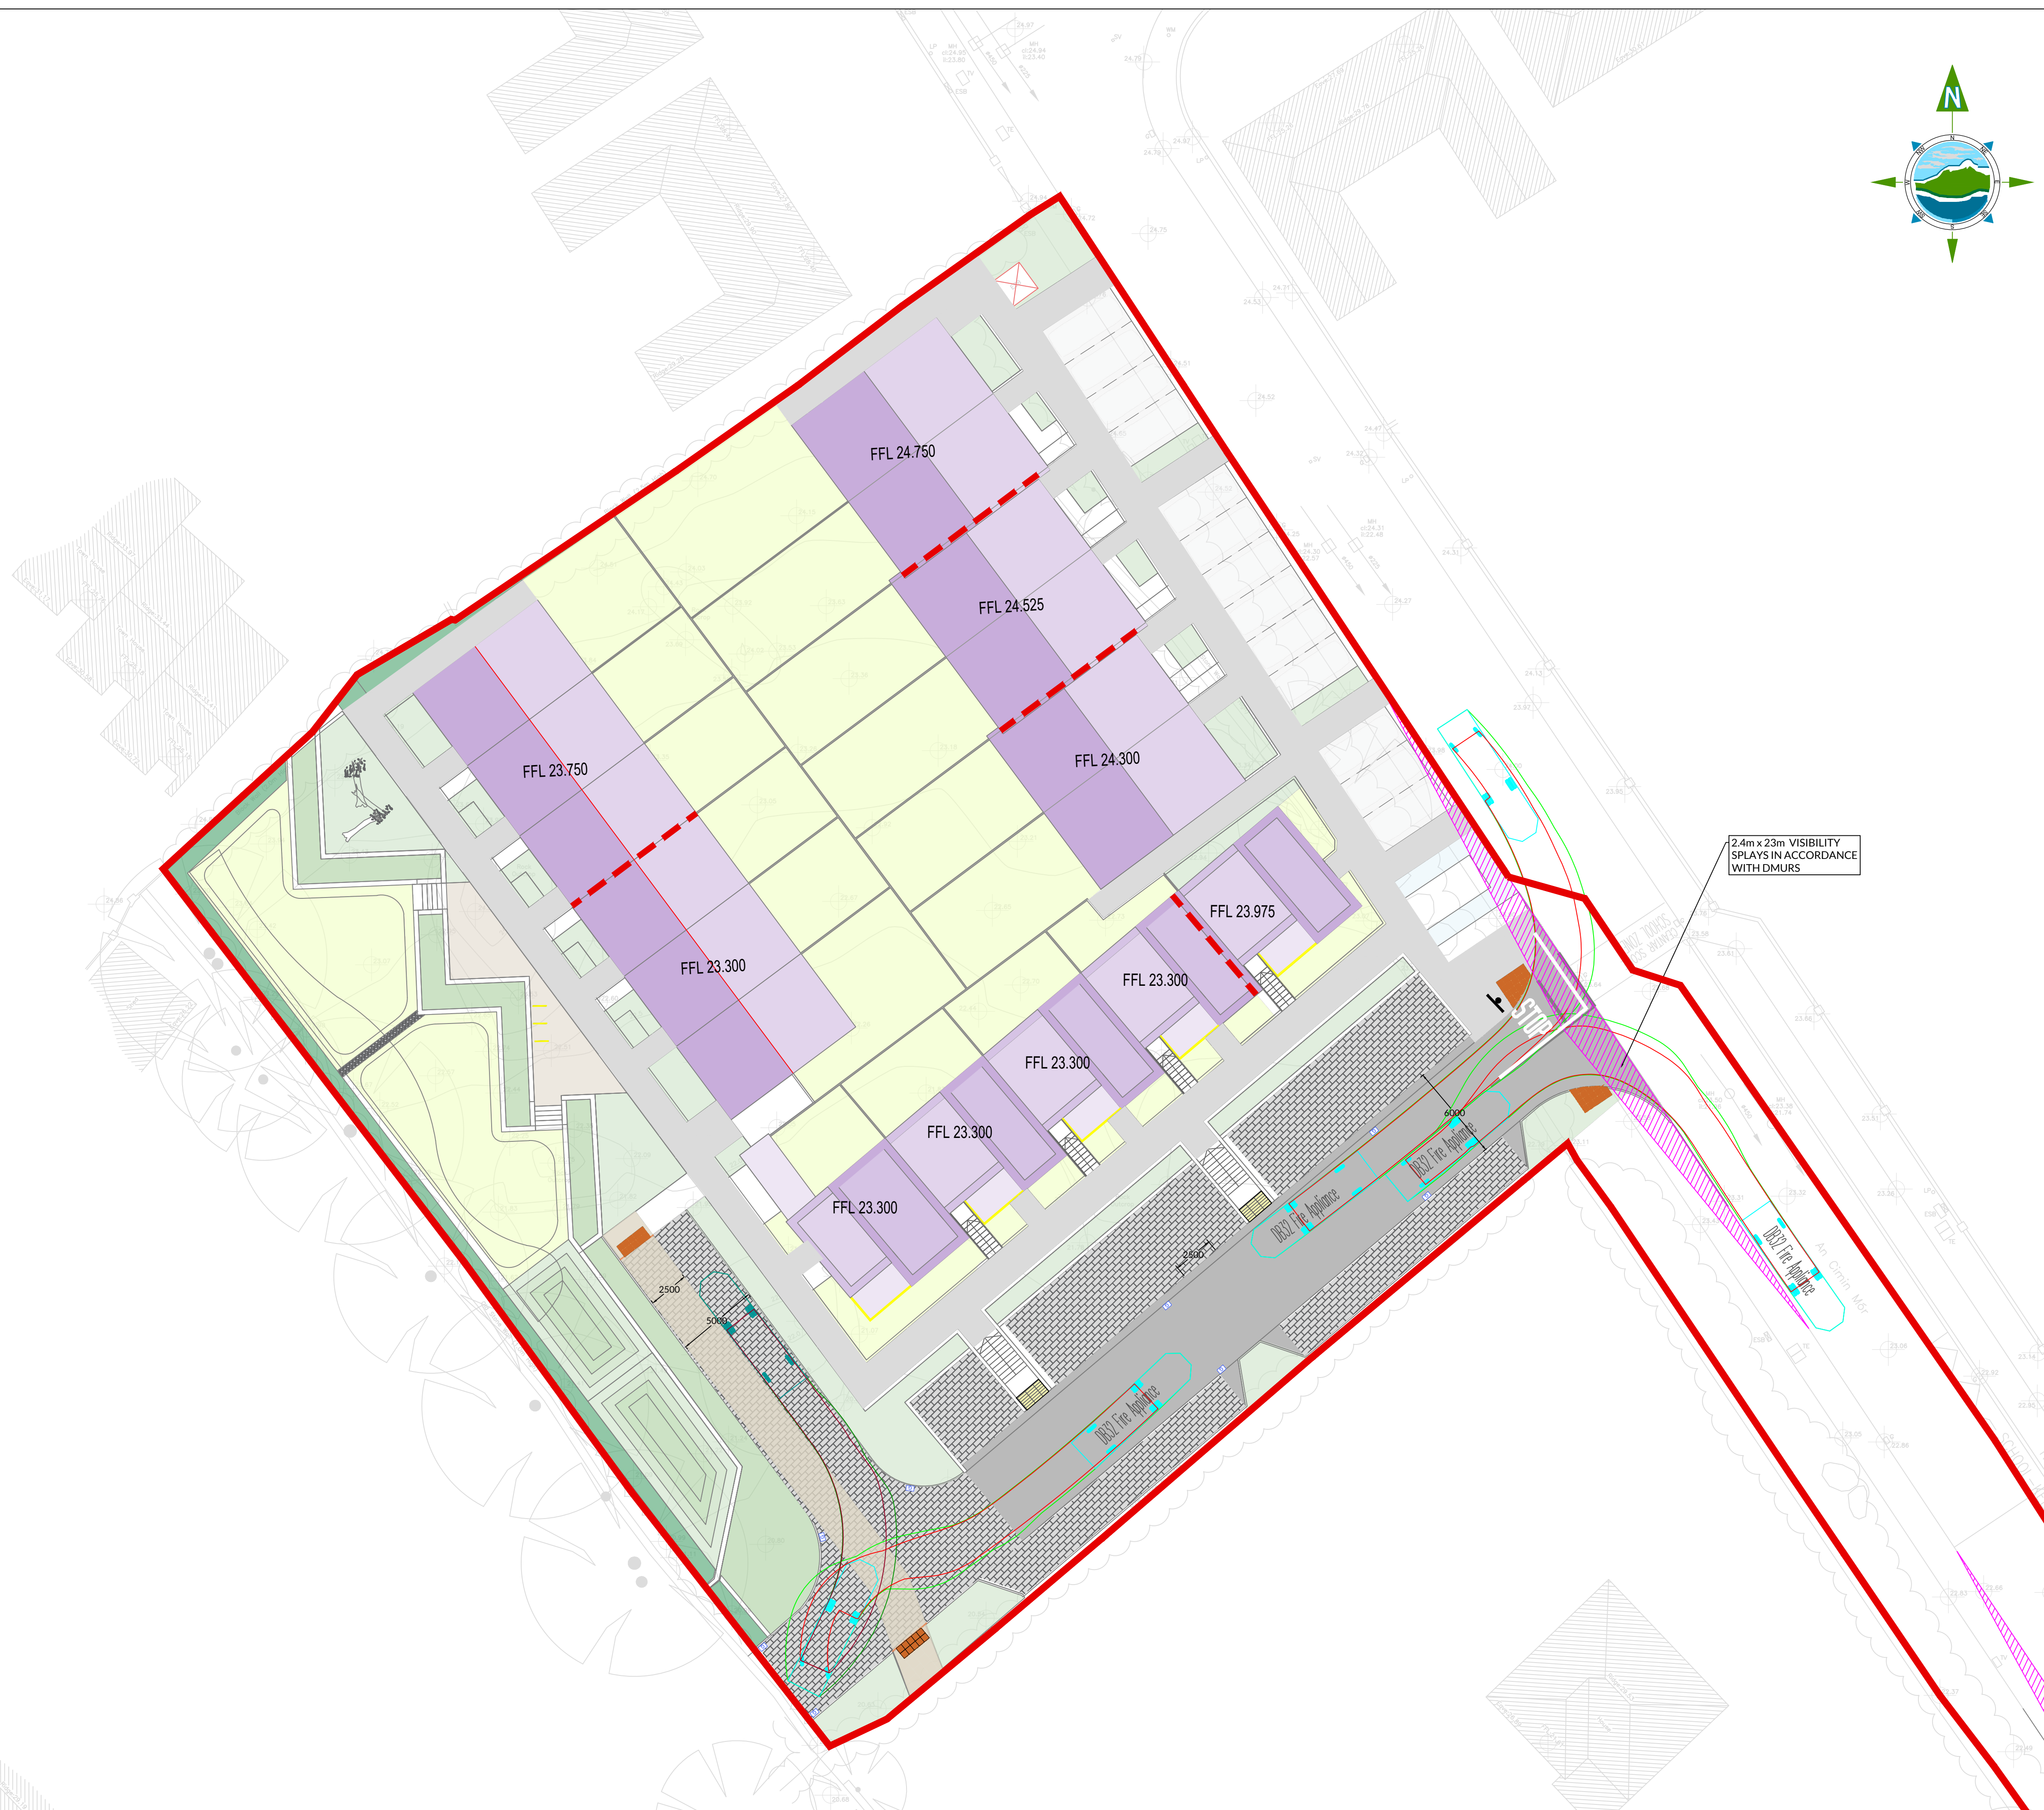
Title:  
**Site B Fire Tender Vehicle Swept Path Analysis**

Diagram of a DB32 Fire Appliance with dimensions: 8.68m (overall length), 1.52m (front overhang), 3.81m (rear overhang).

| DB32 Fire Appliance | 8.680m |
| Overall Length | 2.180m |
| Overall Width | 3.452m |
| Min Body Ground Clearance | 0.371m |
| Max Track Width | 2.921m |

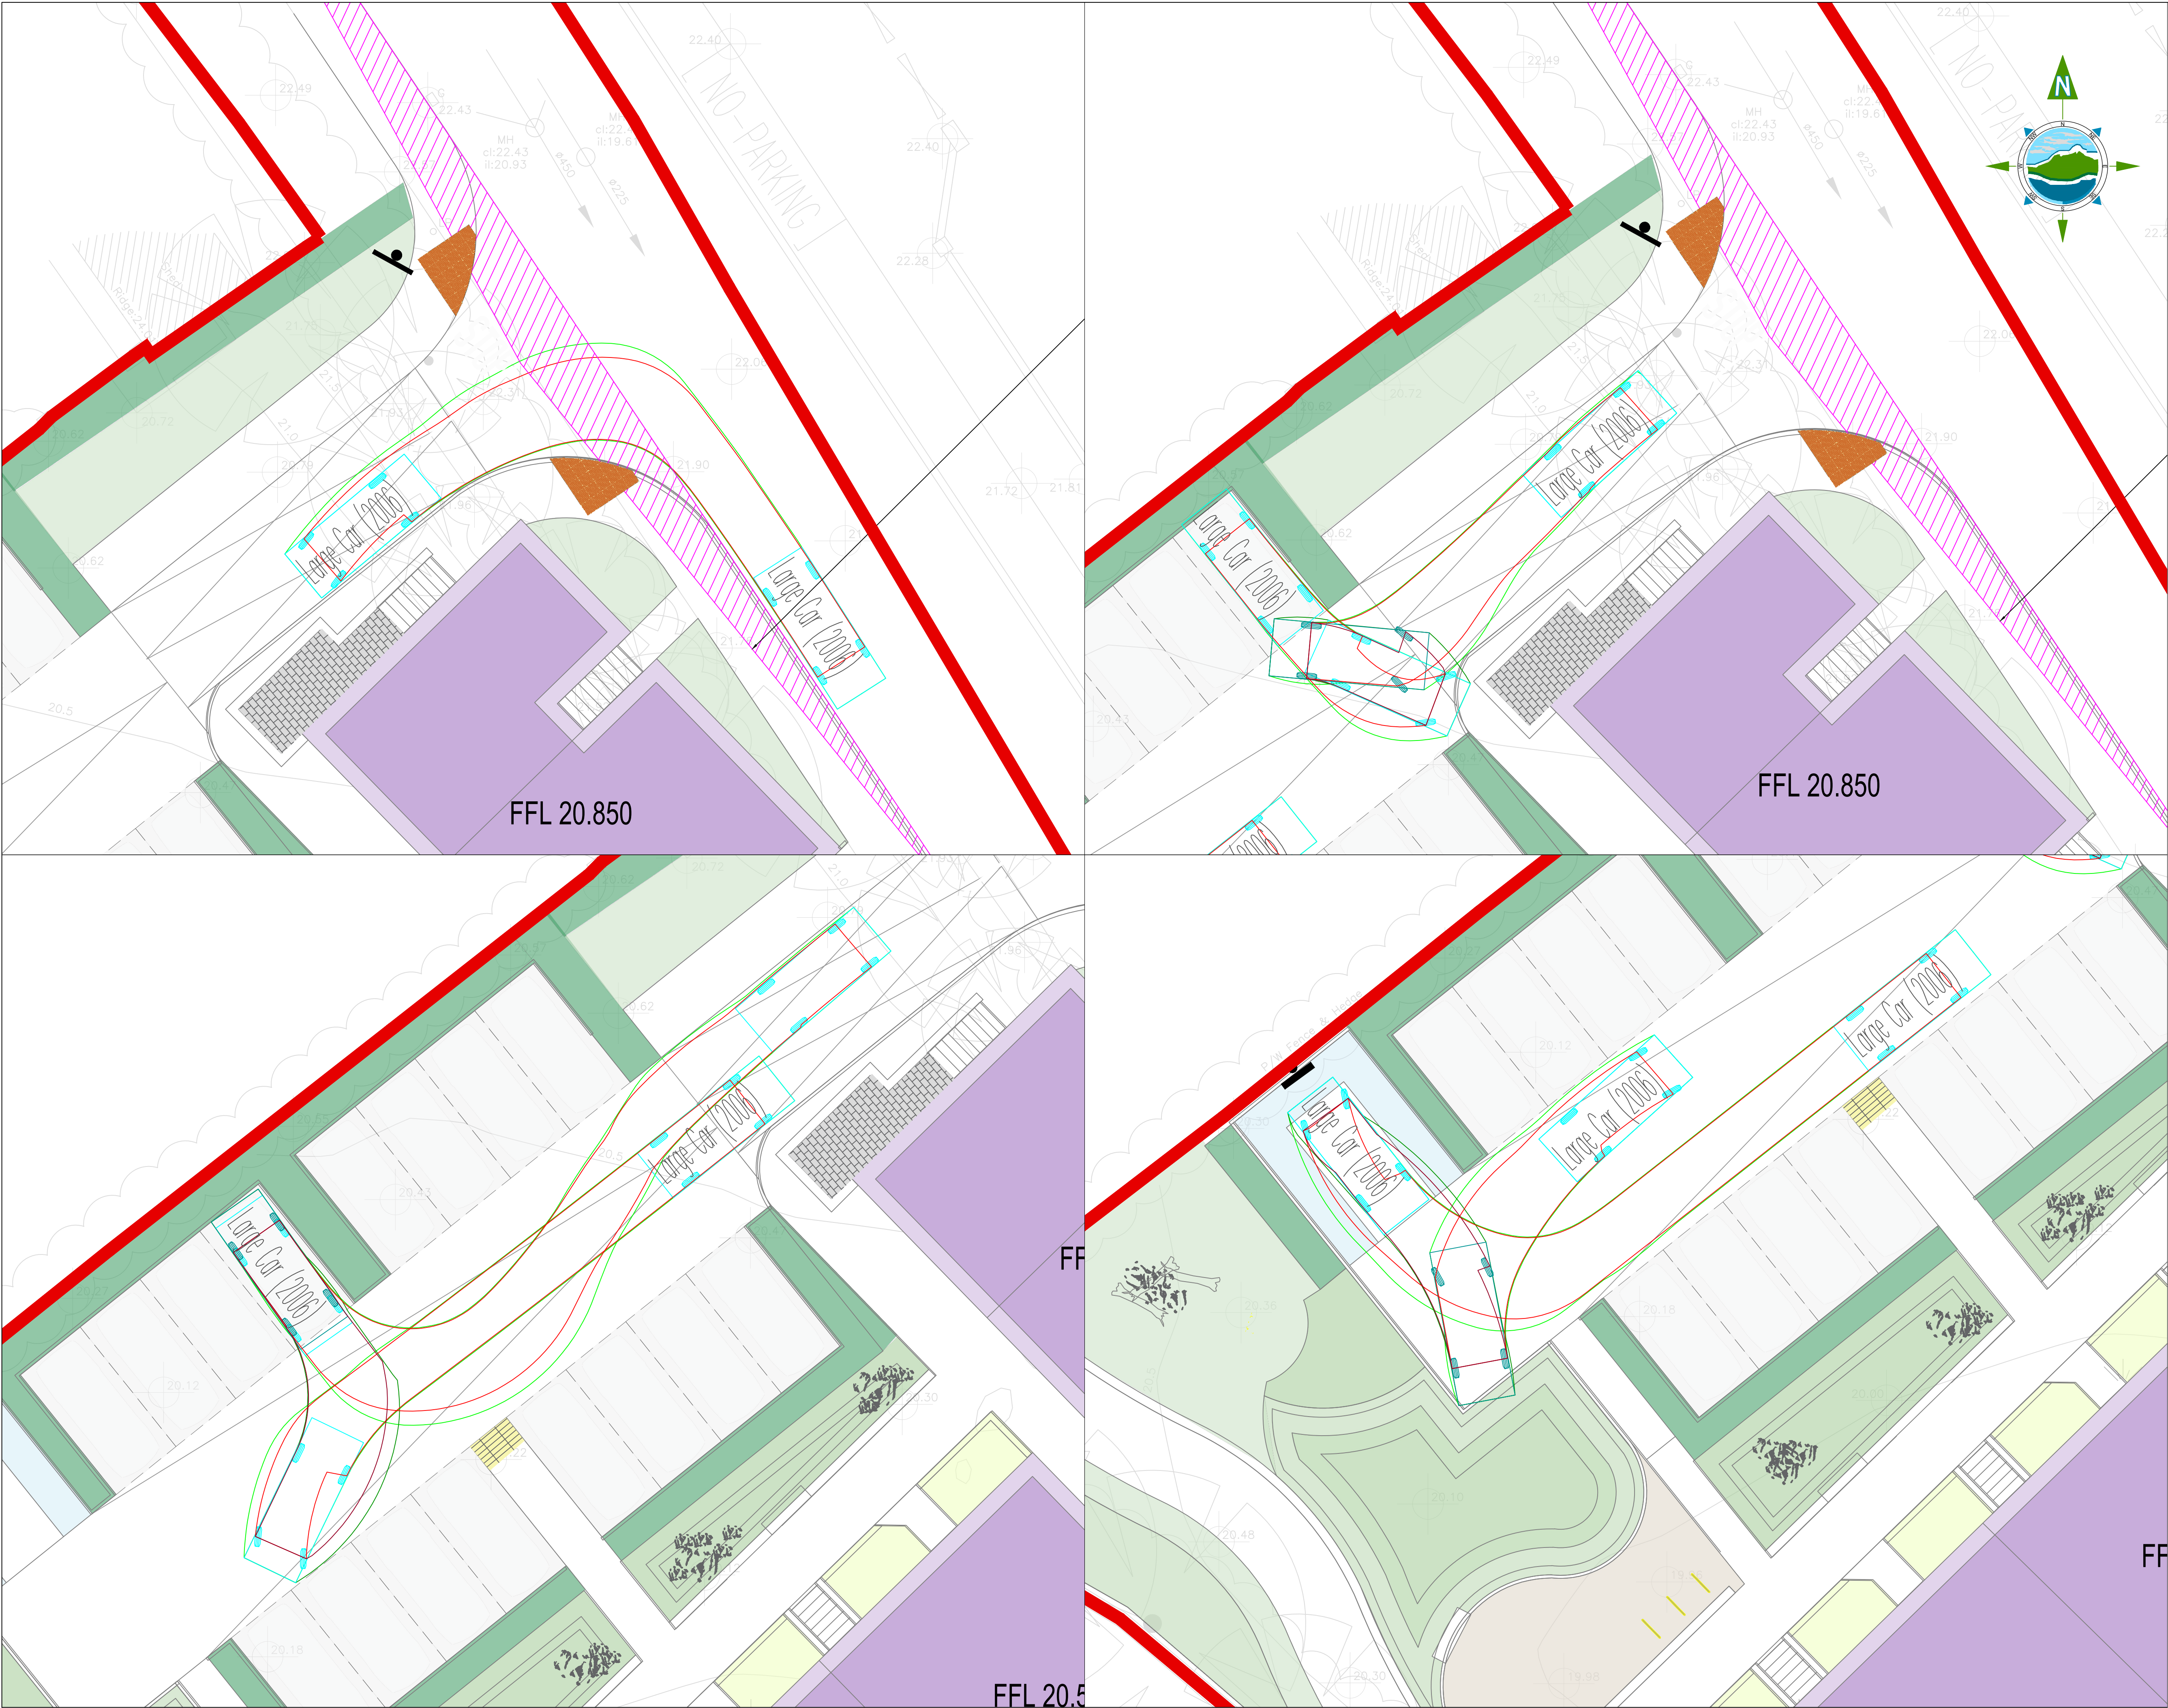
Title:  
Site A Large Car  
Swept Path Analysis

Large Car (2006)  
Overall Length 5.08m  
Overall Width 1.872m  
Overall Body Height 1.525m  
Min Body Ground Clearance 0.310m  
Max Track Width 1.831m  
Lock-to-lock time 4.00s  
Curb to Curb Turning Radius 5.900m
