**HOUSING DEVELOPMENT  
MUNSTER AVENUE  
CO. GALWAY**

## **PRELIMINARY BAT ROOST ASSESSMENT SUITABILITY REPORT**

**February 2024**

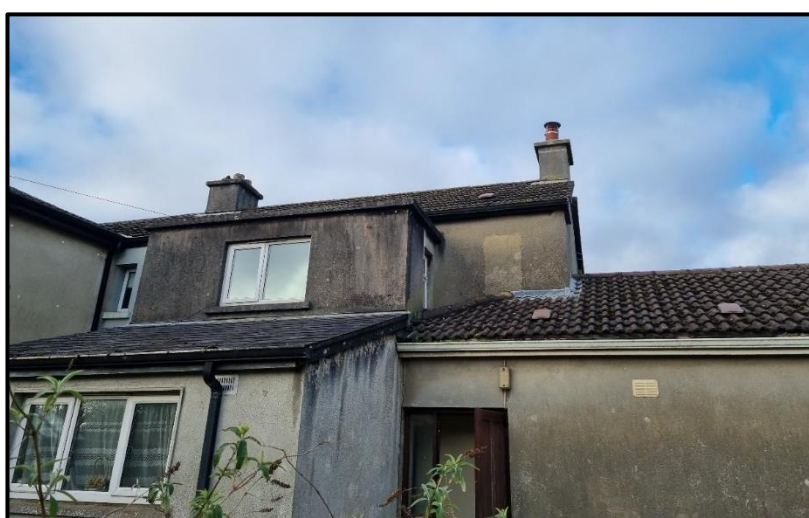
The house located at (Grid Reference: M 29392 24845) was inspected for the bat roost suitability, the house appeared to be structurally sound and not in a state of disrepair (**Figure 4**). All the window frames, tiles and guttering all appear to be in good condition. There are no obvious gaps or broken features allowing access into the property. The external windows and walls were searched for signs such as droppings staining; none were found during the site visit.

**Figure. 5** The rear of the house located at Munster Avenue

1. The eastern proportion (1<sup>st</sup> floor extension) of the property can be demolished with no further bat survey work required. However, if the building deteriorates and/or a two-year period elapses from the time of this survey, the property should be re-evaluated in full.

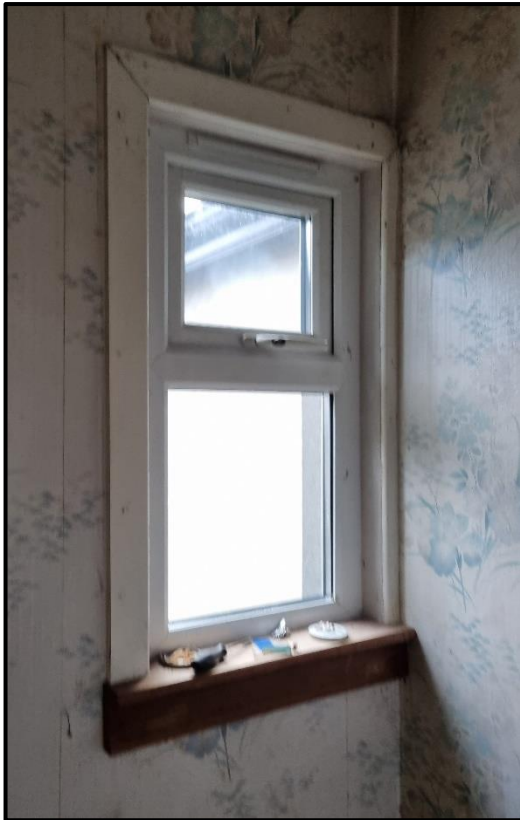
| Area | Description of Potential Roosting habitat and evidence for bats |
|---|---|
| Lower Floor | The lower floor was examined first, all windows and doors were well-sealed with no bat access to the internal areas observed ( <b>Figure 6 &amp; 7</b> ). Internal surfaces were inspected for droppings and feeding signs. No evidence of bats were discovered. |

**Figure 6.** Secure window on ground floor

**Figure 7.** Secure window on ground floor

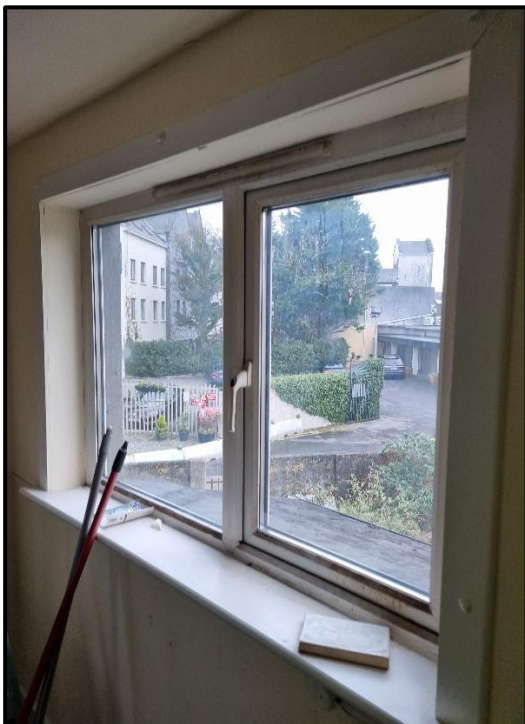
| Area | Description of Potential Roosting habitat and evidence for bats |
|---|---|
| Upper Floor | All windows were well-sealed on this level ( <b>Figure 8 &amp; 9</b> ) and did not allow access to the internal building. Internal surfaces were inspected for droppings and feeding signs. No evidence of bats were discovered. |

**Figure 8.** Secure window on 1<sup>st</sup> floor

**Figure 9.** Secure window on 1<sup>st</sup> floor

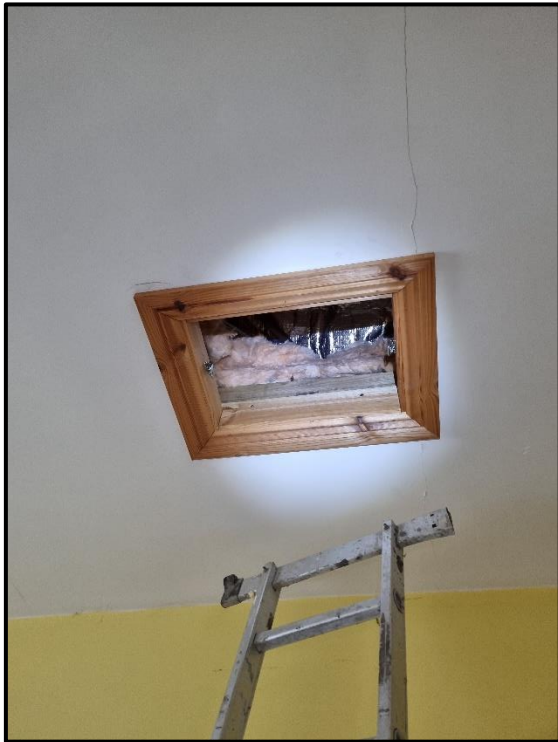
| Area | Description of Potential Roosting habitat and evidence for bats |
|---|---|
| Attic Space<br>lower floor | <p>Access to this roof space was achieved with a telescopic ladder and climbing into a hatch. The loft space was filled with insulation, providing limited/negligible available space for bats to reside (<b>Figure 10 &amp; 11</b>).</p> <p>The second attic space hatch was accessed with a telescopic ladder. This area of the attic was more spacious. No evidence of bats or an associated roost were detected. Thermal imaging and extensive searching did not detect any roosting bats or signs of bats in this space.</p> |

**Figure 10.** First loft hatch filled with insulation

**Figure 11.** View inside second loft hatch

In accordance with the Collins (2016) Bat Surveys Guidelines, this structure has a negligible ranking, as the property has no visible external entrances and no signs of bats within the property.

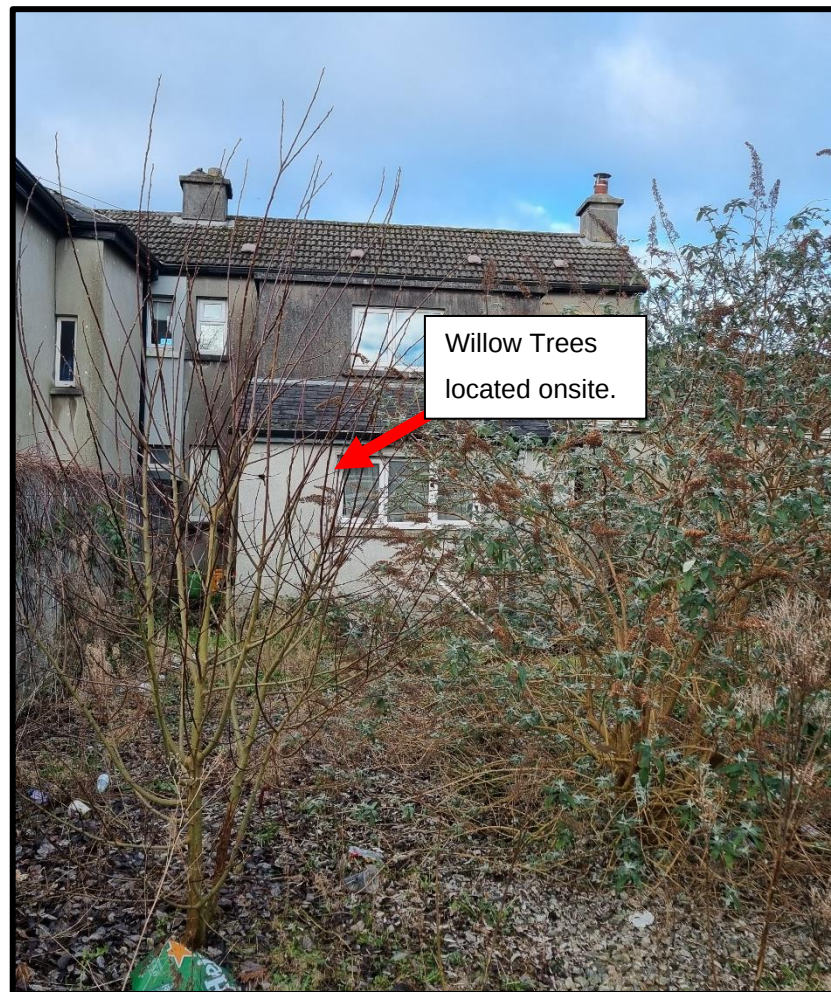
All the trees within the redline boundary of the property they were assessed for Bat Roost potential; due to the size and age of these trees (**Figure 12**), they currently have no potential roosting features for Bats. In accordance with the Collins (2016) Bat Surveys Guidelines, all trees located on site have a negligible ranking.

**Figure 12.** Young willow trees located at the rear of the property.

2. Any trees onsite (front and rear) which require felling can commence. All tree felling works must occur outside of the bird breeding season (March 1st – August 31st is bird breeding season).

3. It is recommended that bat boxes should be installed where trees/structures are removed to provide bat roost habitat.
4. Any artificial lighting installed in a newly proposed development should be directional, to reduce the impact on any bats which forage in the development area.
