Woodquay Park Enhancement

Engineering Planning Report

231101-PUNCH-XX-XX-RP-C-0005

September 2024

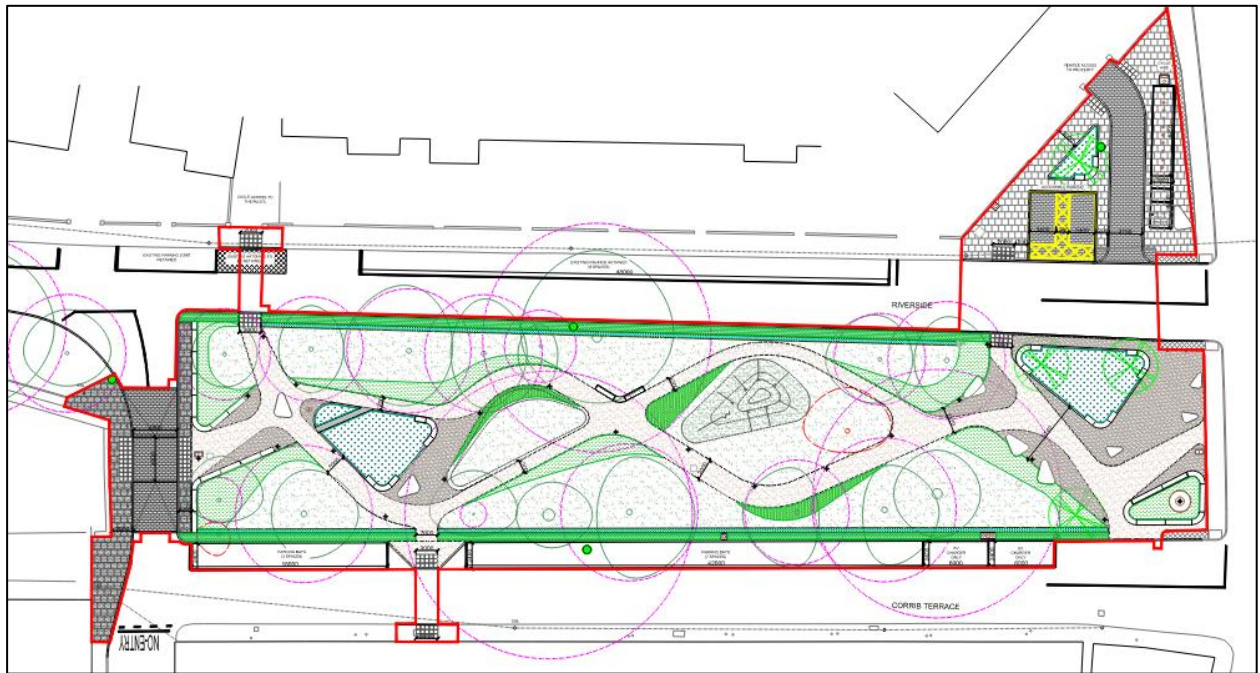
Figure 1-2: Proposed Site Layout (Ref: LUC Architects)

The proposed Woodquay Park Enhancement consists of enhancement measures to existing park to include highways improvements, parking, new paths and paving, seating, lighting, public art, sustainable urban drainage, and new biodiverse planting. An extract from LUC Architect's site layout drawing is included in Figure 1-2.

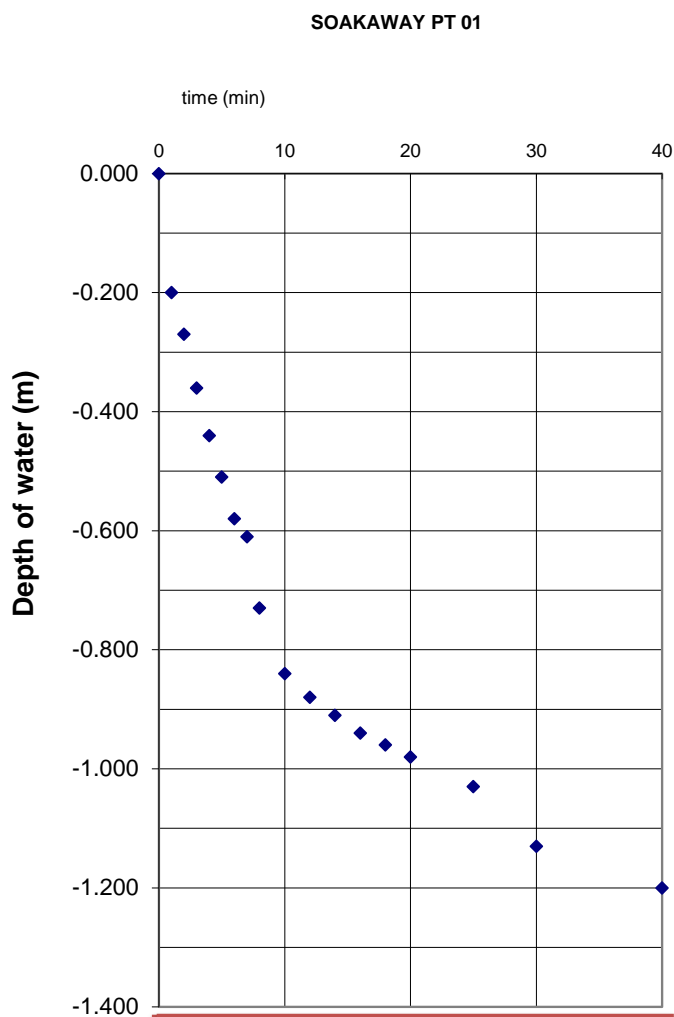
Top of water level: 0.00 m
Base of trial pit: 1.20 m
Dims. of trial pit: 1.1 x 0.3

time min	WL m
0	0.000
1	-0.200
2	-0.270
3	-0.360
4	-0.440
5	-0.510
6	-0.580
7	-0.610
8	-0.730
10	-0.840
12	-0.880
14	-0.910
16	-0.940
18	-0.960
20	-0.980
25	-1.030
30	-1.130
40	-1.200

Soil Infiltration Rate = 1.79×10^{-4} m/s

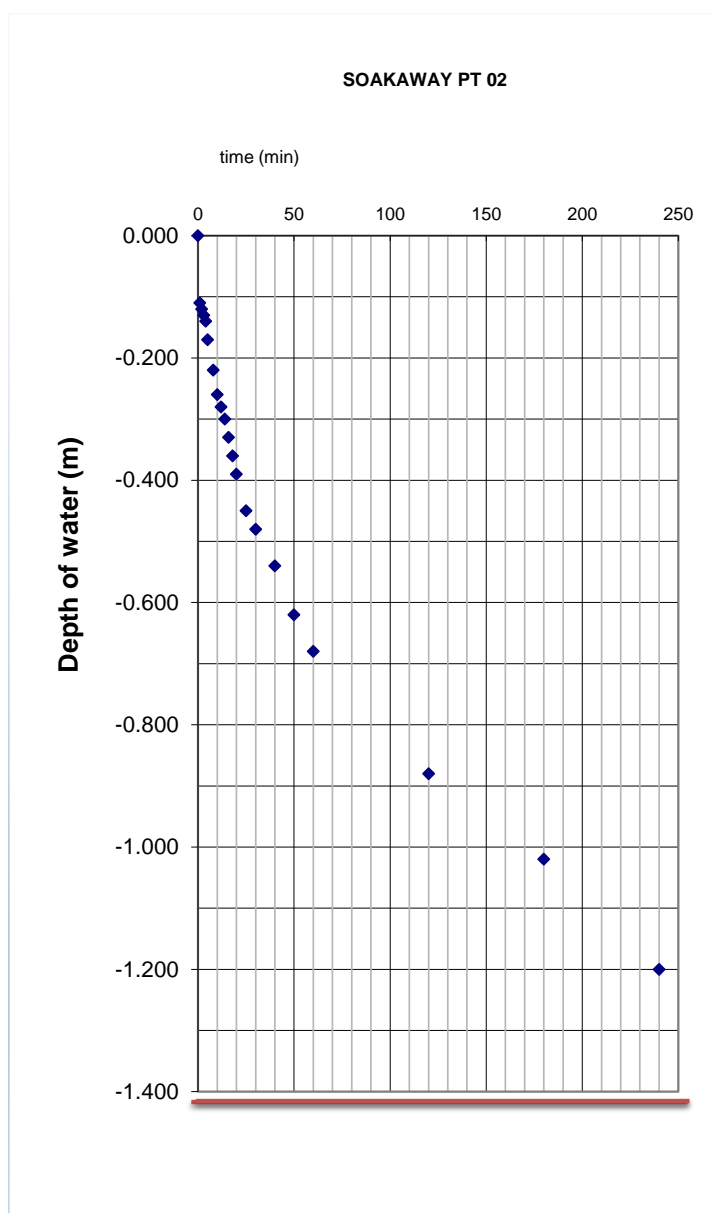
Top of water level: 0.00 m
Base of trial pit: 1.20 m
Dims. of trial pit: 1.3 x 0.3

time min	WL m
0	0.000
1	-0.110
2	-0.120
3	-0.130
4	-0.140
5	-0.170
8	-0.220
10	-0.260
12	-0.280
14	-0.300
16	-0.330
18	-0.360
20	-0.390
25	-0.450
30	-0.480
40	-0.540
50	-0.620
60	-0.680
120	-0.880
180	-1.020
240	-1.200

Soil Infiltration Rate = 1.77×10^{-5} m/s
