# GALWAY'S HERITAGE IN STONE

## Catalogue No. 9

### The 2023 Archaeological and Conservation Works at St. Nicholas' Collegiate Church Galway and Menlo Castle

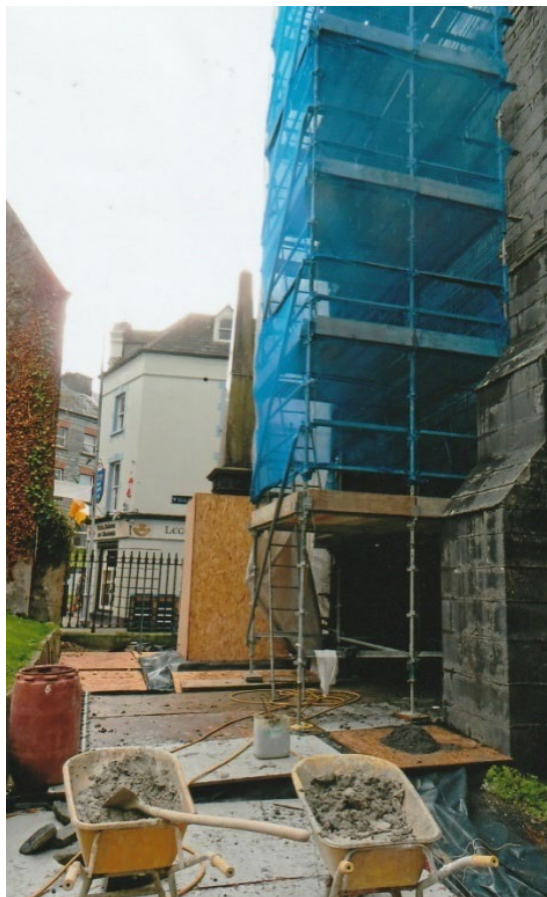
*Fig. 1 The scaffolded area of the 16<sup>th</sup> century southern extension to the south transept of St. Nicholas' Collegiate Church. The extension consists of the area to the left of the buttress shown in the photograph.*

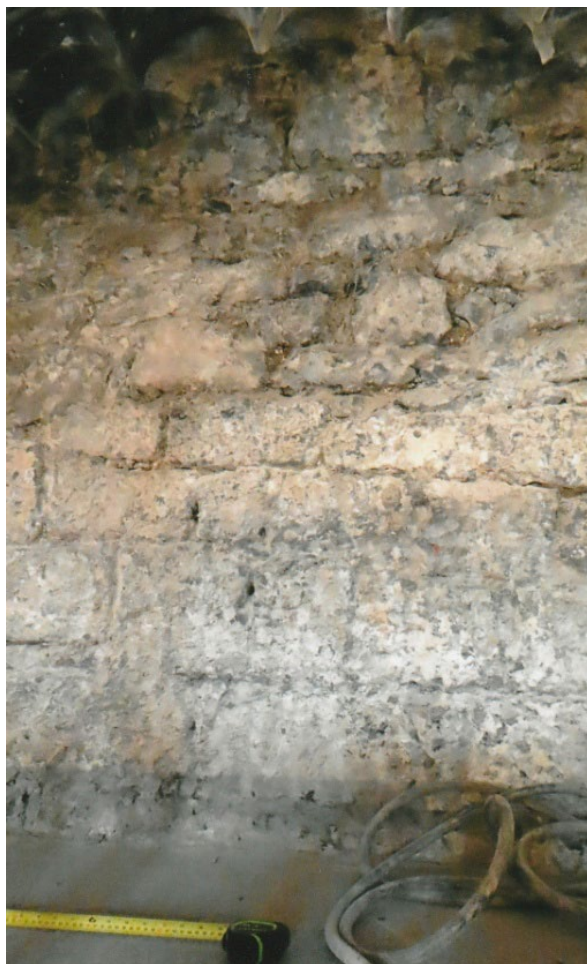
*Fig. 5 Varied coursing and quality of stone used in the walling at the back of the flamboyant canopied and traceried Lynch Tomb seems to suggest two teams of masons or some rebuilding. Photograph: J. Higgins.*

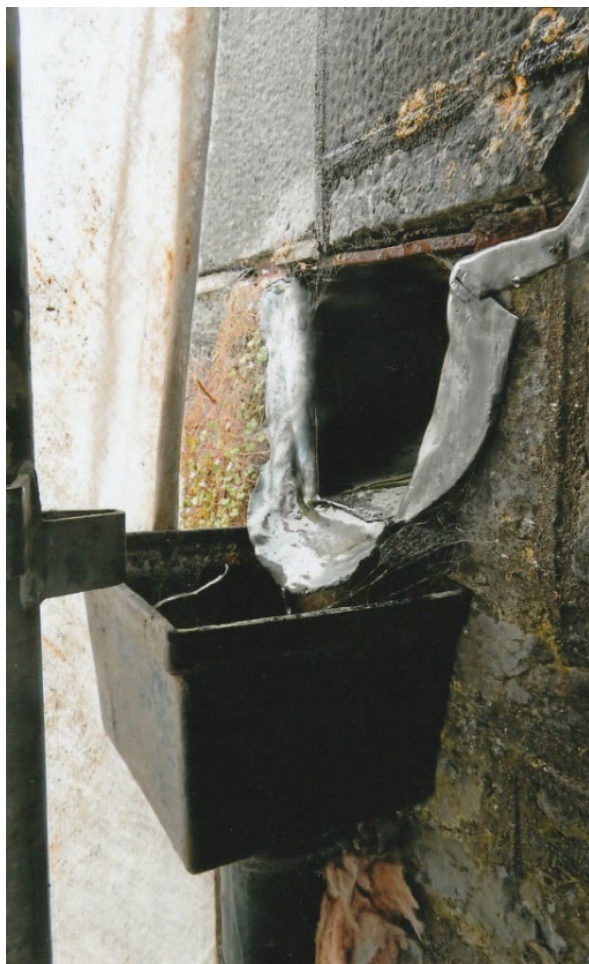
*Fig. 7 The lead lined outlet from the parapet wall to the 1950's – 1960's hopper and downpipe. A larger diameter downpipe in cast iron will be required.*

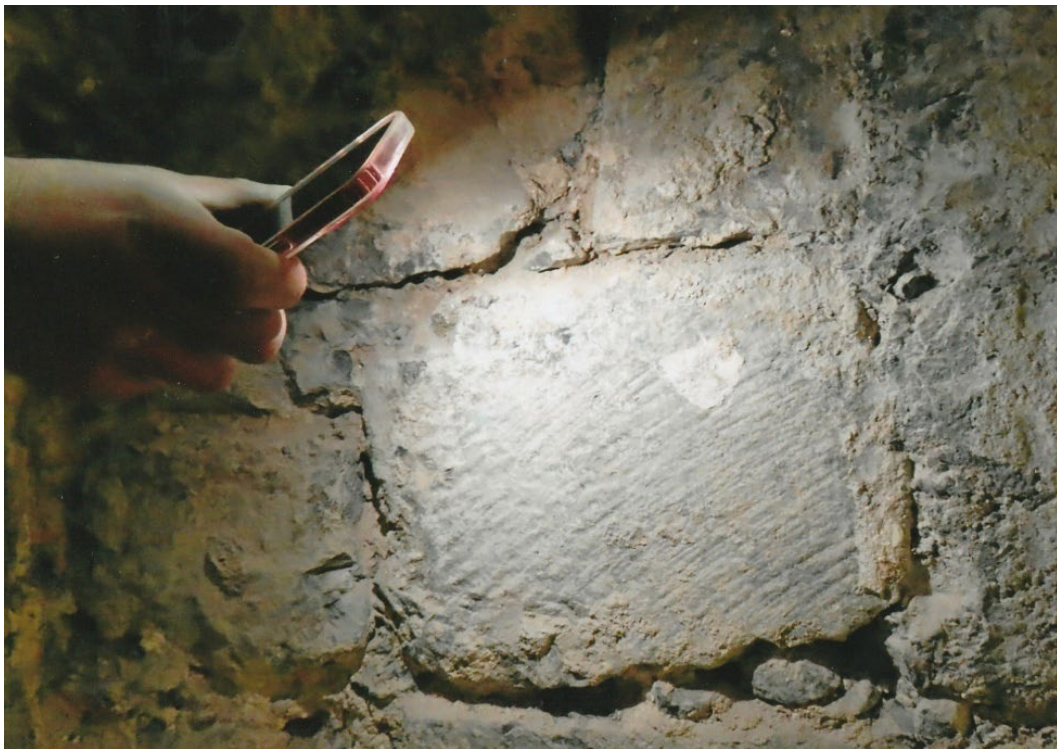
*Fig. 10 Ashlar block with diagonal tooling of a type common between the 12th and 14th centuries incorporated in the rectangular projection from the wall. This occurs 297cms above ground level. It and 15th – 16th century worked stone has been reused in the walling supporting the flamboyant Lynch canopied and traceried wall tomb.*

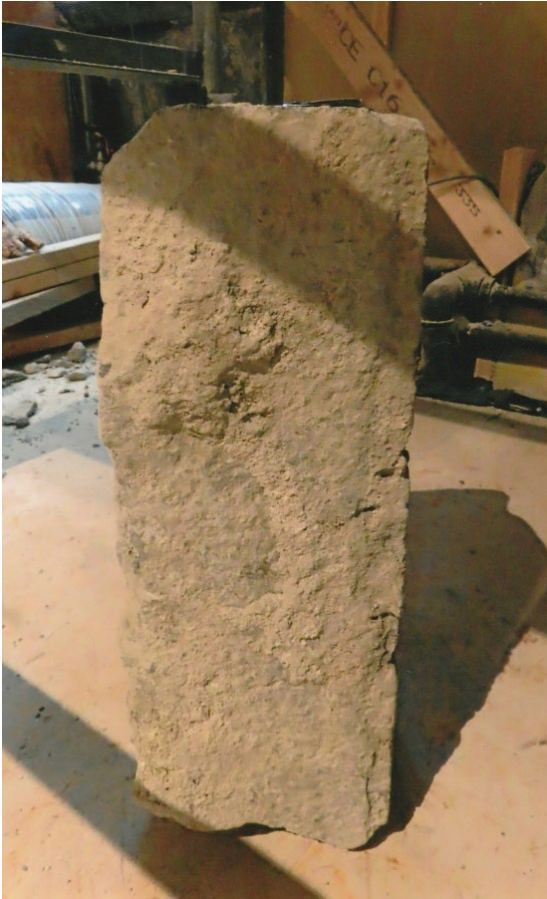
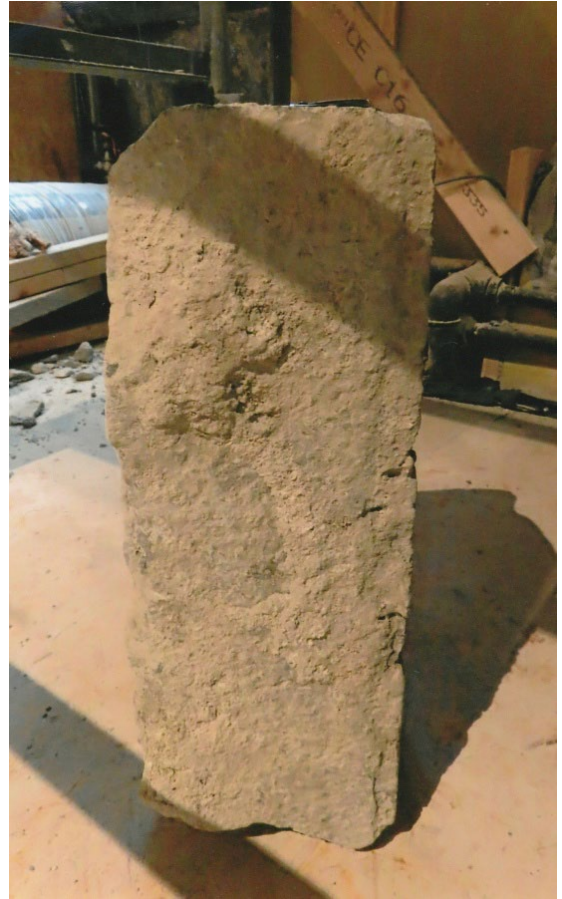
*Fig. 21 A&B Two sides of an ashlar block with a thin coat of 1950's – 1960's cementitious shuttering from the ground floor window of the south transept extension. The ashlar block is probably of the 14th to 15th centuries. Photographs: J. Higgins.*

Ashlar block, limestone, a roughly rectangular block of dressed stone of medieval type found in the fill of the partly blocked lower part of the ingoing of the window which lit the lynch corner tomb in the south transept it had been reused in the fill to retain rubble and decayed mortar and bears traces of the shuttered concrete used to block the lower fill of the window space. It measures 51cms long 24cms wide and 20 thick and one surface (the original 'back' is more crudely finished and less obviously tooled than on the front face and the sides.

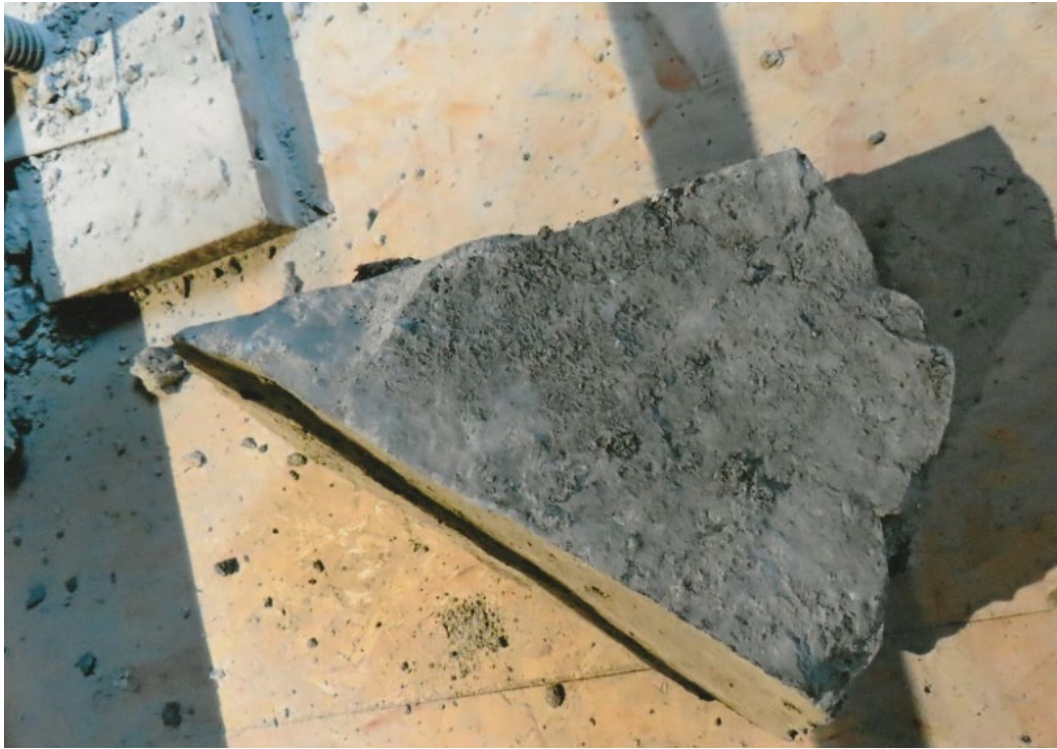
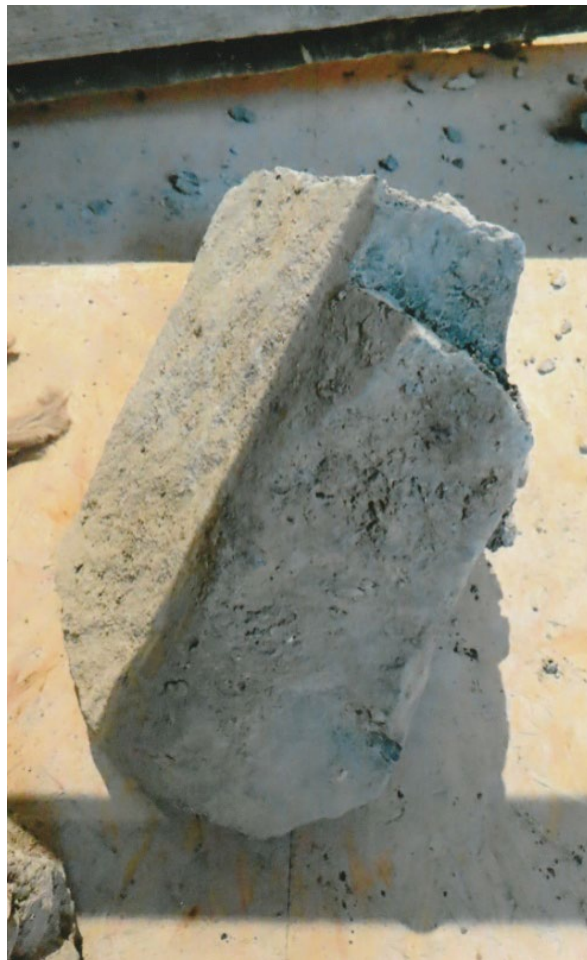
*Fig. 24 Triangular stone from the fill of the sill of the lower window.*

*Fig. 25 Another view of the same stone which is unworked. Photograph: J. Higgins.*

This roughly triangular lump of limestone was retained by the masons. It is 36.5cms in height and 26 in width. It is fortuitously but accidentally fractured but is not tolled and is not an architectural fragment.

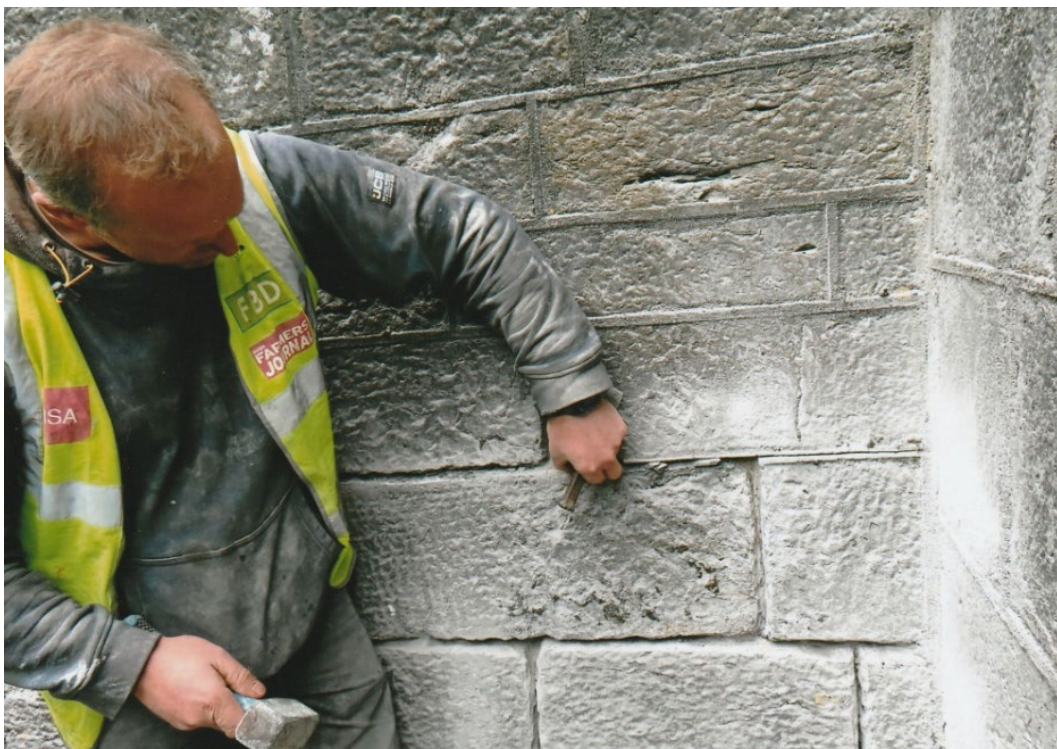
*Fig. 27 Cleaning the joints after the ribbon-pointing was removed. Photograph: J. Higgins.*

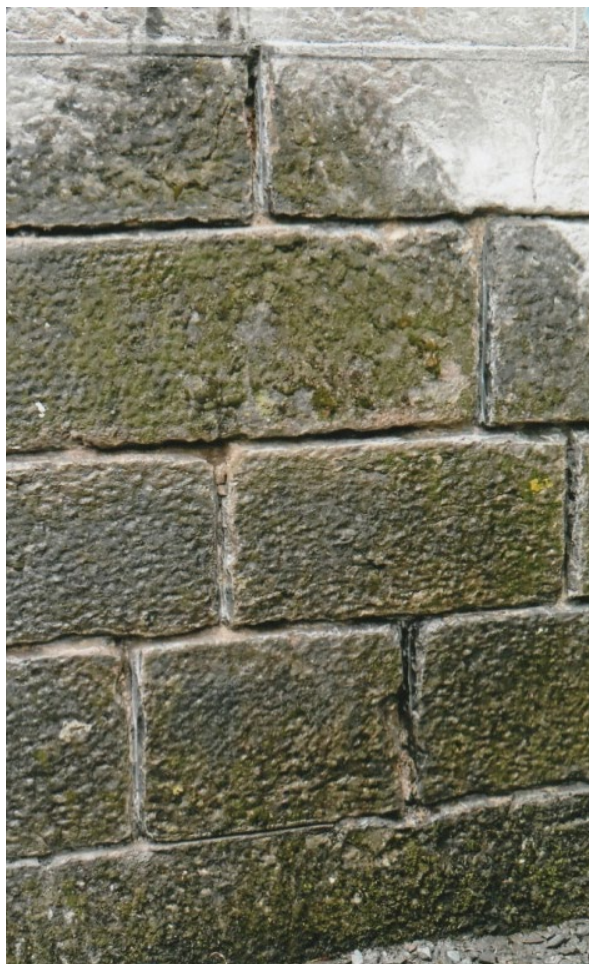
*Fig. 28 Cleaned joints between the 16th century ashlar blocks, with some remaining ribbon pointing at the top of the image. Photograph: J. Higgins.*

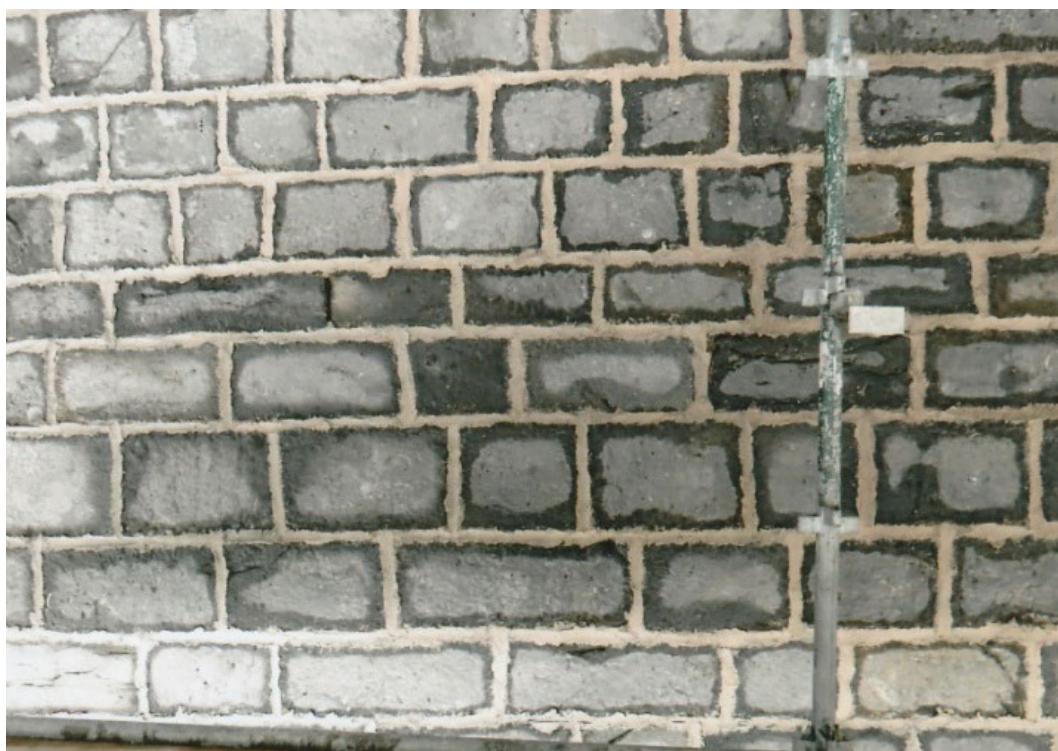
*Fig. 29 Preliminary packing of joints with new lime mortar as part of the repointing process. Photograph: J. Higgins.*

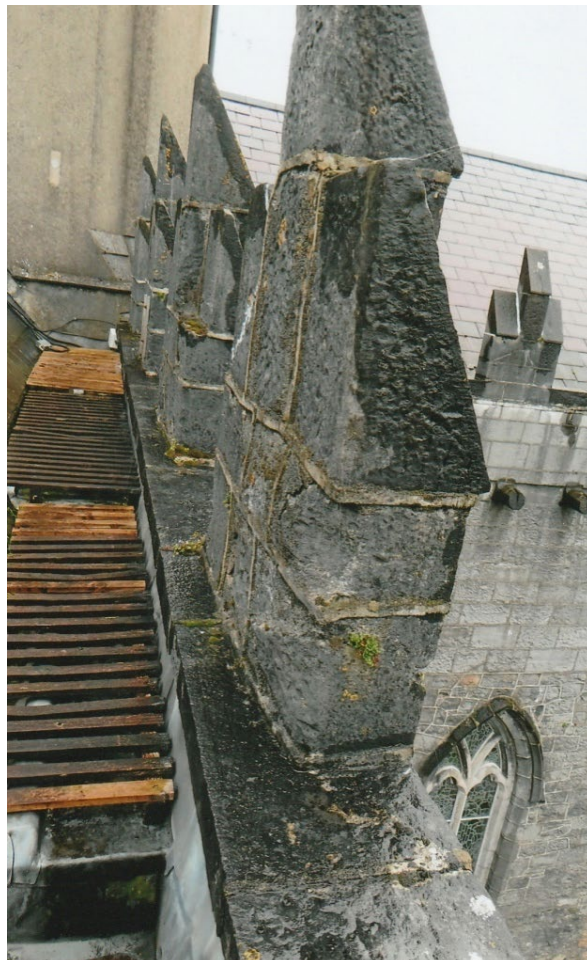
*Fig. 37 The wooden duck-walk behind the parapet covers a metal drainage trough with feeds into the hopper at the top of the cast iron down pipes.*

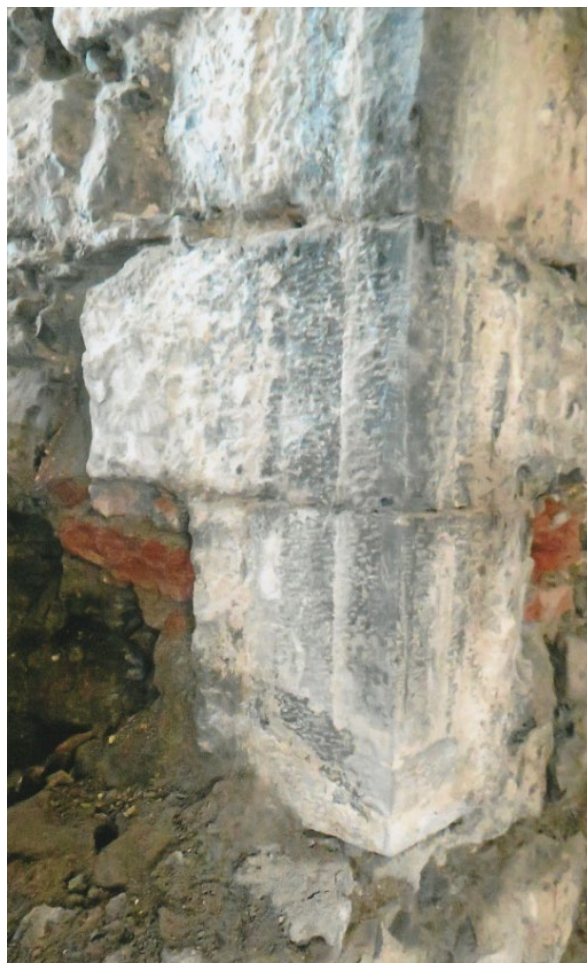
The upper window had 3 replacement stones which were probably mid or late 19<sup>th</sup> century insertions at the lower ends of its ingoing. Red and yellow brick occurred in the sloping ingoing on the right side of the window behind some of the inserted stones which also supports the idea of a 19<sup>th</sup> century phase of

*Fig. 45 Two lowermost stones on the right side of the upper window in the east wall of the South Transept Extension are retooled or 19th century insertions as is the red and yellow brick behind them. Note the binder of the lime-wash on the ingoing and outside it the line of the 1950's – 1960's render. A plain band was left outside of this on the sides of the ingoings and window soffits. Photograph: J. Higgins.*

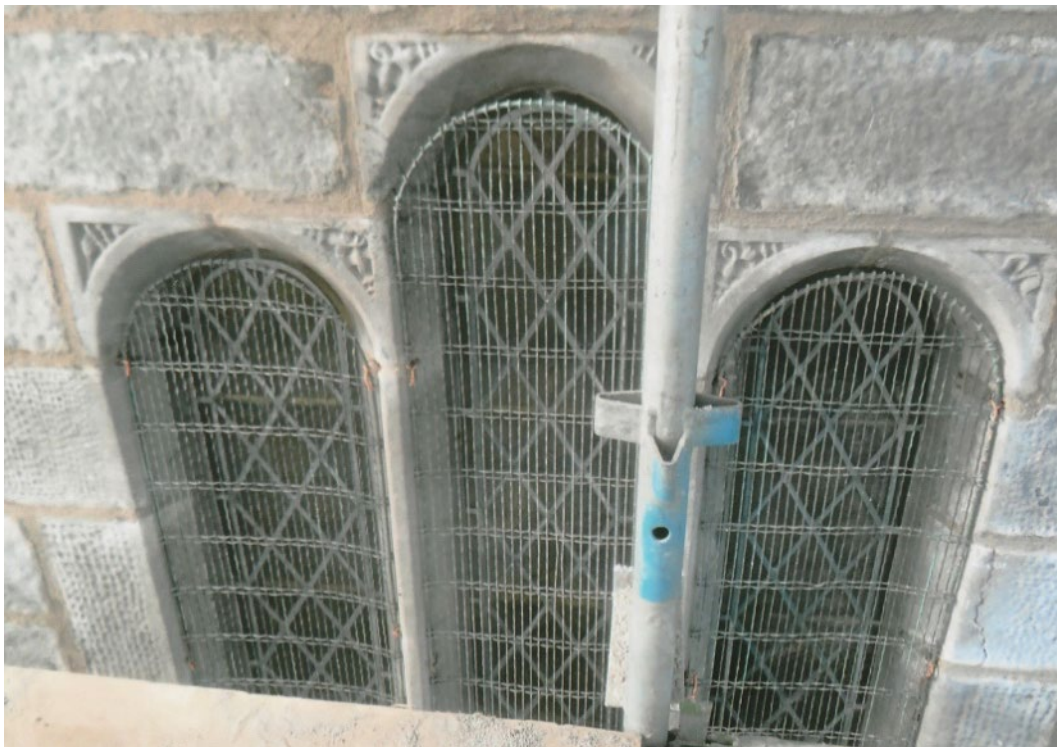
*Fig. 47 The 1950's – 1960's grills repositioned on the windows. Photograph: J. Higgins.*

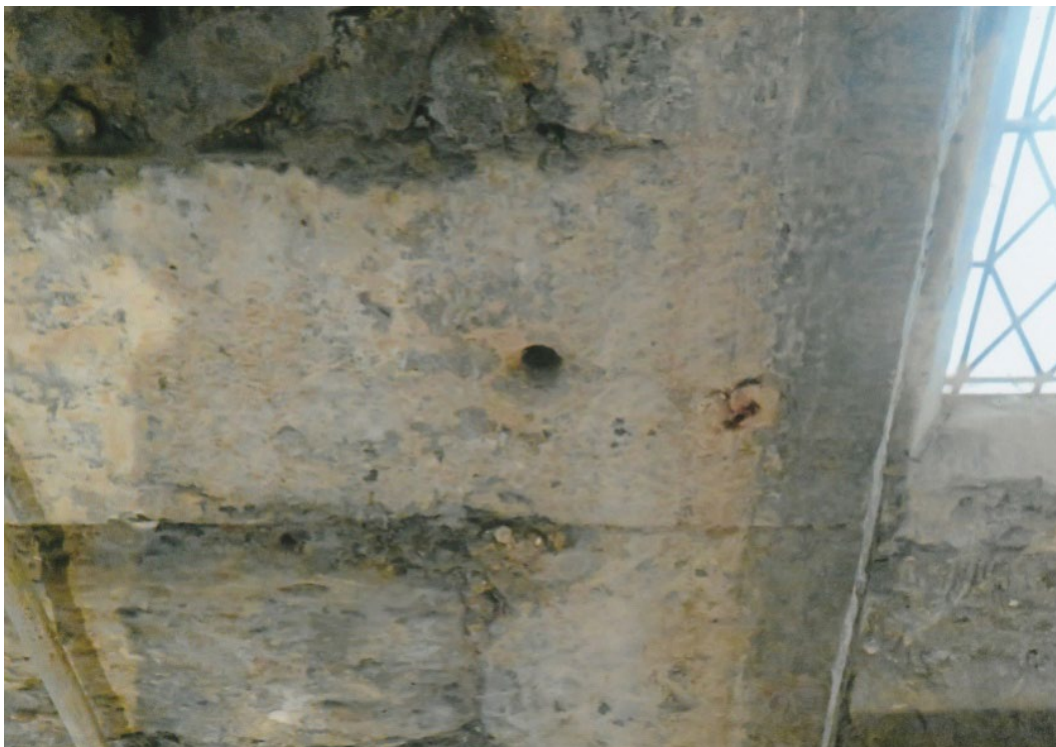
*Fig. 52 A drill hole and a timber-filled drill hole with a nail at the side of the widow.*  
*Photograph: J. Higgins.*

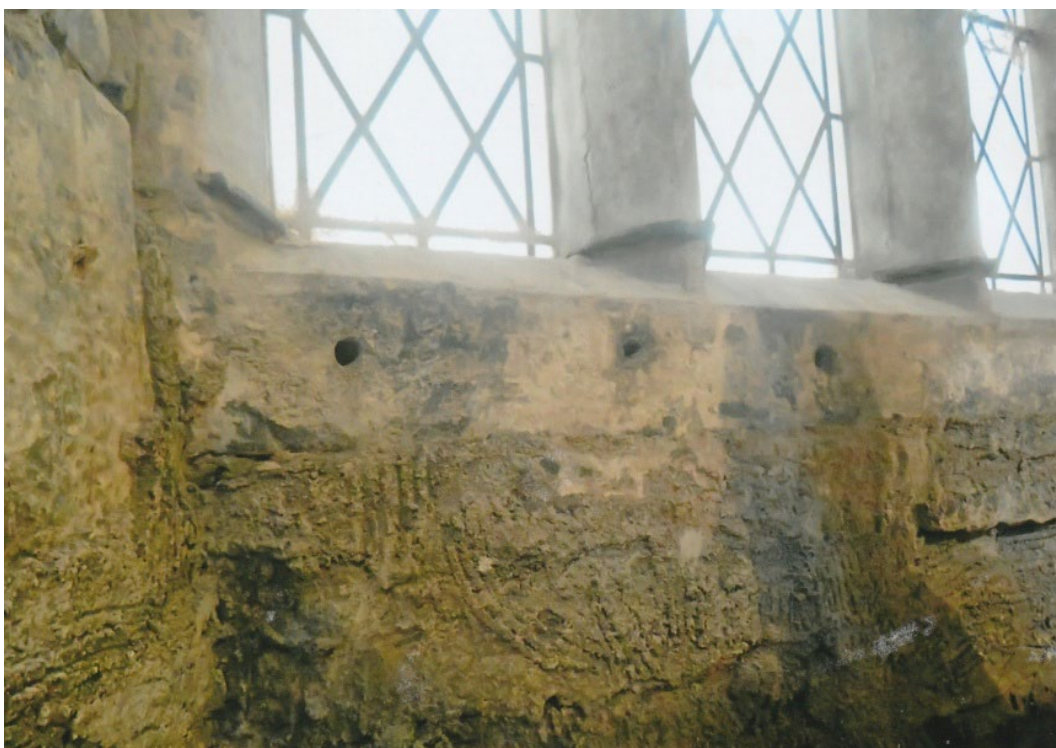
*Fig. 53 Drilled holes of unknown function in the sill of the window.*  
*Photograph: J. Higgins.*

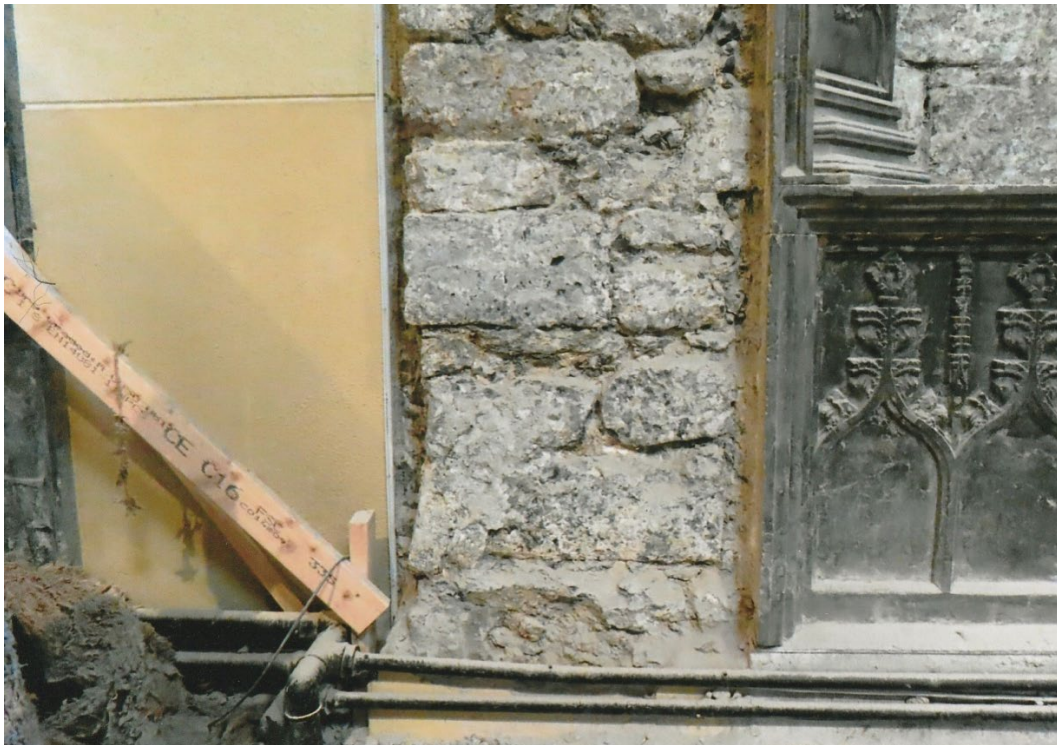
*Fig. 55 The blocked ope, truncated lintel and relieving arch to an opening to the left of the base of the Lynch Tomb.*

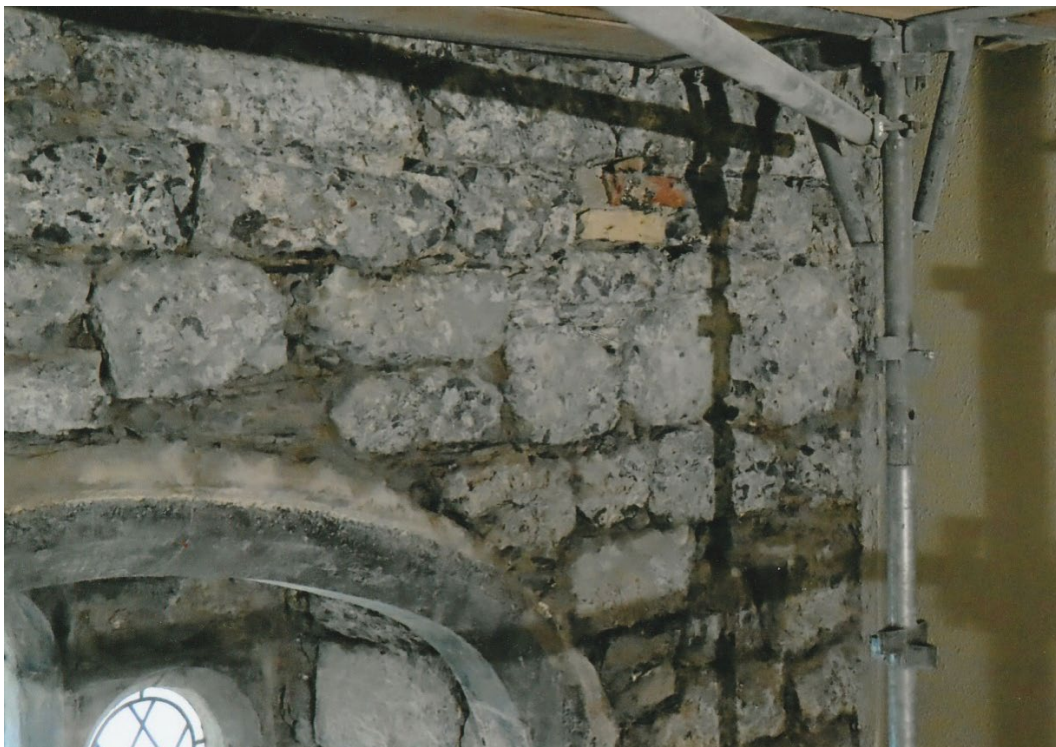
Two further brick filled sockets were also found higher up in the interior of the east wall of the South Transept Extension.

*Fig. 56 Brick filled socket above the upper window in the South Transept Extension (upper right corner).  
Photograph: J. Higgins.*

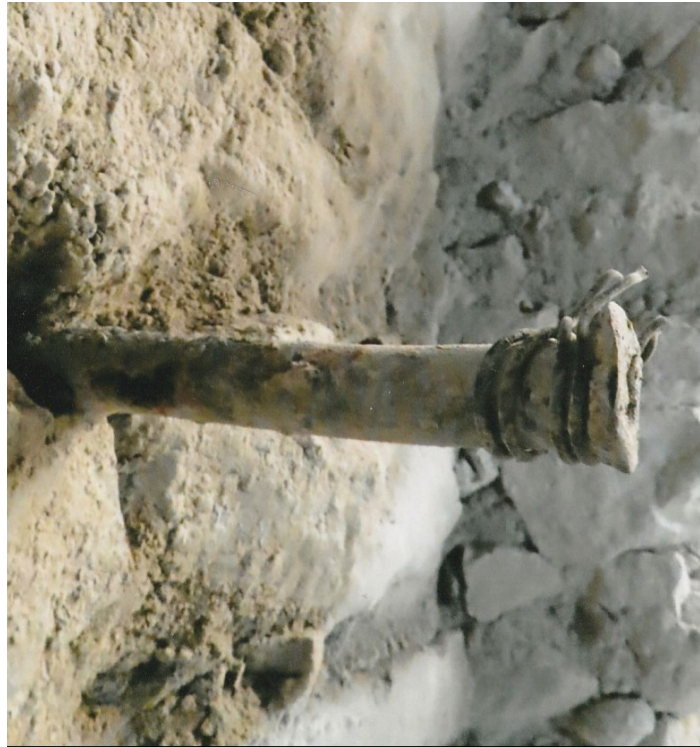
Fourteen pieces of scrap metal were driven into the wall face of the niche in an attempt to help to secure the shuttered concrete metal tubing, iron spikes, hammered band iron, circular sectioned iron and steel, spiked supports for gutters and a tubular copper alloy spikes were among the items used. A large heavy chisel with a faceted shank and burned top had an interesting history. It had been purposed by heating and reshaping its working end and bending its shaft to an elongated L shape. It is reminiscent of a modern mason's tool for pushing mortar into joints, though it must have been difficult to use. Its altered end has been reduced to a point by rusting.

*Fig. 58 Copper alloy spike, one of 14 metal pieces driven into the back wall of the niche over the Lynch tomb to help to hold the 1950's – 1960's shuttered concrete.*

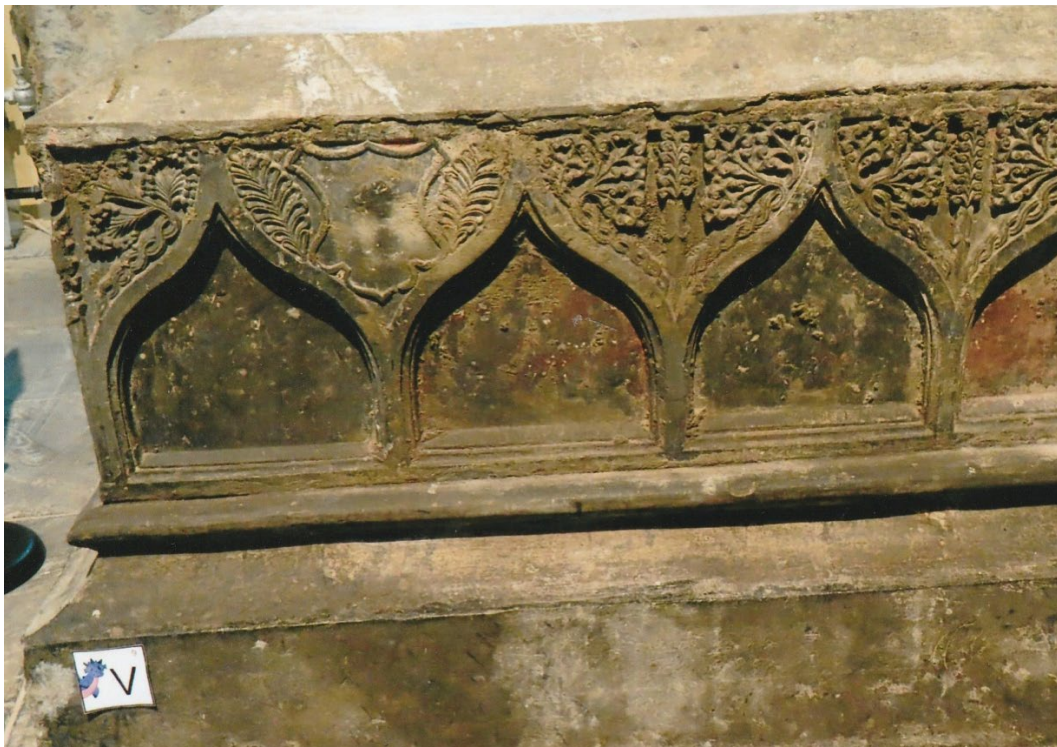
Traces of green and possibly red paint survive in a very dark form on this tomb and blue and red colouring survives on the Lynch Corner Tomb. It is hoped to get paint and plaster, whitewash and other analysis done with a Heritage Council Grant in 2024. A modern tile was found in the small rough stones. It has been decided not to re-render or replace coverings on the bases of windows until next year and to monitor how the fabric dries out in the meantime. Considerable drying had taken place in the month since the stripping works were carried out.

*Fig. 61 Some of the carved panels of the Lynch Tomb were painted originally. This will be analysed in 2024.*

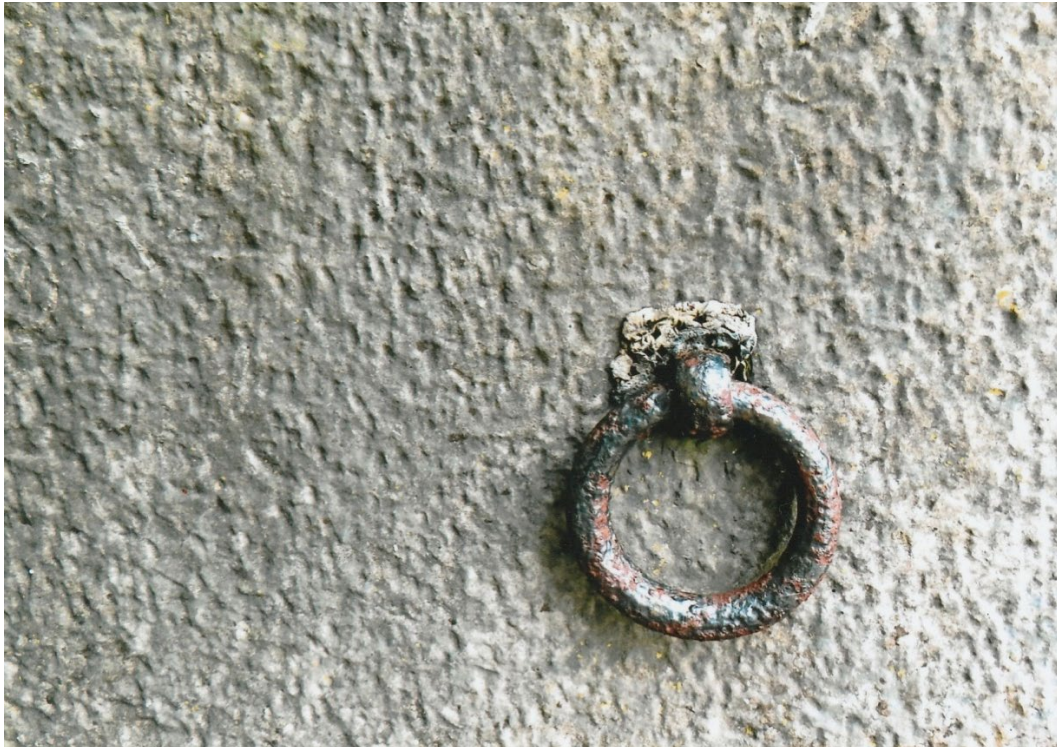
*Fig. 62 A ring-pull like the St. Nicholas discovery set in the side of a box-tomb at Fortbill Cemetery, Lough Atalia Road, Galway.*

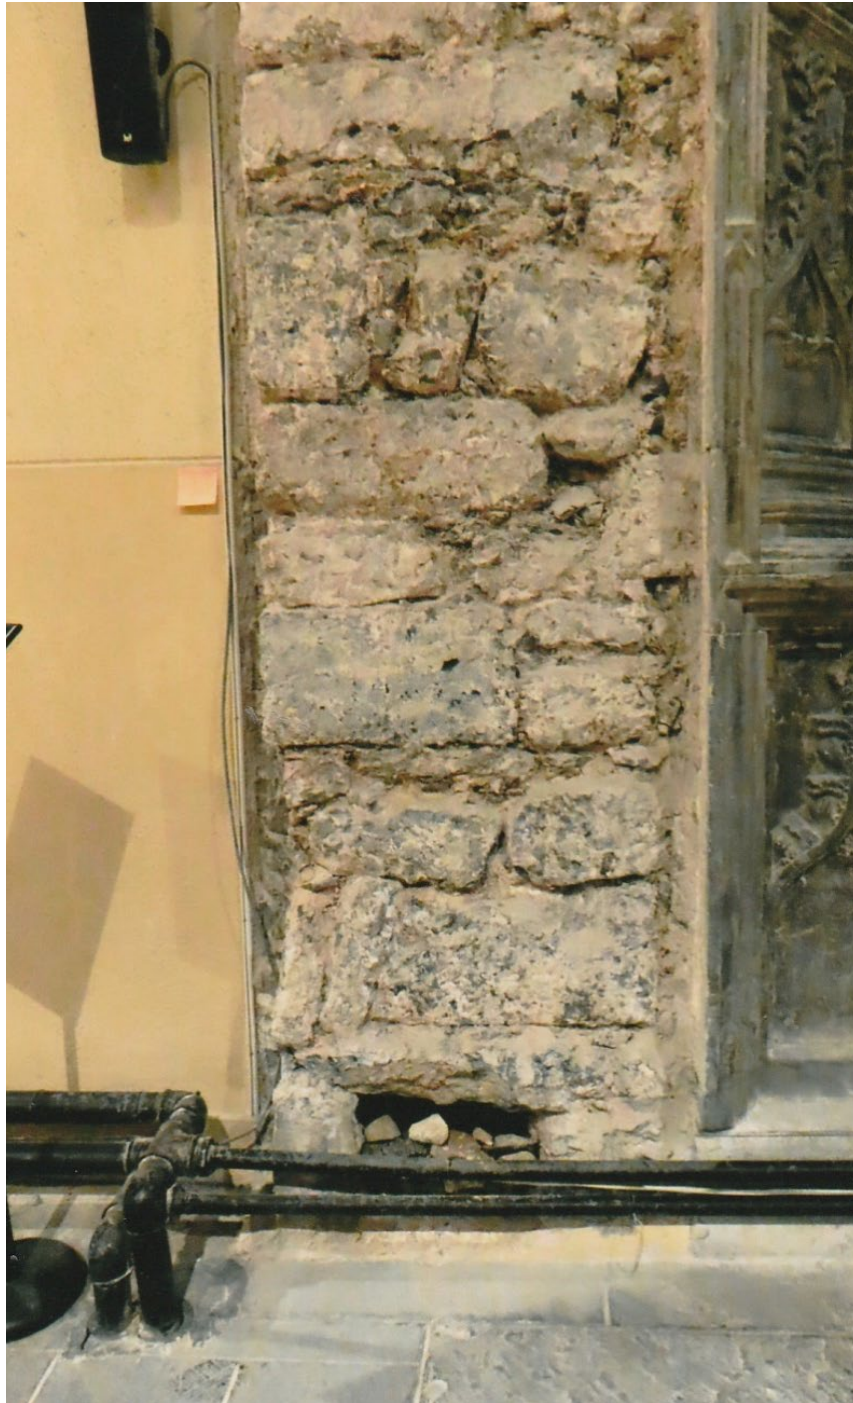
*Fig. 64 The removal of some of the late mortar from a sample area of the lintelled ope to the left of the Flamboyant Canopied and Traceried Lynch tomb showed the presence of an ope with walling to the back of it.*

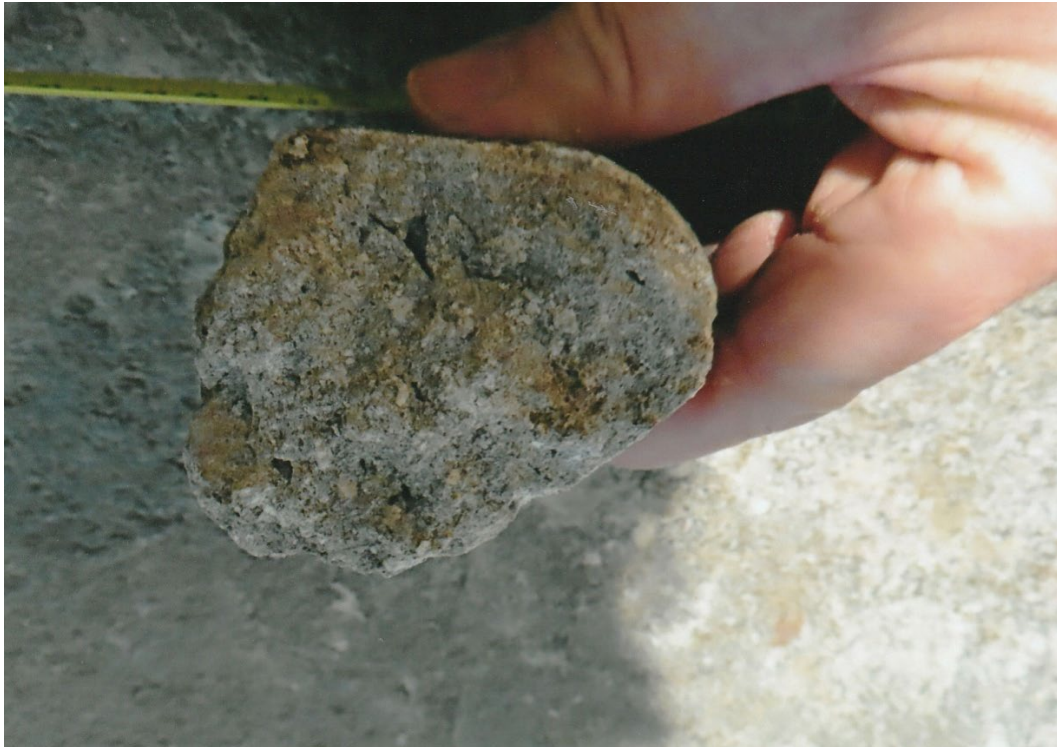
Part of a roll moulding of gritty grey plaster. The surface layer of smoother plaster off while plaster. The external surface has been painted or stained and is dark grey to greenish black in colour where the outer surface survives. H: 6.2, L:10.2, T: 6.5cms.

*Fig. 65 A piece of moulded plaster moulding found in the recess below the Lynch Canopied and Traceried Wall Tomb.*

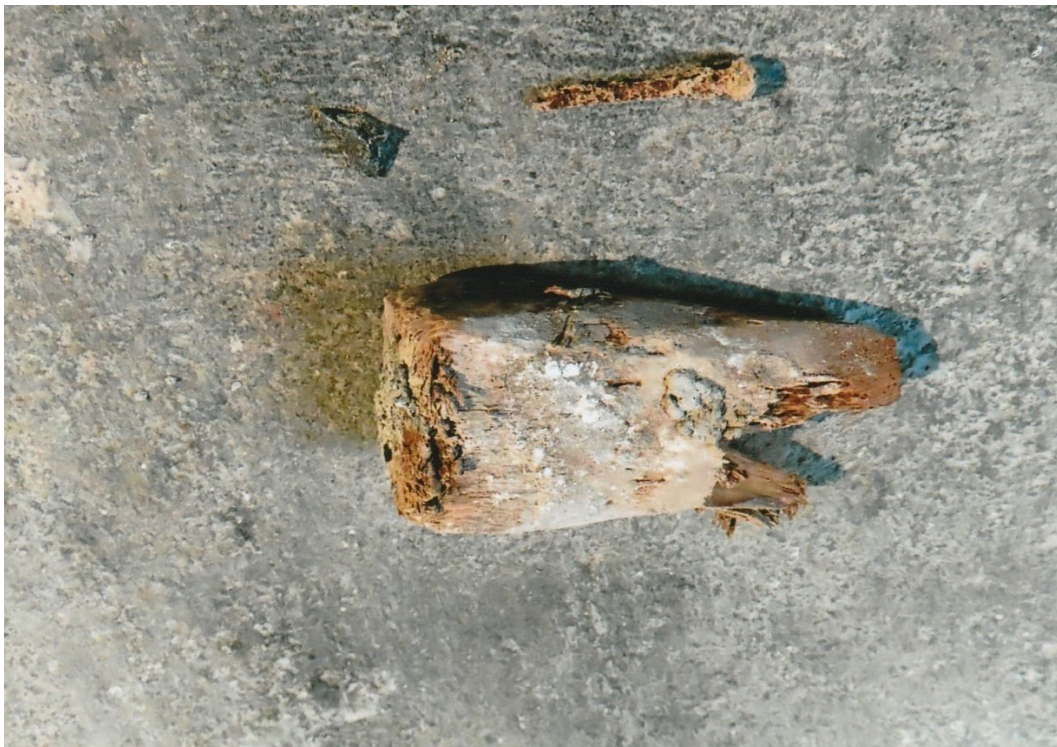
The wedge has been damaged by hammering into the fill of the blocking of the fragmentary lentelled opening below the Lynch Flamboyant and Traceried Canopied Tomb. Several facets cut by an axe or adze survive may have been attached to old render or a 19<sup>th</sup> century heating system. Numerous other pieces of timber driven into the north pane of the lower widow of the South Transept Extension. Six of these may have been for supports for timber and plaster lining. These were left in *situ*.

*Fig. 66 Nail and wooden wedge from the interior of the blocking and wooden wedge from the interior of the infill of the ope below the Lynch Tomb.*

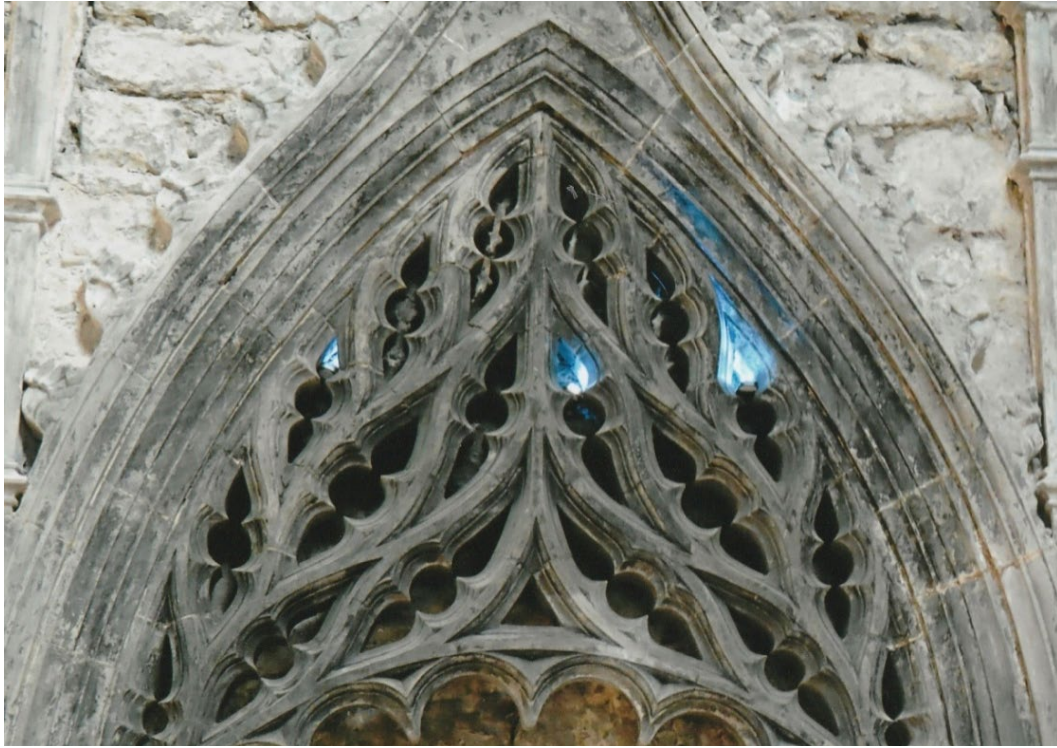
*Fig. 67 The tracery of the flamboyant Gothic Style Canopied and Traceried Wall Tomb Lights have been inserted to show the line of a cut stone recess with a chamfered edge occurs behind the upper part of the tomb. It is unclear whether this feature continued on either side as the tomb recess is blocked with stone mortar and a (19th century) tile.*

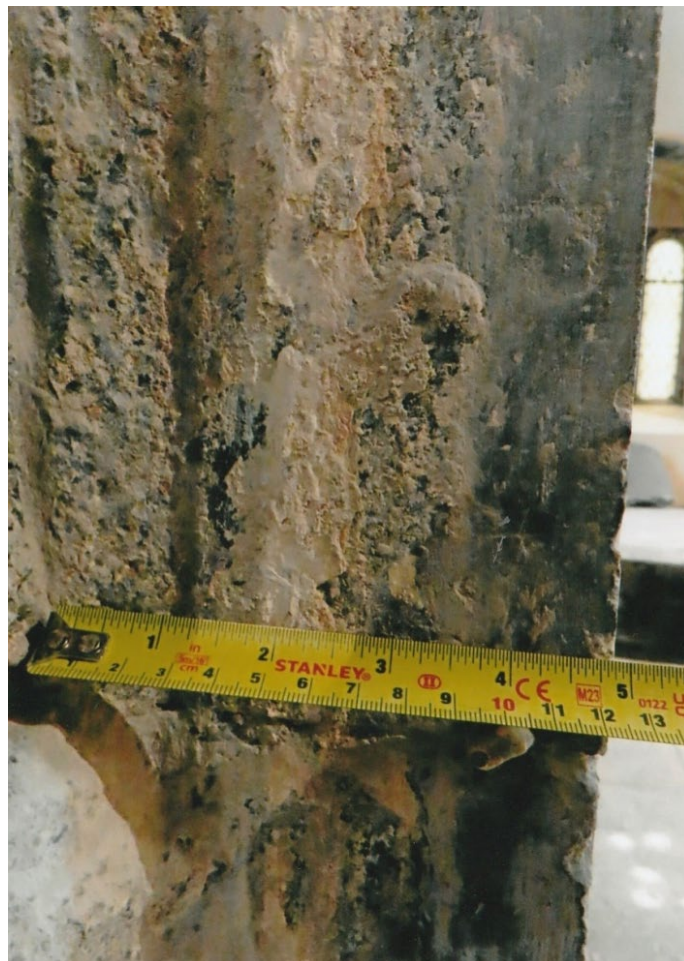
*Fig. 68 Layers of lime wash on the moulded side of the canopied wall-tomb.*

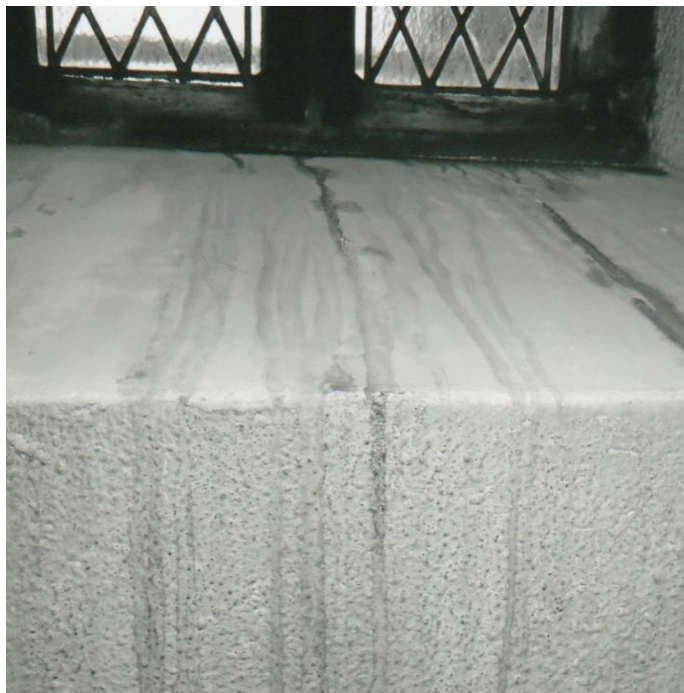
*Fig. 69 Water flowing from a window sill in the South Transept of St. Nicholas' Collegiate Church October 2023. The window embrasures were filed to the base of the interior of the sills prior to the 1950's – 1960's re-rendering of the interior of the church.  
Photograph: J. Higgins.*

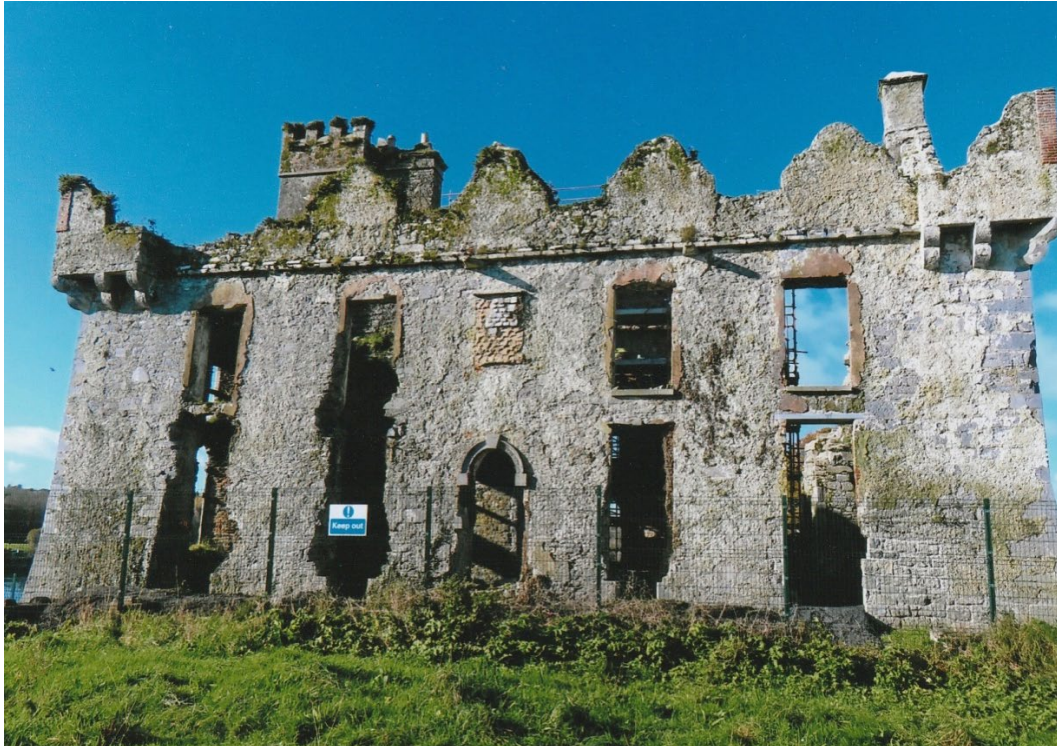
*Fig. 72 The main frontage of Menlo Castle has yet to be conserved. The Georgian doorcase in the middle had a porch in front of it and a doorcase of Renaissance style and early 17<sup>th</sup> century date. The doorcase is now at Ashford Castle though parts of its jambs are still at Menlo and were identified in 2023.*

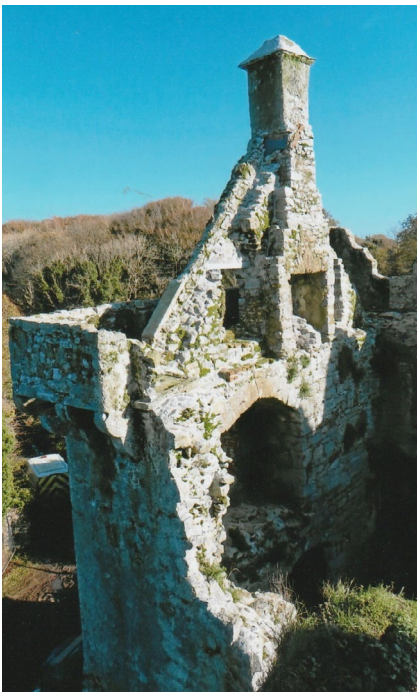
*Fig. 73 Part of the Tower House element of Menlo Castle conserved in 2022. It may incorporate earlier fabric of a Hall House.*

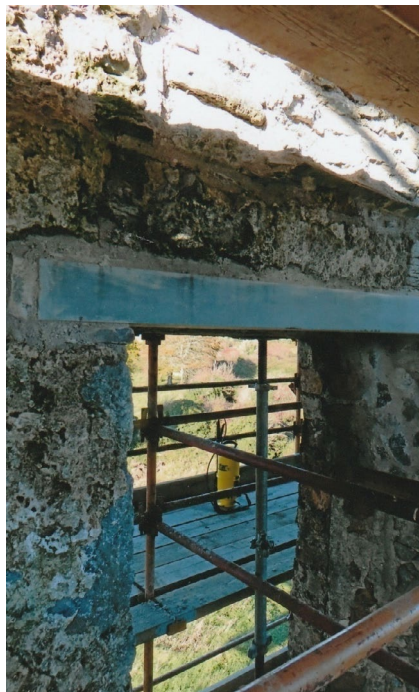
*Fig. 74 A limestone lintel inserted over a window. The original lintels had rotted out but were circular logs of wood cut in half.*

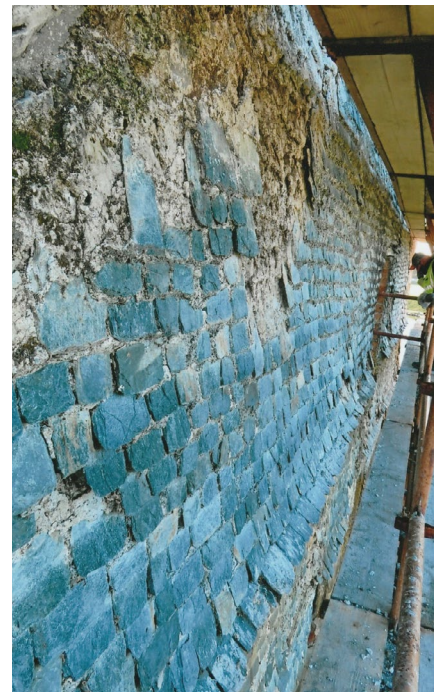
The ivy growth removed in 2021 had loosened many slates and as many as possible were put back in the 2023 conservation work.

*Fig. 75 The schist weather sheeting on Menlo Castle. Ivy growth had dislodged many slates prior to its removal in 2021.*
