# GALWAY'S HERITAGE IN STONE

## Catalogue No. 9

### The 2023 Archaeological and Conservation Works at St. Nicholas' Collegiate Church Galway and Menlo Castle

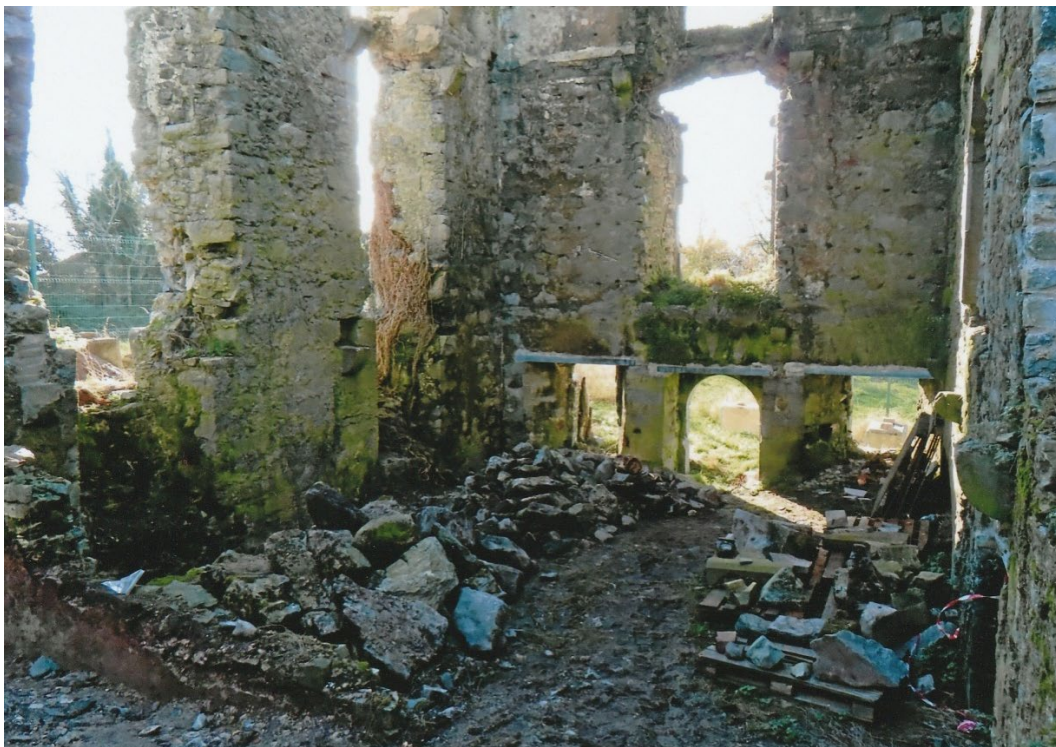
*Fig. 76 The interior of the 17<sup>th</sup> century block of Menlo. Fallen stone and rubble was sorted and architectural fragments were put on pallets in 2022 and 2023.  
Photograph: J. Higgins.*

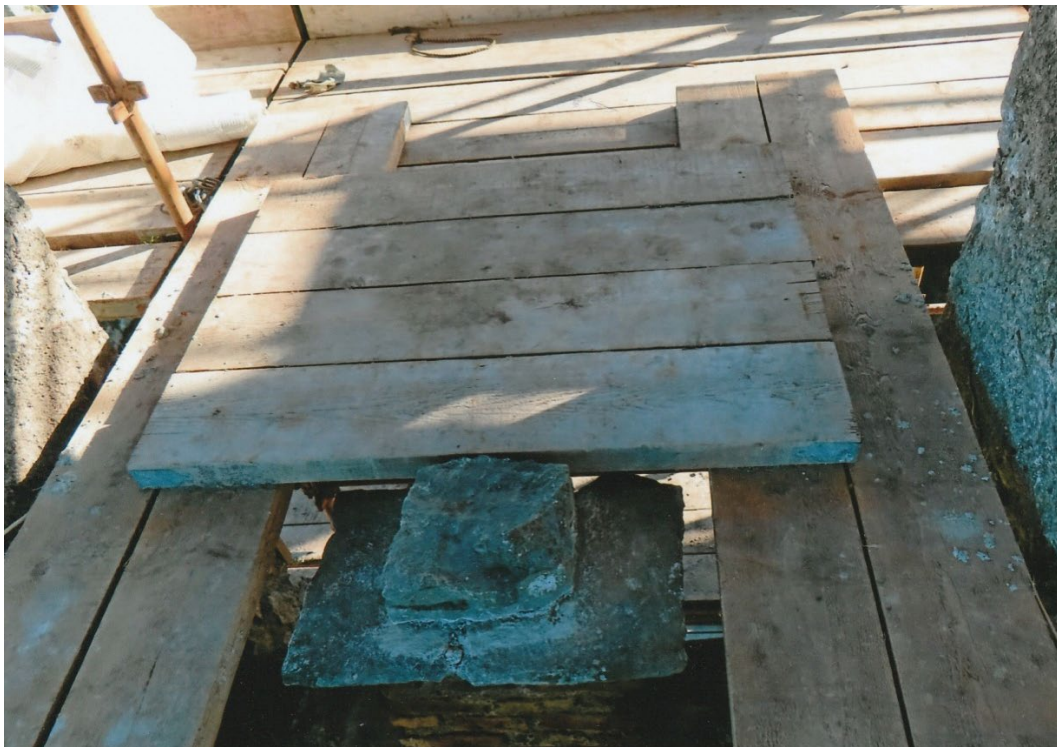
*Fig. 79 Scaffolding and planking around decorative finials of brick and stone on the River front of Menlo Castle. The brick was Annaghdown – Clonboo brick and had previously been rendered in lime mortar and harling.*

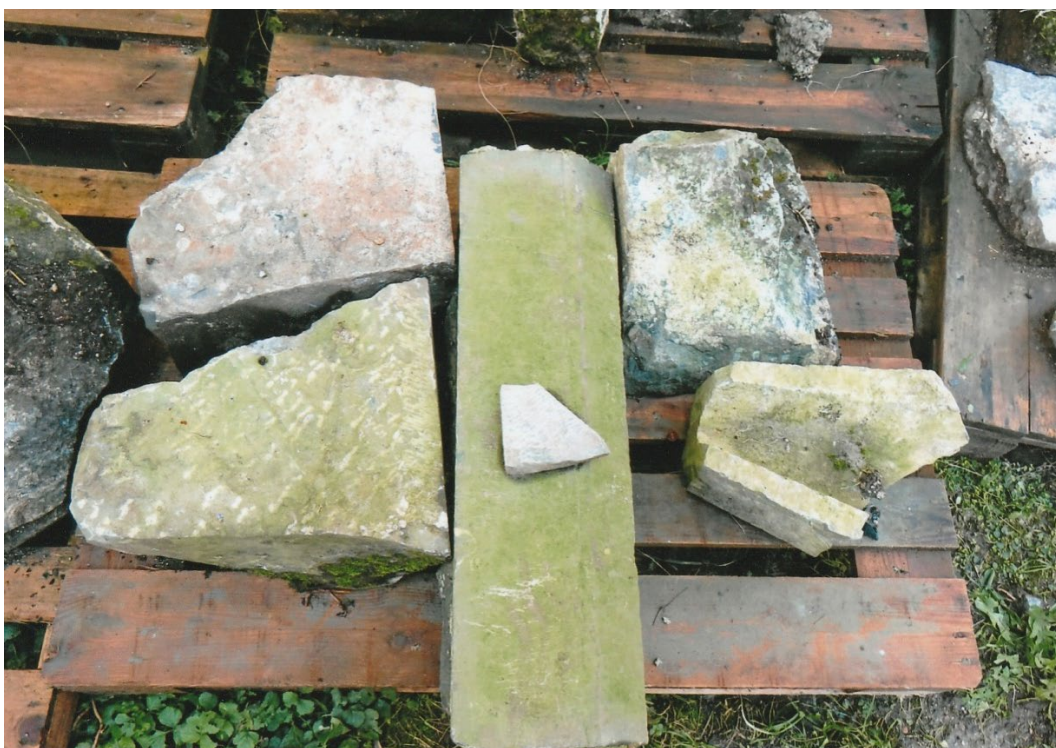
The front of an octagonal water spout was found in 2022 and the remainder of it in 2023.

*Fig. 84 Window, door and water spout fragments on pallets in 2023. The tapering water spout comes from a broken water spout on the 17<sup>th</sup> century frontage and will be put back in position. The window fragment in the middle was found in 2022. A full catalogue of architectural fragments is in preparation.*

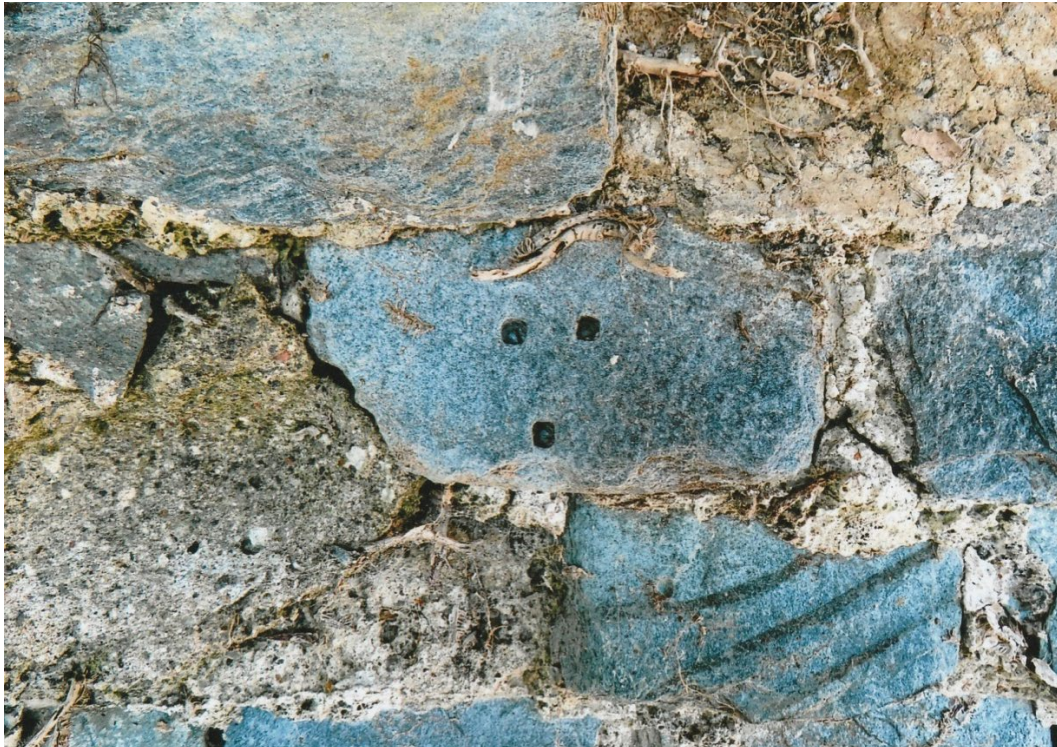
*Fig. 89 Not a plug socket! Just old holes in some of the schist weather slating at Menlo Castle.  
Photograph: J. Higgins.*

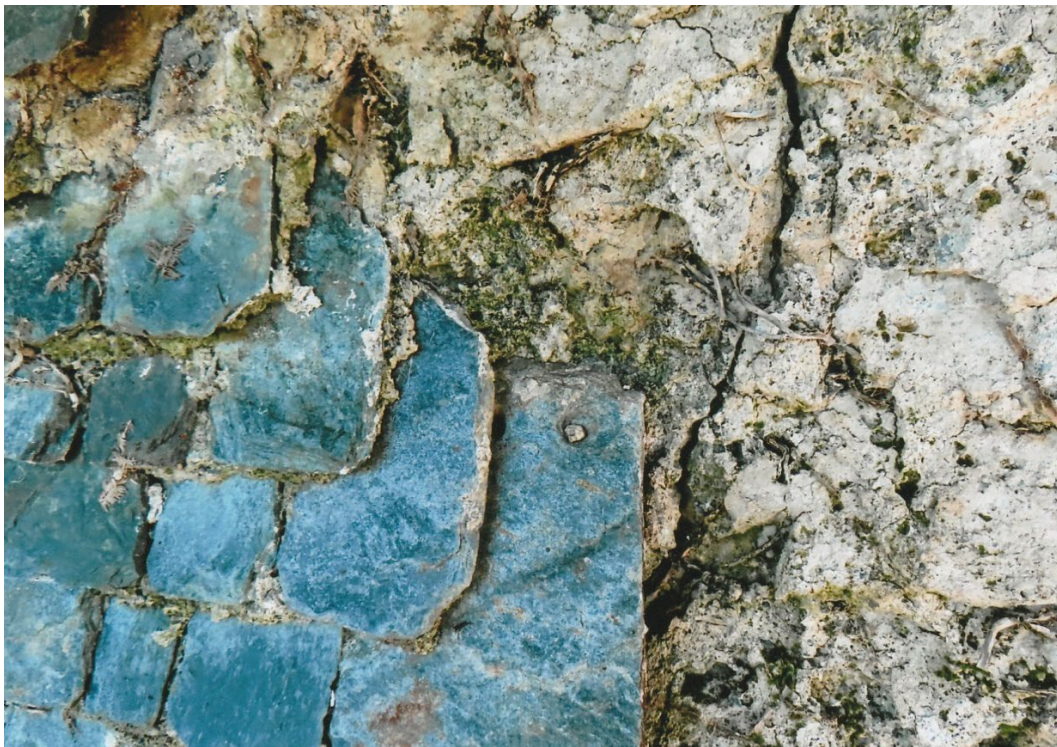
*Fig. 90 Some of the surviving schist weather sheeting bedded in lime mortar some have nail holes but are reused.  
Note the remnants of ivy roots.  
Photograph: J. Higgins.*

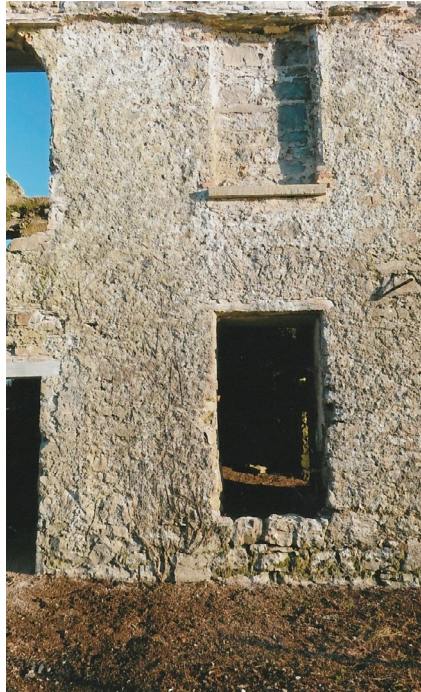
*Fig. 96 Ground floor window with relieving arch above a lintel. Part of the lower walling of this frontage may be late medieval. The upper, blocked window is 18th – early 19th century.*  
*Photograph: J. Higgins.*

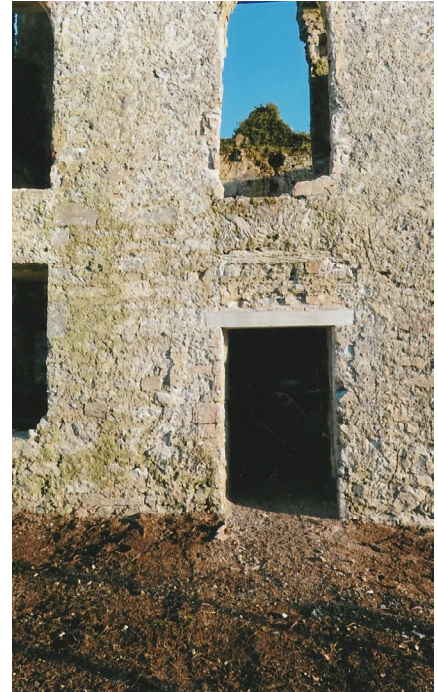
*Fig. 97 Doorway with new lintel inserted in 2023. May originally have been a late medieval window with a lintel and a relieving arch over it.*  
*Photograph: J. Higgins.*

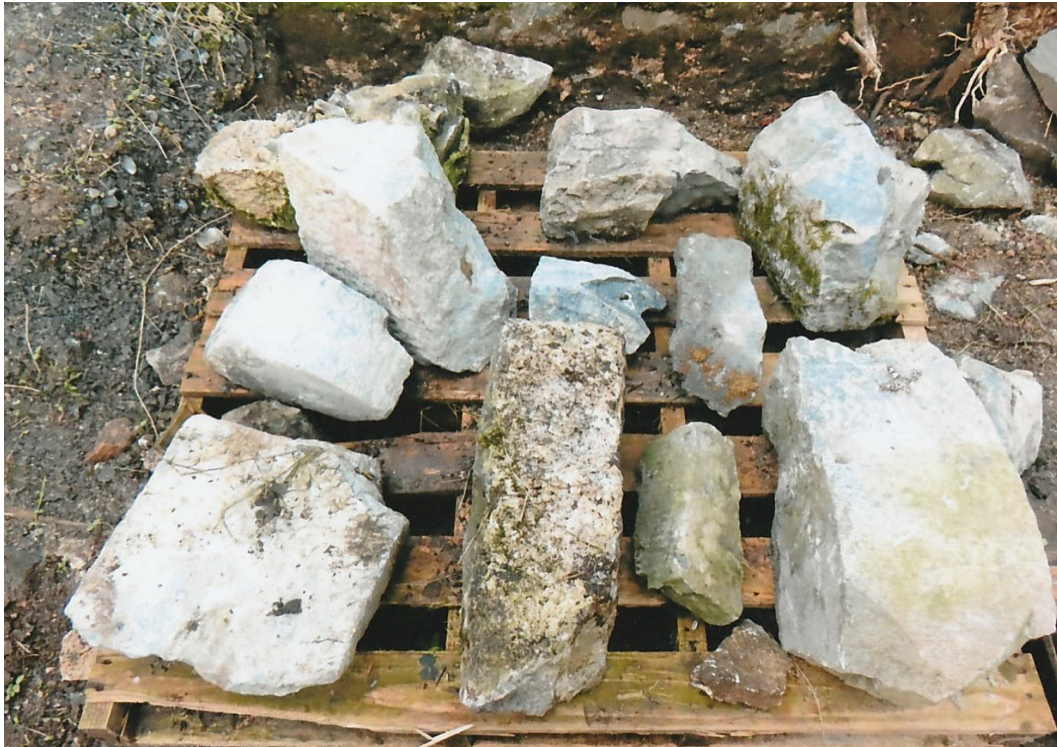
A course of corbels on the inside of the wall of the main front was fragmentary and some had fallen into the building when they sheared off. Several were found in 2022 and more in 2023.

*Architectural fragments including fragments of corbels from the internal face of the main front.  
Photograph: J. Higgins.*
