Technical Report

NEW LAWN CEMETERY

HYDROGEOLOGICAL ASSESSMENT

| Document Control Sheet | |
|---|---|
| Client: | Galway City Council |

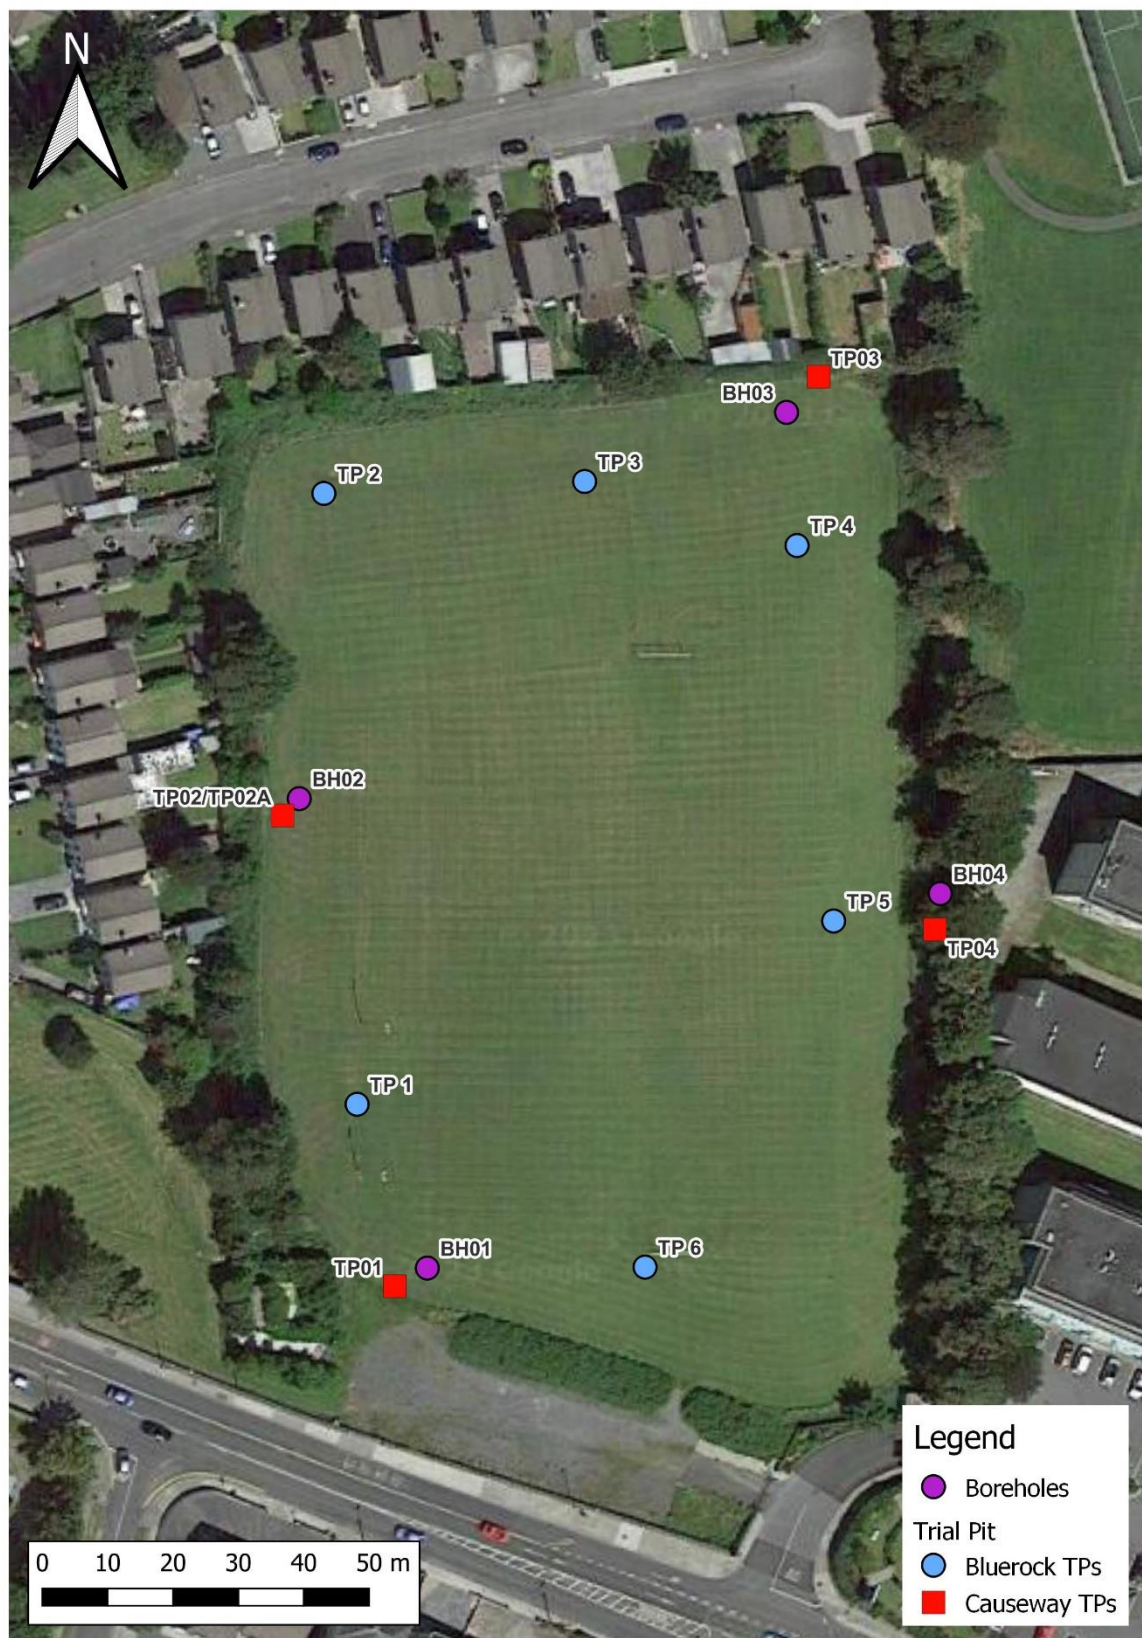
Figure 1 Location of exploration boreholes and trial pits at New Lawn site.

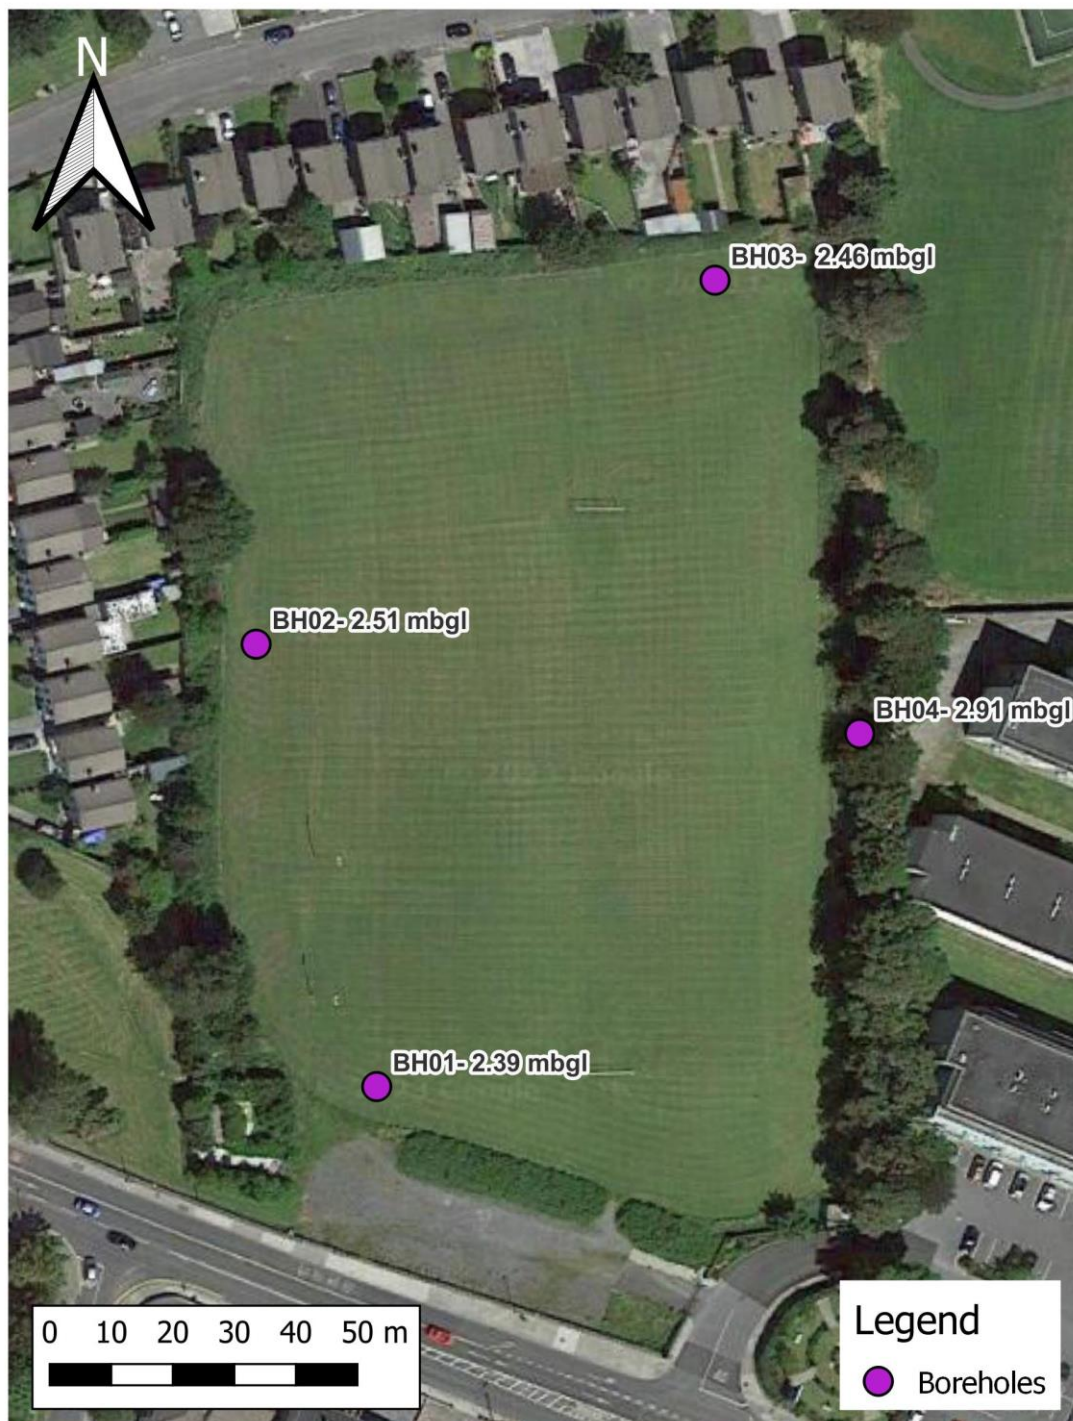
*Figure 3 Watertable maximum observed in the 4 no. boreholes as per the BREL 2022 report*

Based on the recorded water levels in the four monitoring boreholes, across most of the site, the water table rebounds to above the top of the rock into the overburden (see Figure 2 and Figure 3).

The groundwater table maximum at each of the boreholes as per the logger data reported in the Bluerock report, is shown on Figure 3. Groundwater levels at each of the boreholes consistently rise into recommended unsaturated zone beneath the grave bottoms (<2.8 mbgl), although do not appear to exceed the minimum grave depth of 1.8 mbgl.
